DIY Write-Up
Ball Joint Replacement
2007 Honda Accord SE 4CYL

At 318K Miles (2007 4CYL SE) my lower ball joint (factory original) started squeaking over bumps and there was visible play in the joint. I replaced the ball joint and learned a lot along the way. In the hope that it might save others from some hassle, this document shows the process I went through to replace the ball joint and documents a few things I learned along the way.

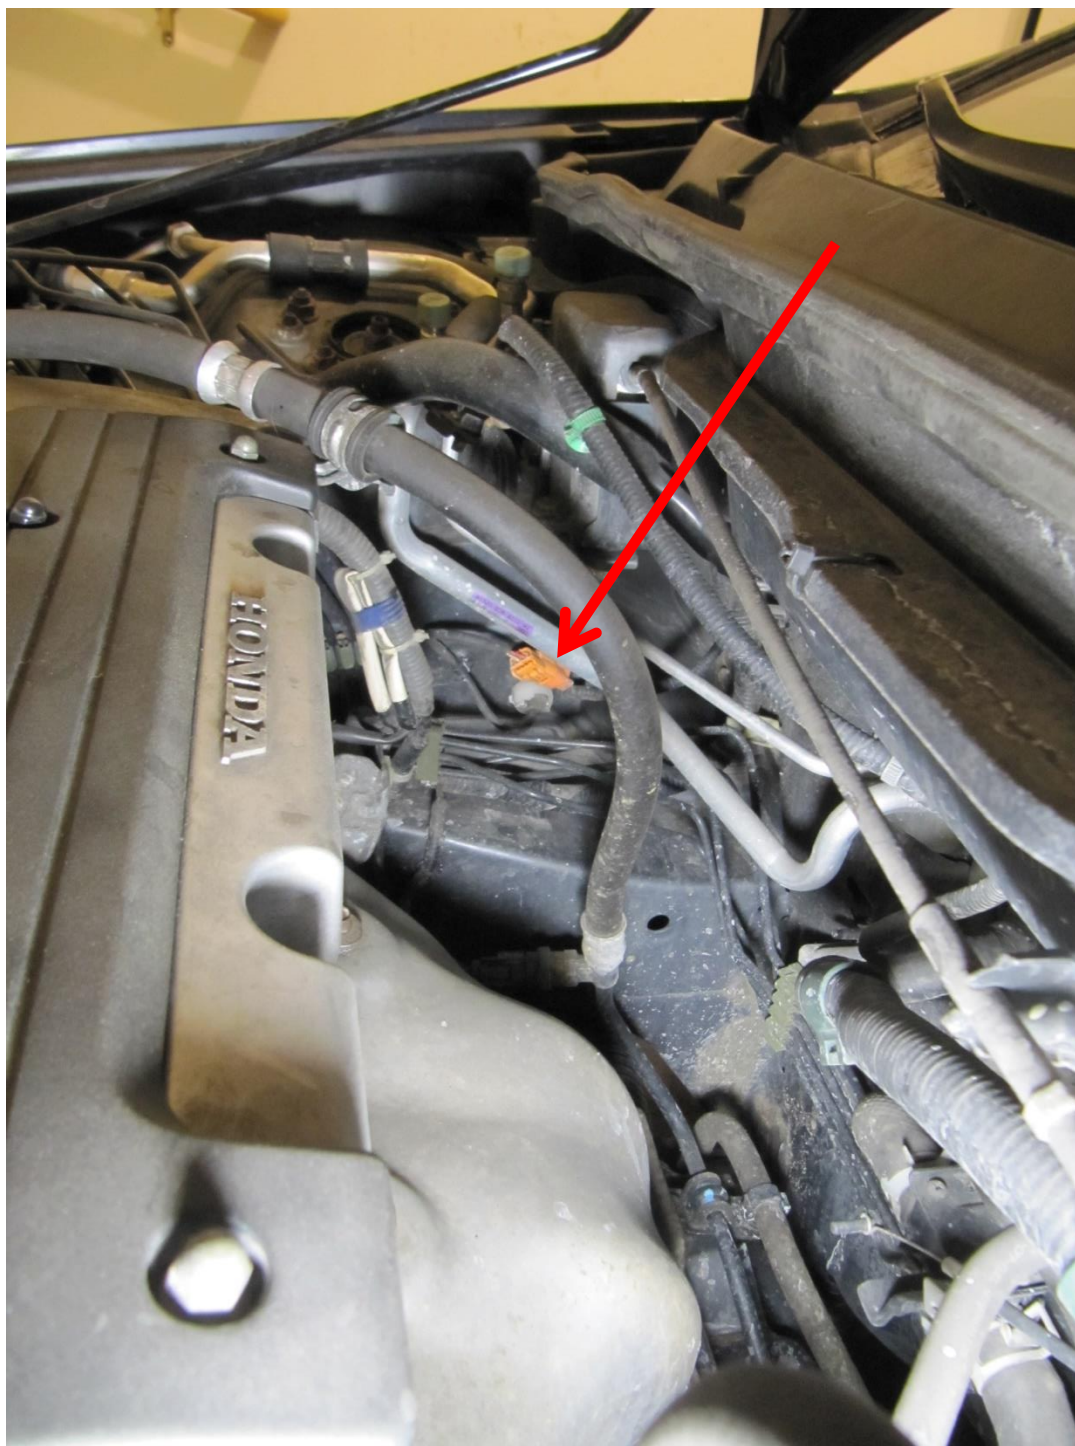
It can be pretty difficult to remove the ABS sensor from the knuckle (mine were really rusted in). I found it easier to simply disconnect the ABS sensor at its connector under the hood as shown below instead:

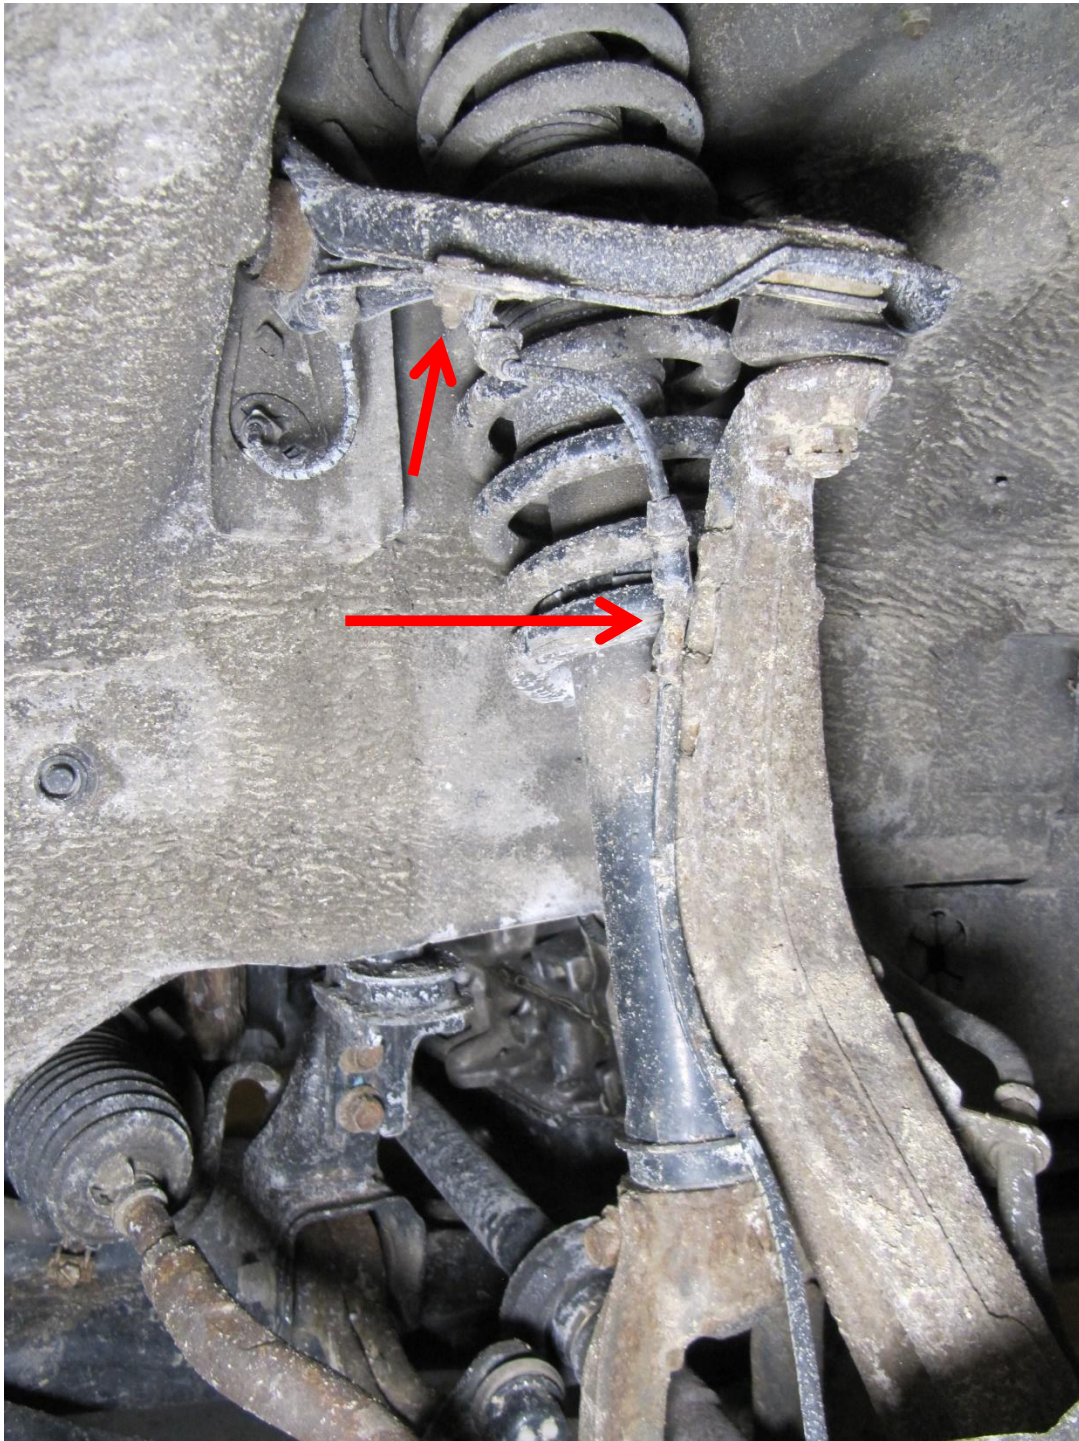
Next, remove the two bolts holding the ABS wire onto the upper control arm and knuckle:

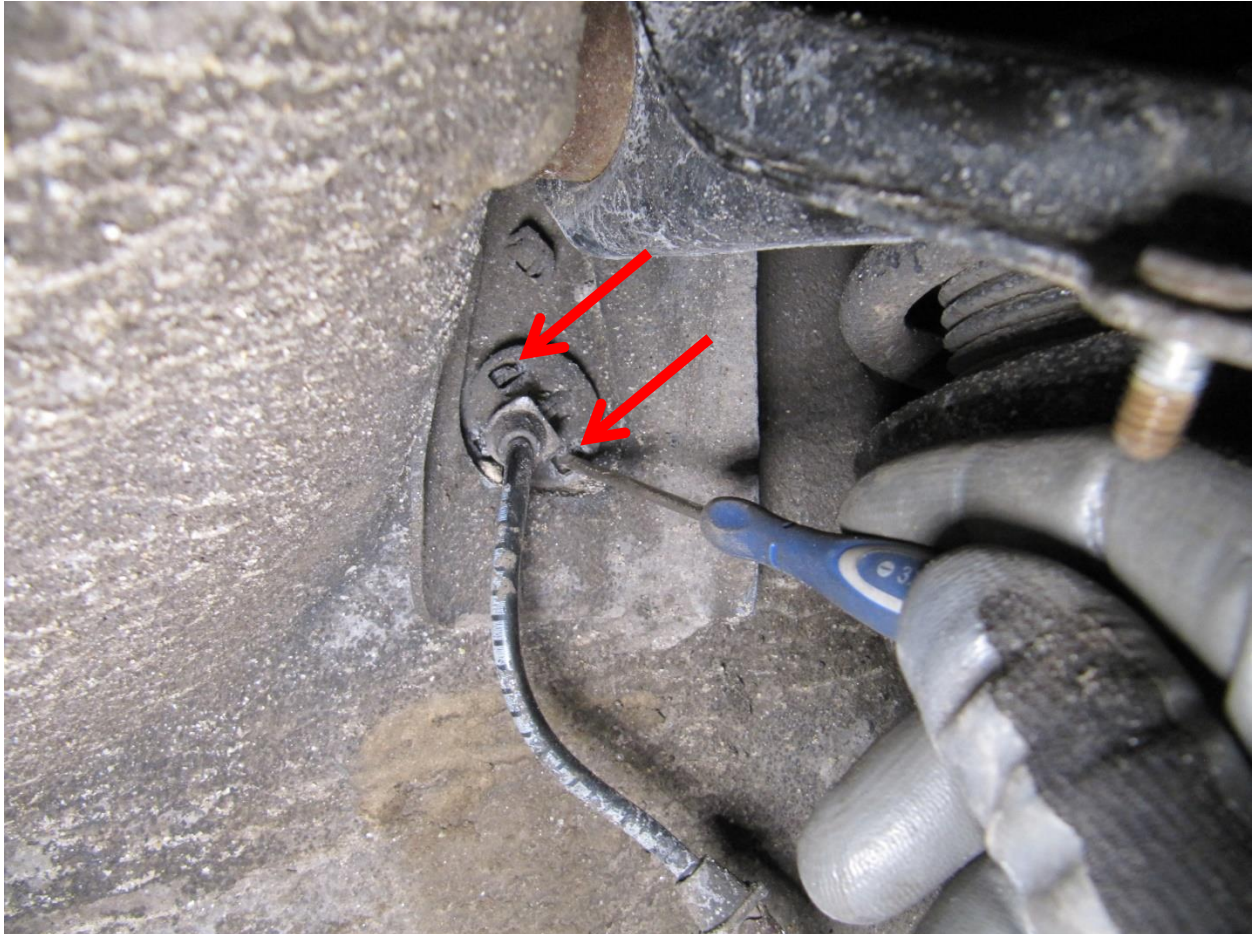
There are two small tabs that you need to press in with a screw driver in order to remove the ABS line from the body.

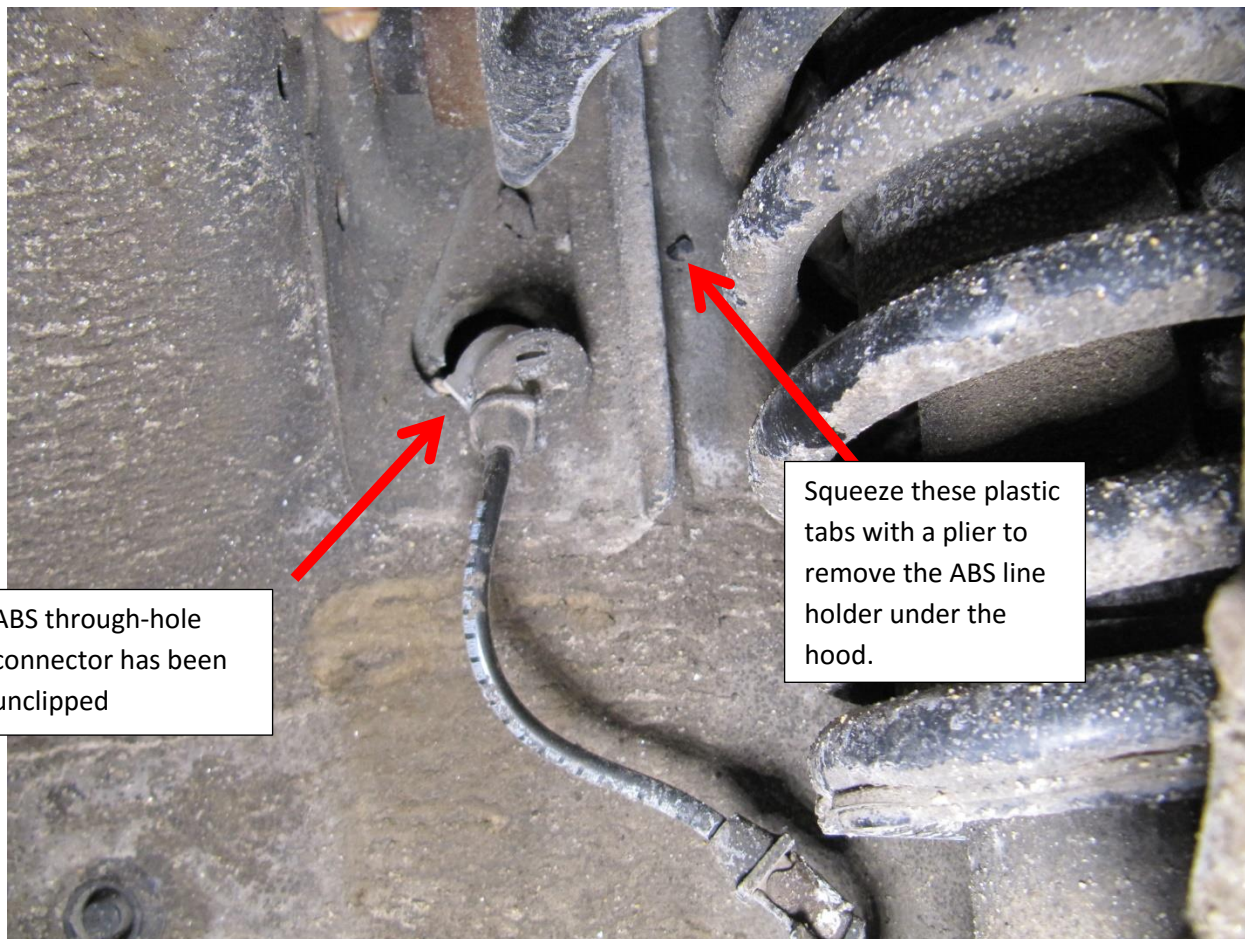
Once the ABS through-hole connector is removed, there is another wire holder on the inside of the engine compartment that holds the wire in place. This can be removed by squeezing the plastic tabs at the location shown below and then pulling the wire holder off from under the hood:

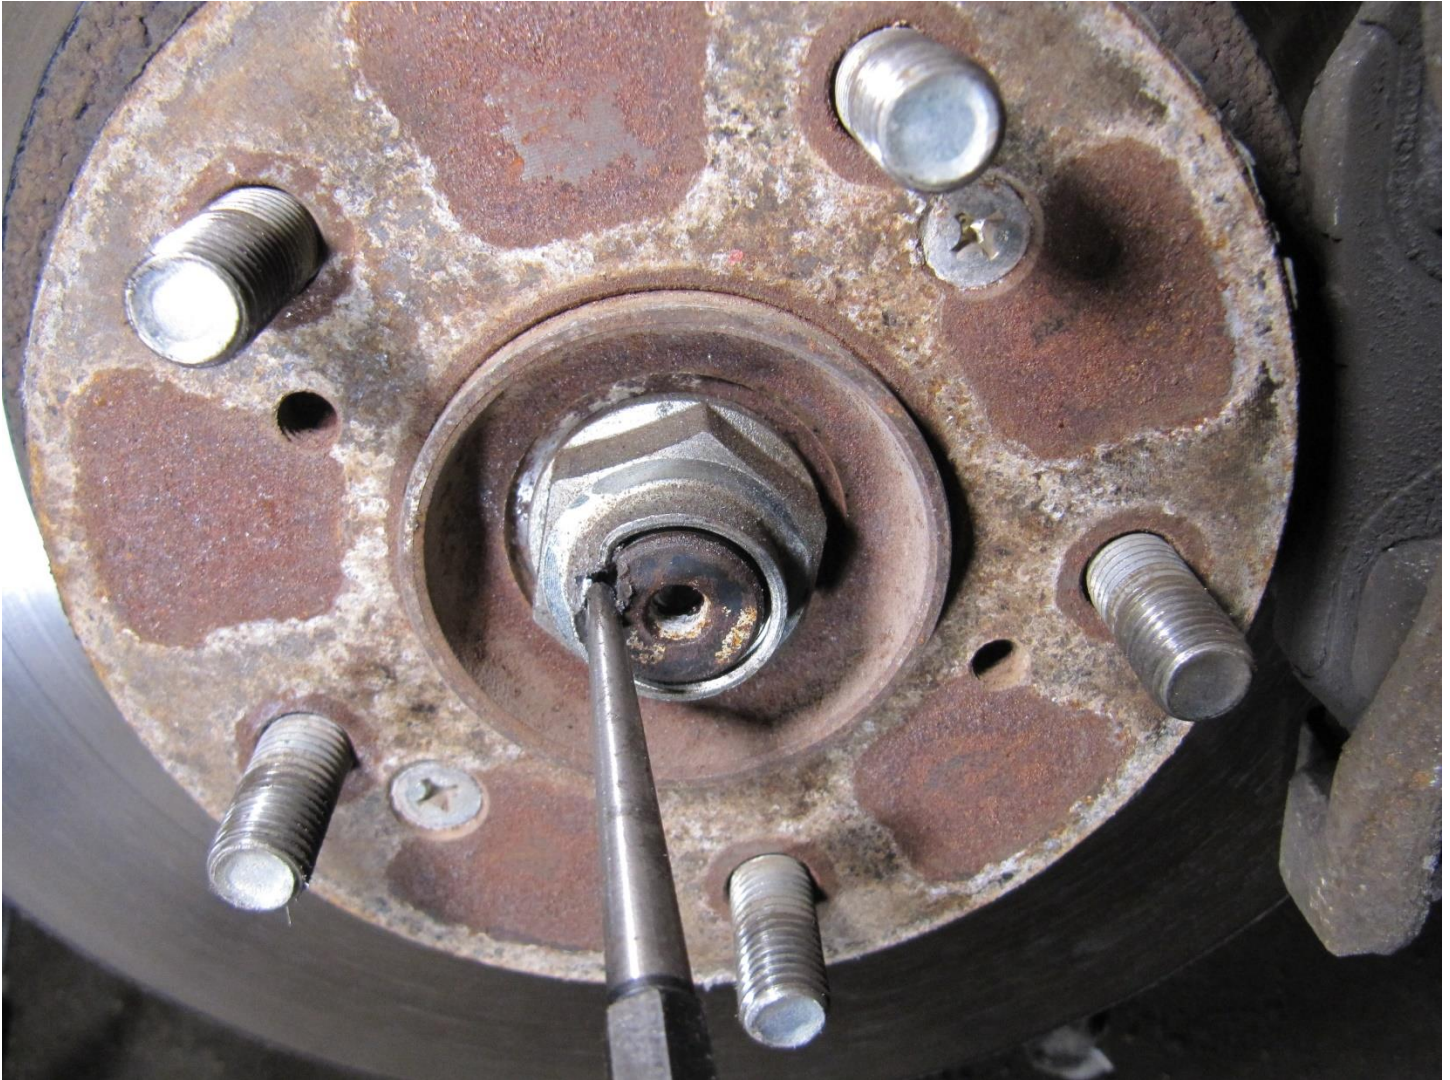
Un-stake the axle nut:

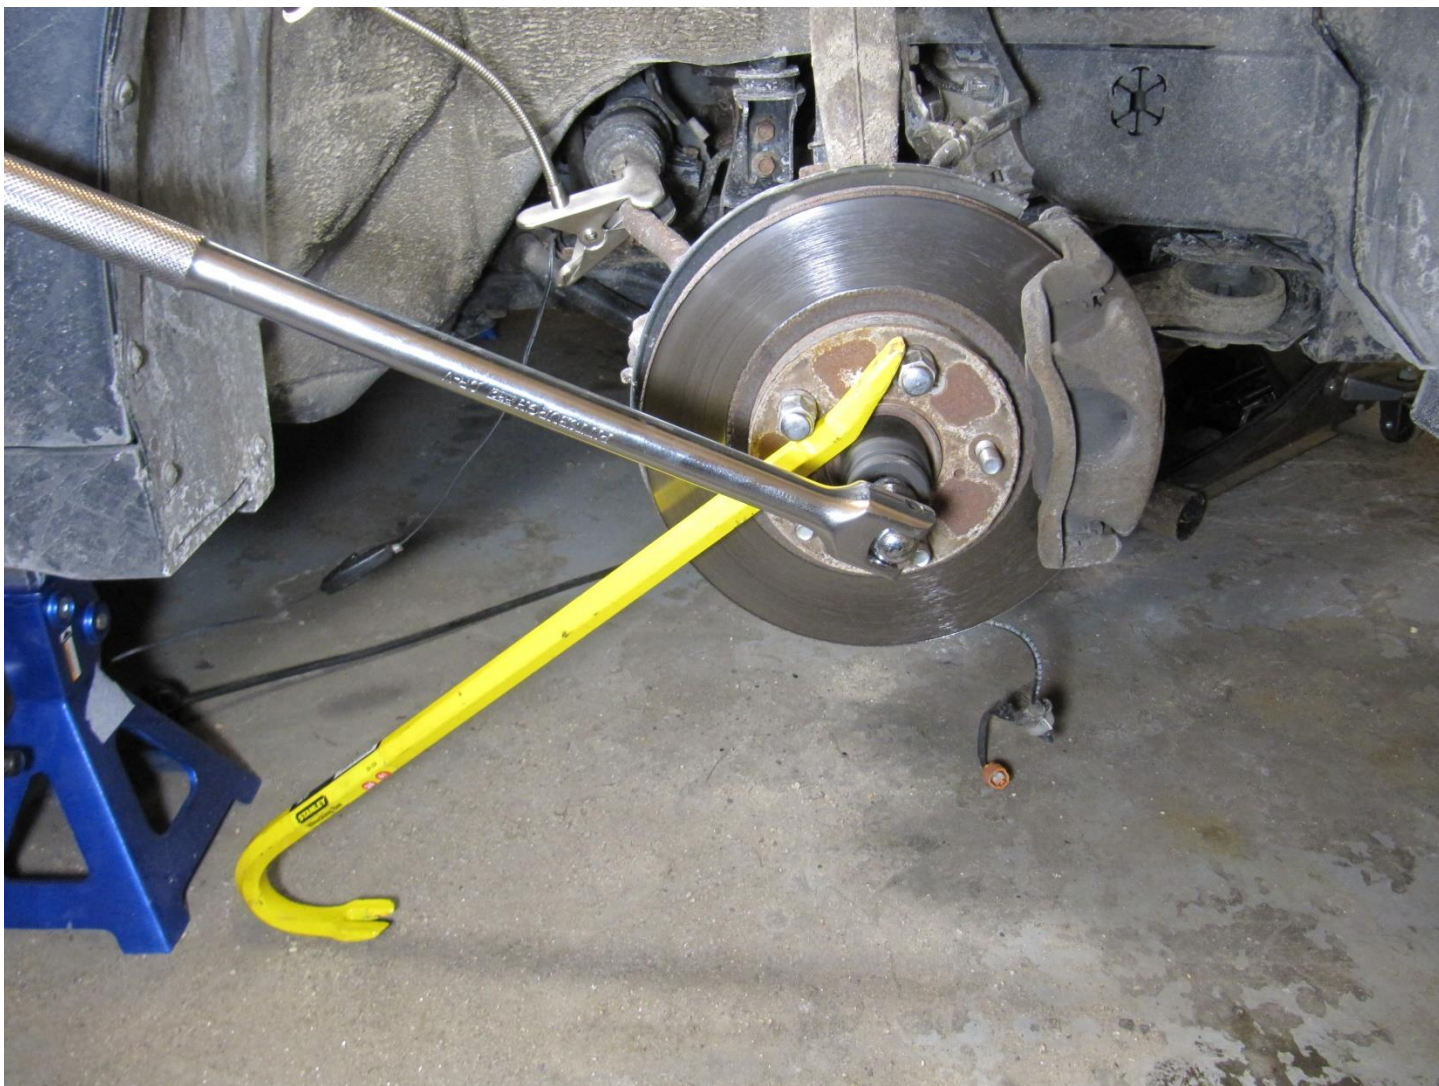
And remove the axle nut. I used a crowbar to keep the rotor/hub from turning. If you use this method, be sure you put lug nuts on to ensure that the threads don't get marred up in the process. Another option is to loosen the axle nut with the wheel still on before jacking up the car.

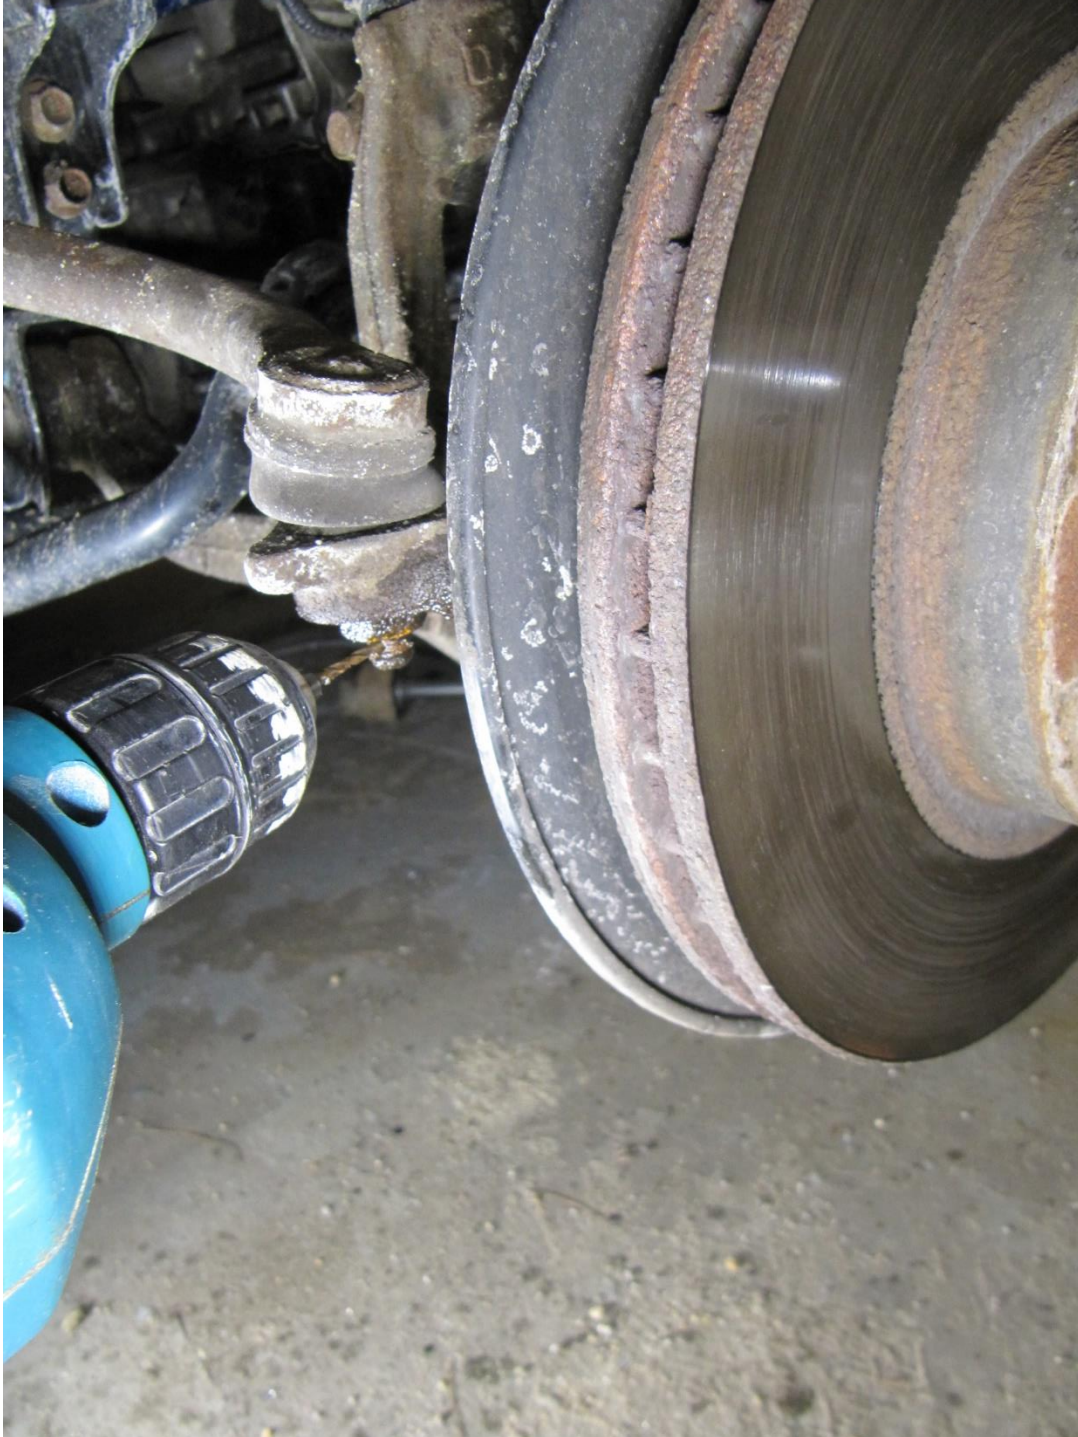
Next, remove the cotter pin from the tie rod end (if you can!). In my case the cotter pin was so rusted in (it has been in there for about 10 years) that there was no way it was coming out. I just cut off the ends of the cotter pin and drilled out the hole:

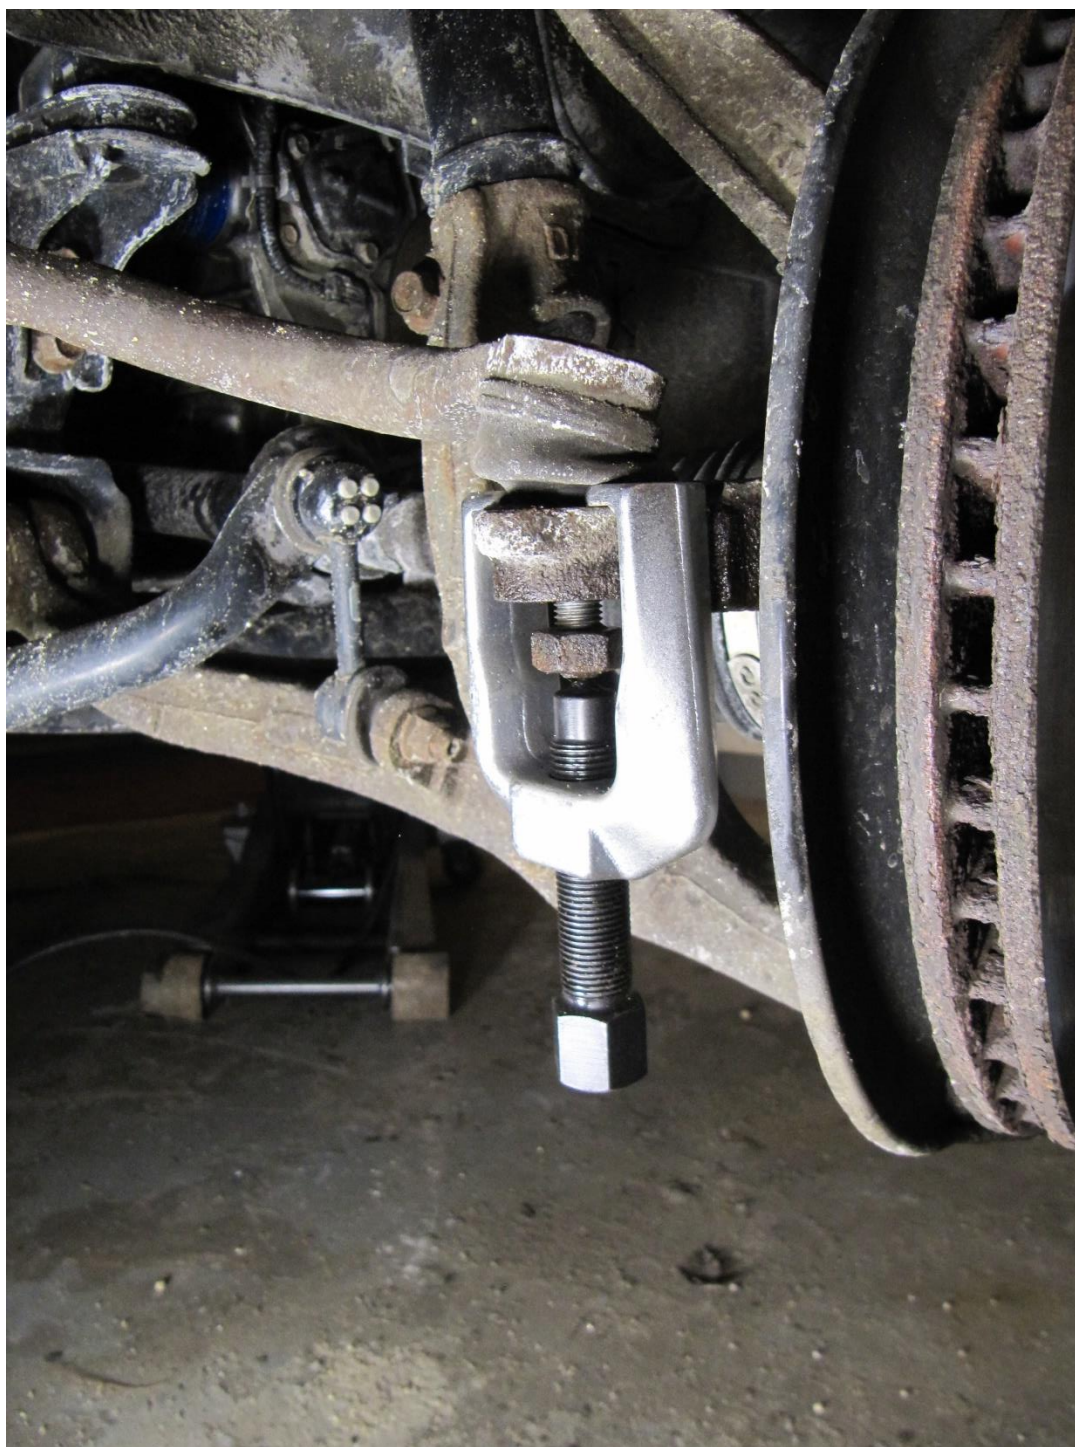
Use a Pitman puller to remove the tie rod end from the knuckle (or hammer on the knuckle where the tie rod end goes through it, if you prefer):

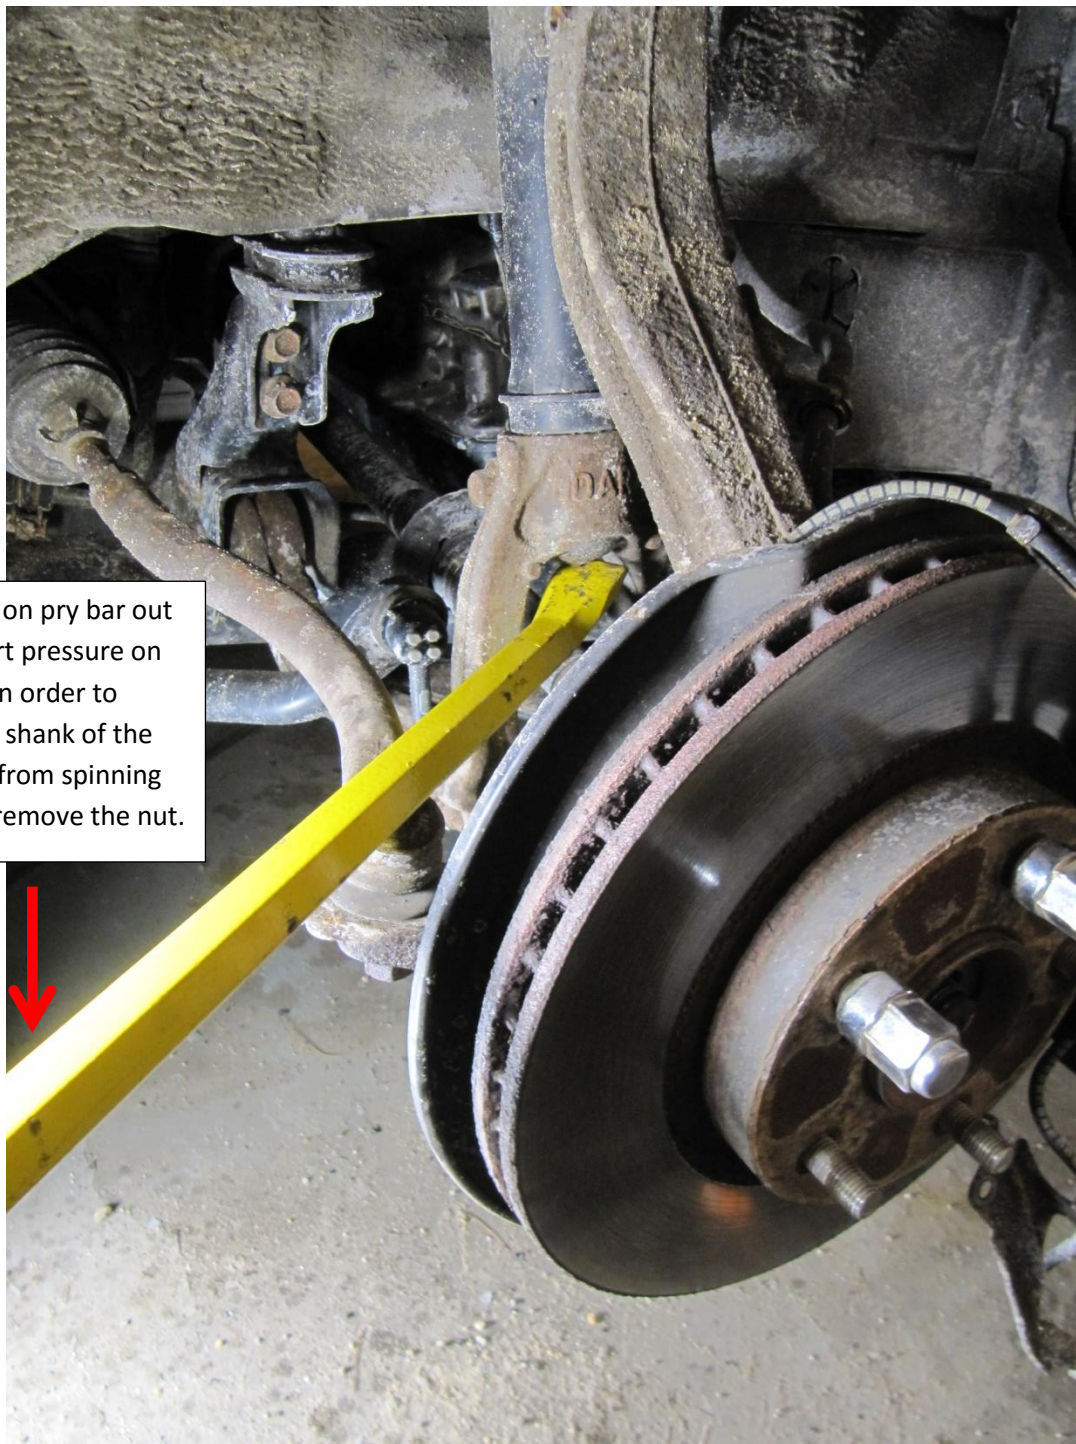
When you go to remove the tie rod end nut, you may find that the tie rod ball joint spins (instead of the nut). If so, it may be necessary to apply some downward pressure on the tie rod end to prevent this from happening as shown below:

Press down on pry bar out here to exert pressure on the tie rod in order to prevent the shank of the tie rod end from spinning in order to remove the nut.

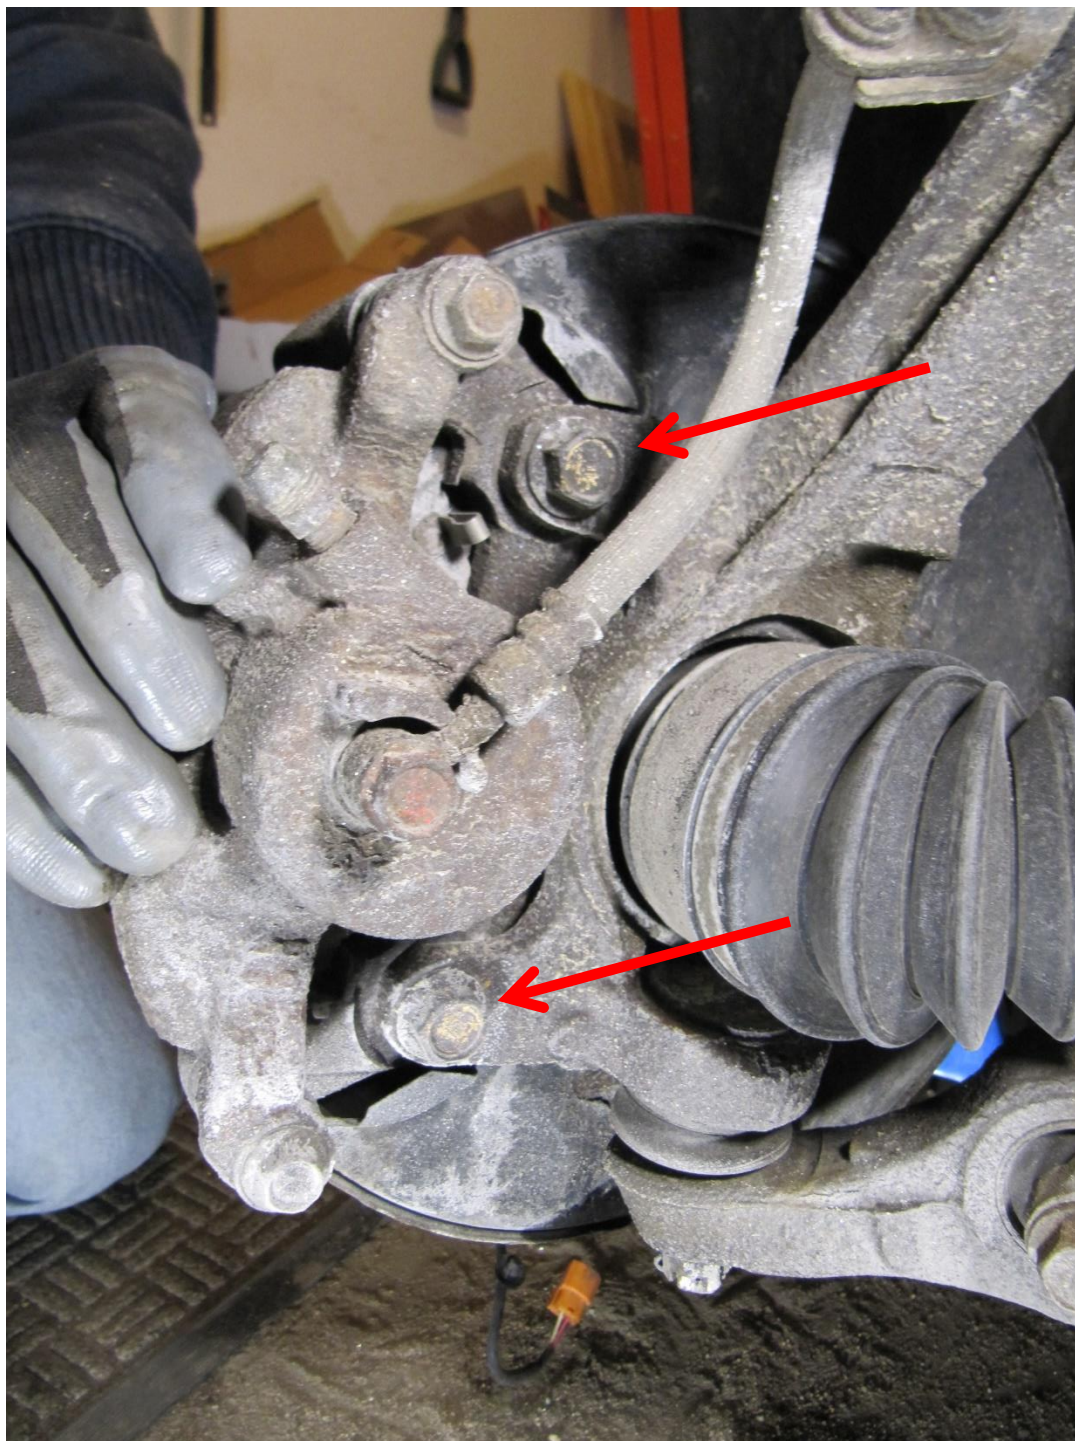
Remove the two bolts holding the caliper bracket (and entire caliper) onto the knuckle:

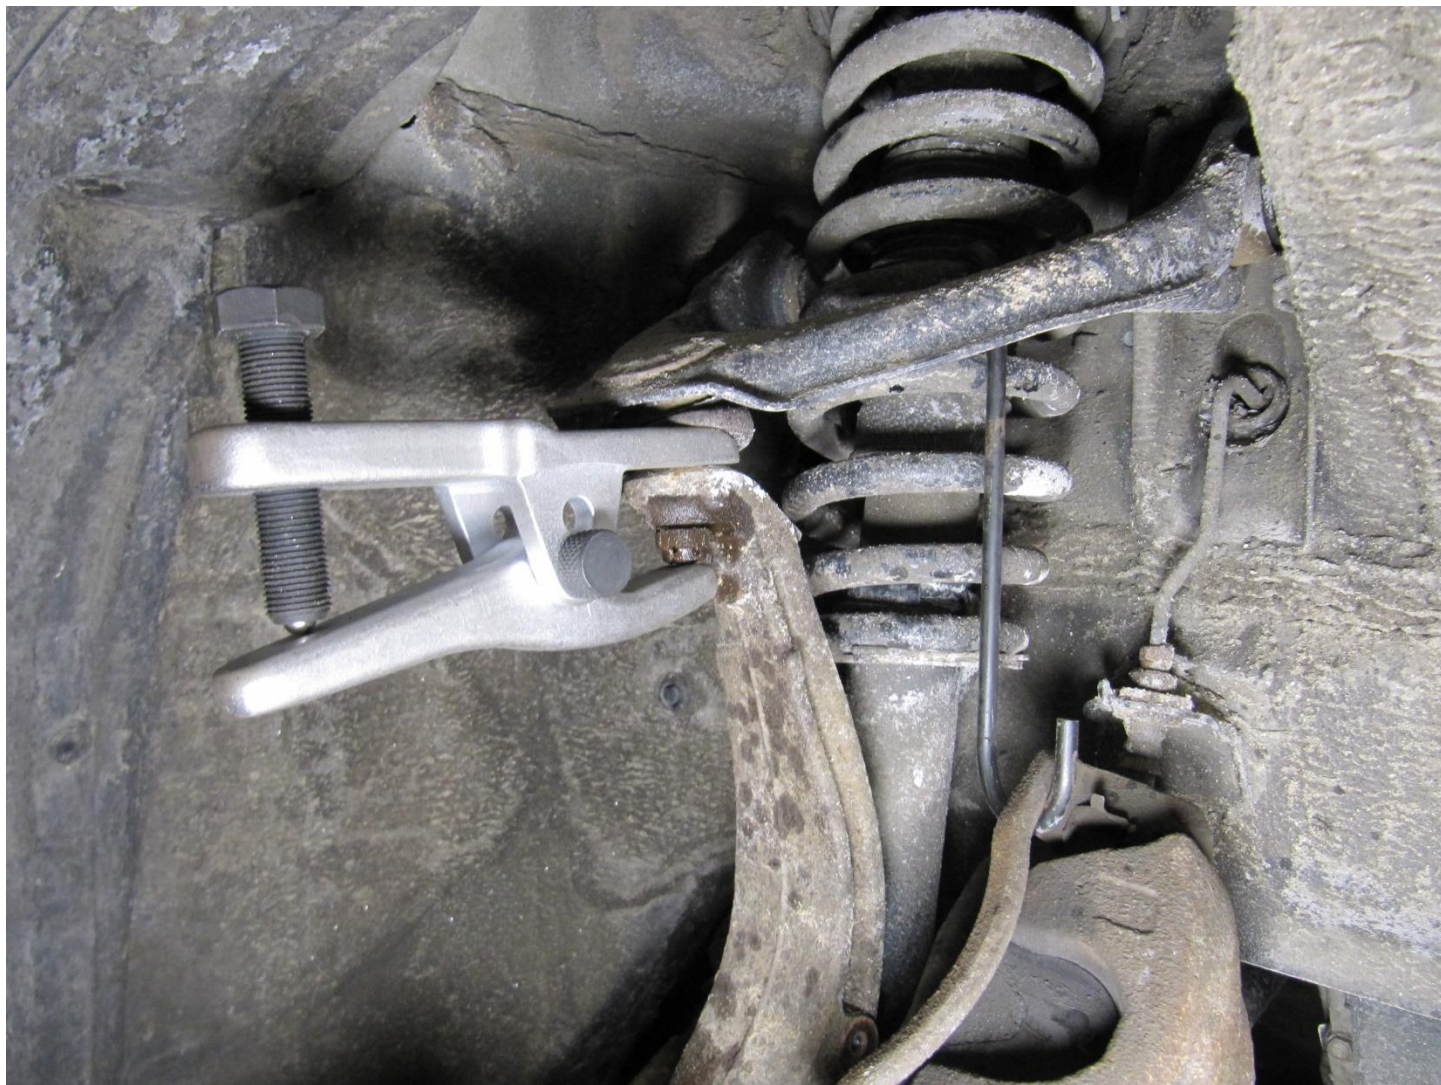
Use a ball joint separator to separate the upper ball joint (leaving the nut on will prevent the whole knuckle from flying around when the joint breaks loose):

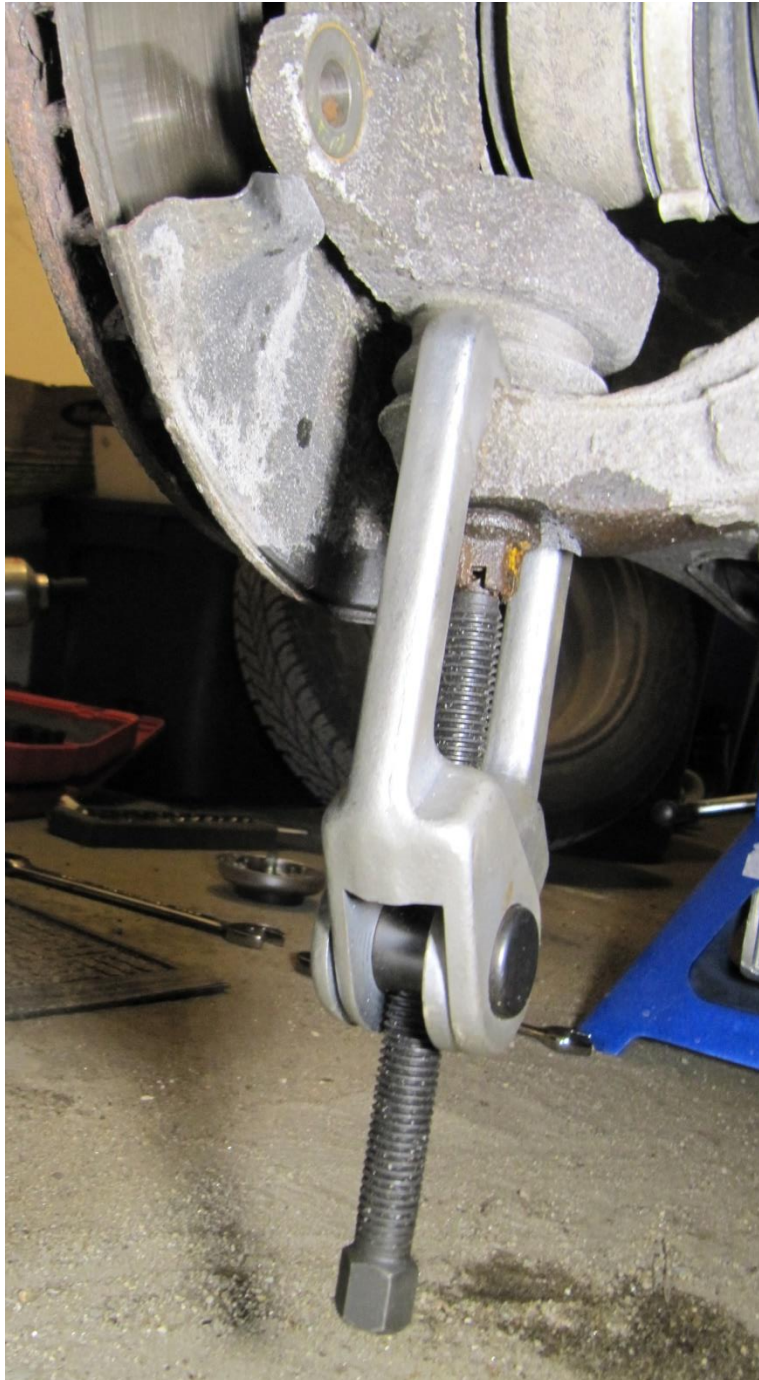
And use a two jaw puller to separate the lower ball joint (leave the nut on, but loosened to prevent everything from flying around when the joint pops loose):

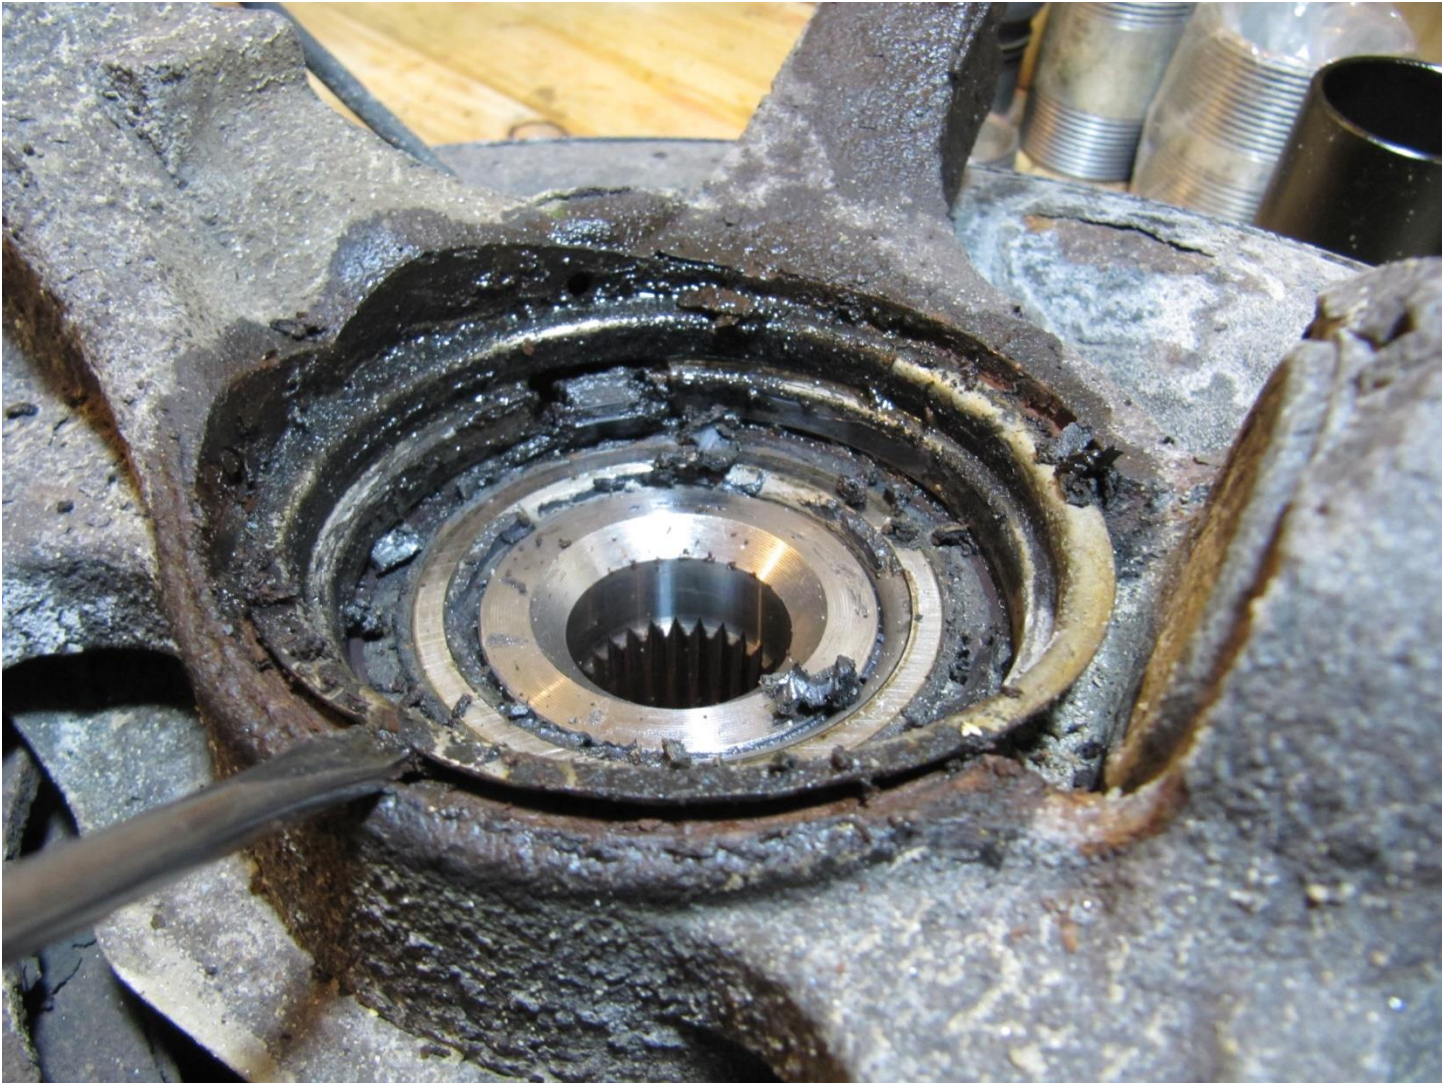
Then I pried up gently around the edges with a screwdriver. The dust shield is made out of pretty thin metal, so take care to not deform it or damage it in the process of removing it:

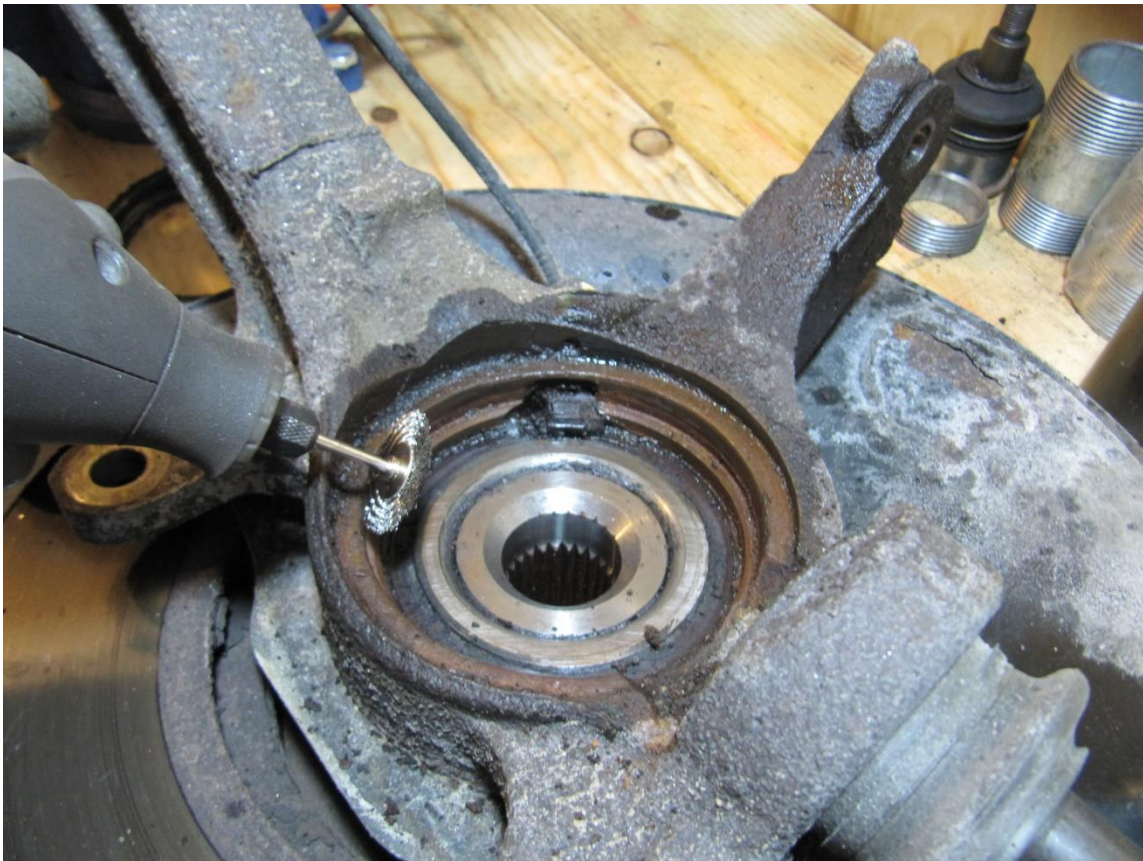
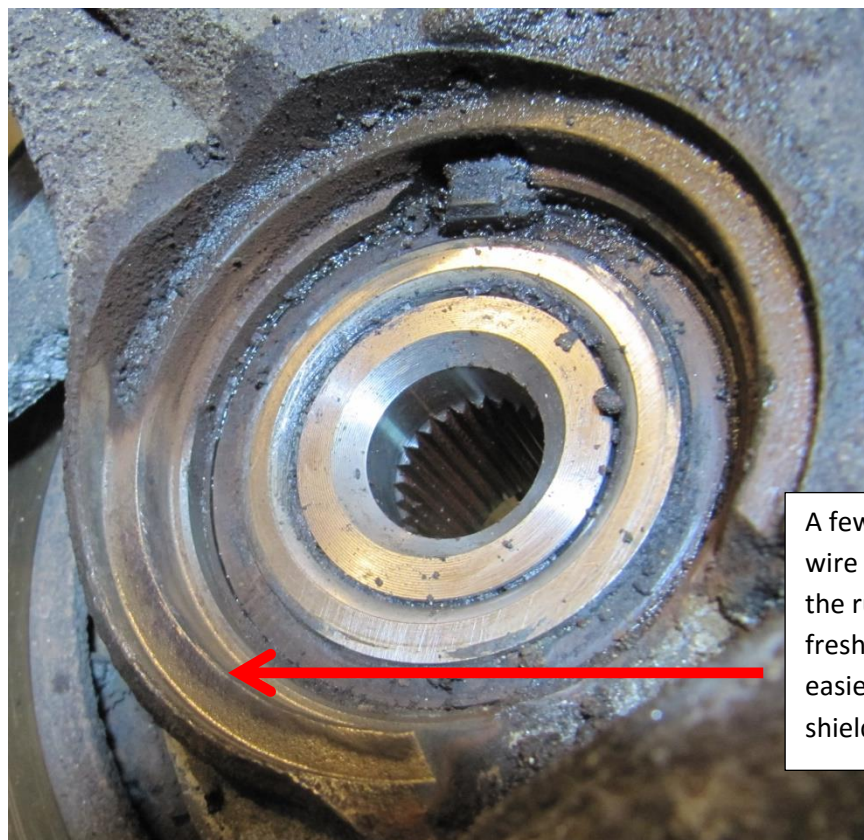
I used a Dremel Tool and wire wheel to clean up the seat for the dust shield. I find this method to be very quick and easy and it is able to get into all the small and awkward places.

A few seconds with the wire wheel takes off all the rust and leaves a nice fresh surface (to make it easier to reinstall the dust shield later)

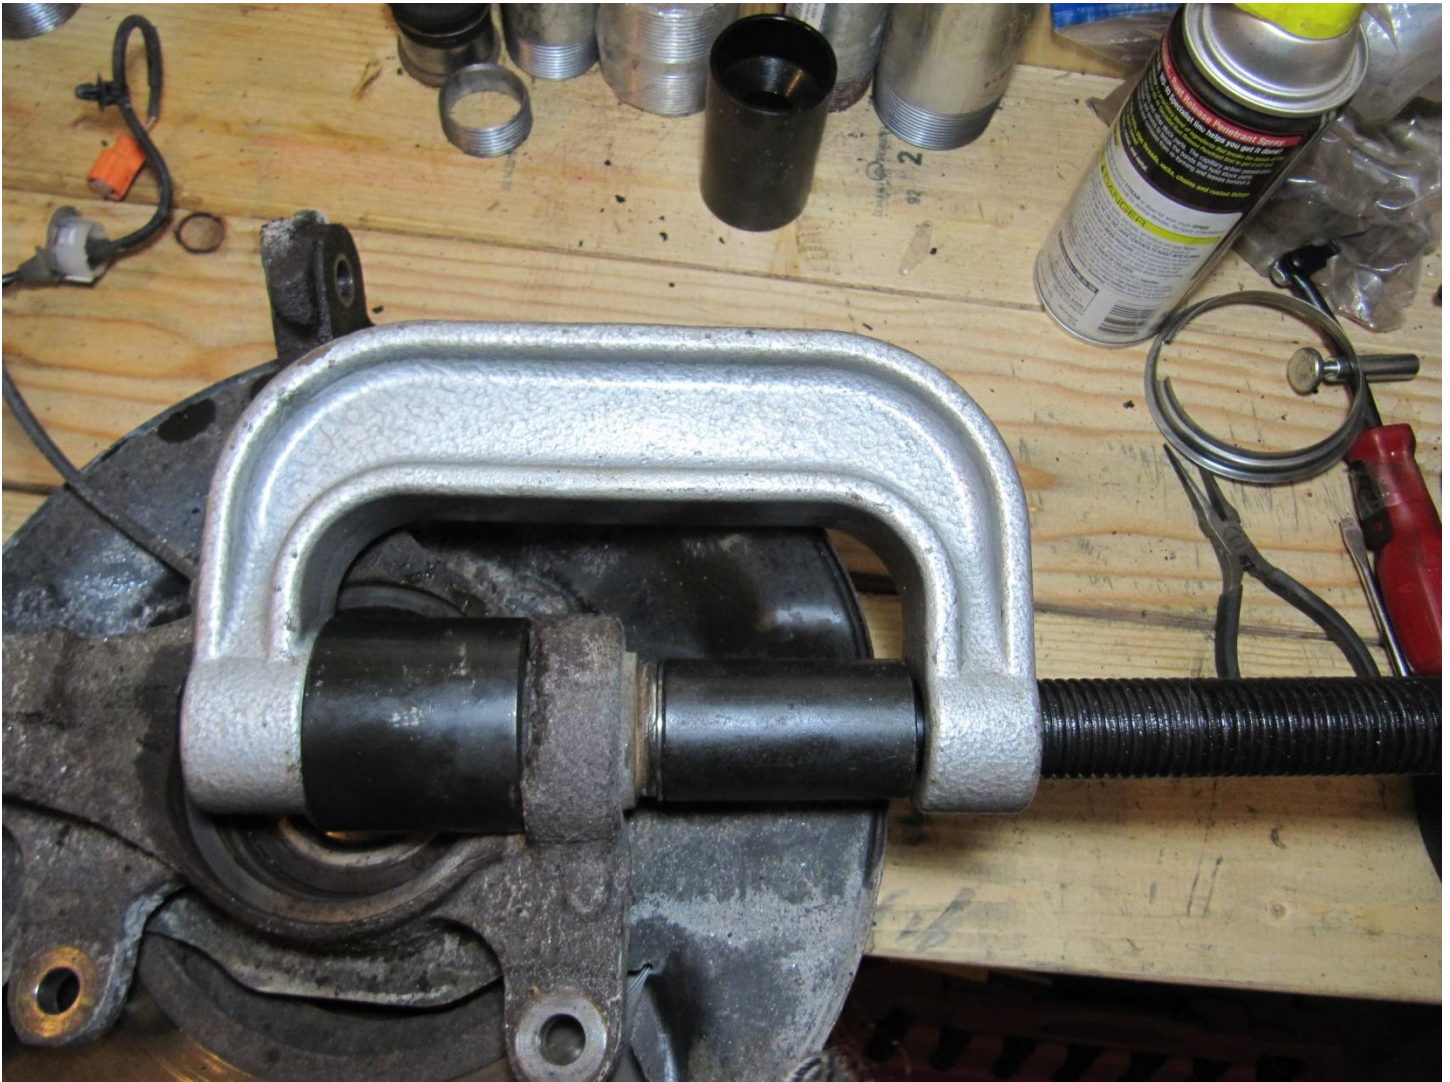
I use a C-Frame Press with the OTC 6734 adapters to press out the old ball joint.
