DIY Write-Up
Ball Joint Replacement
2007 Honda Accord SE 4CYL

At 318K Miles (2007 4CYL SE) my lower ball joint (factory original) started squeaking over bumps and there was visible play in the joint. I replaced the ball joint and learned a lot along the way. In the hope that it might save others from some hassle, this document shows the process I went through to replace the ball joint and documents a few things I learned along the way.

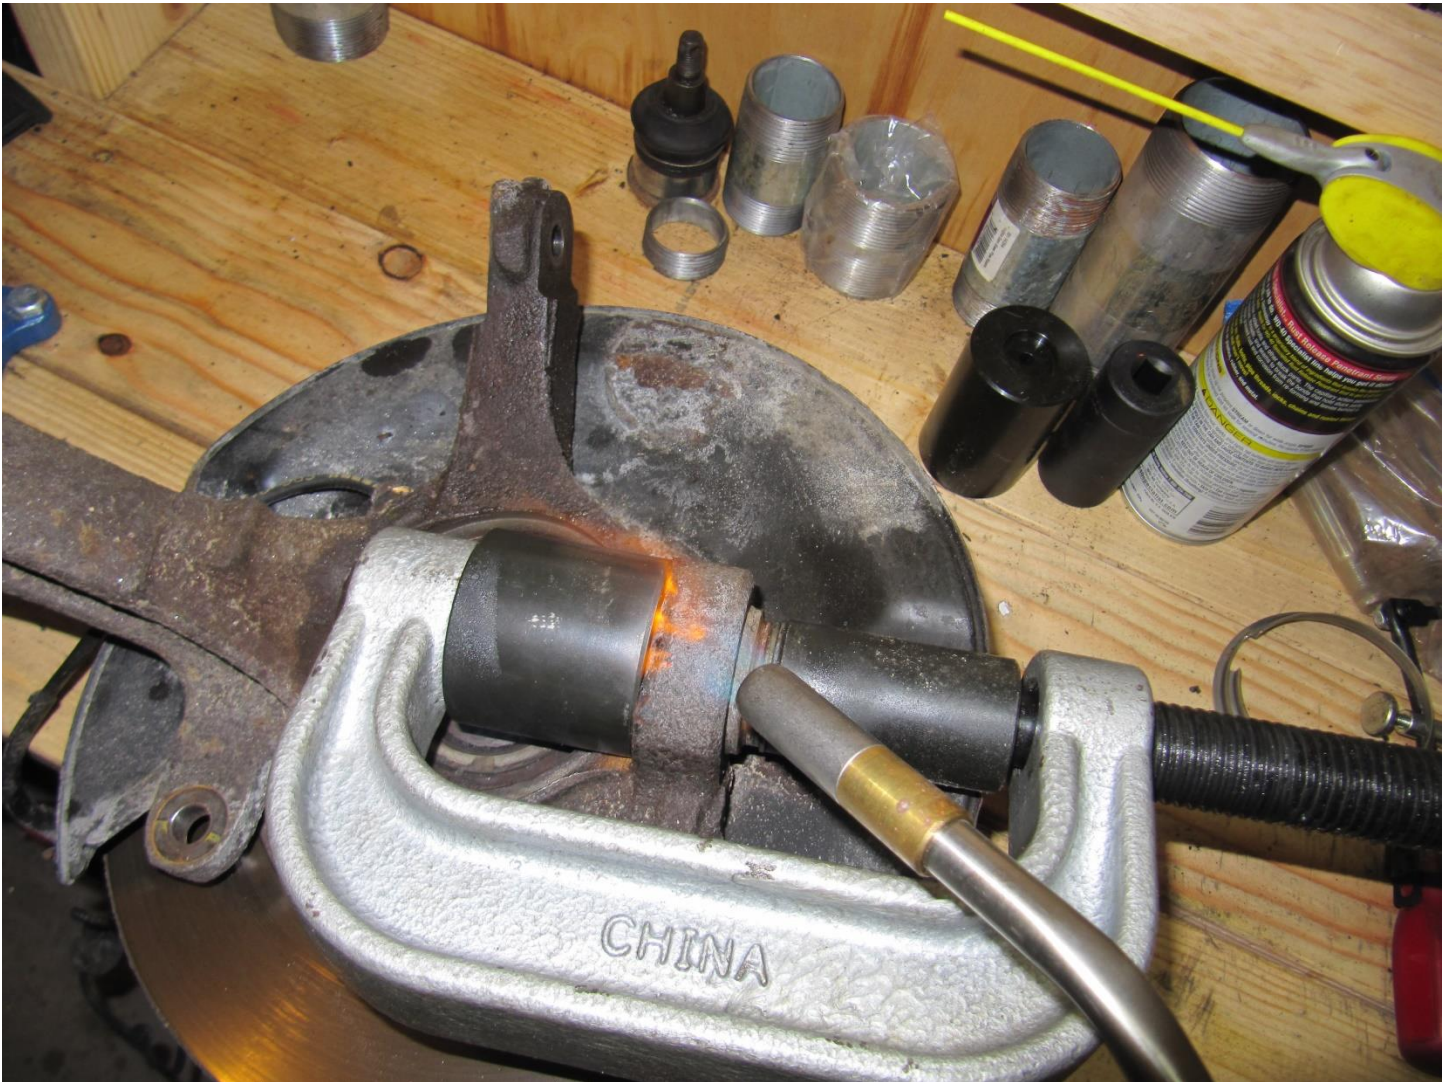
I found that applying a little heat to the knuckle around the ball joint helped a great deal. I wouldn't go too crazy as you probably don't want to cook the wheel bearing or ABS sensor. I used a simple plumbers (MAP) torch and just heated the outside of the "ring" for probably under 10 seconds. This definitely made it much easier to extract the ball joint.

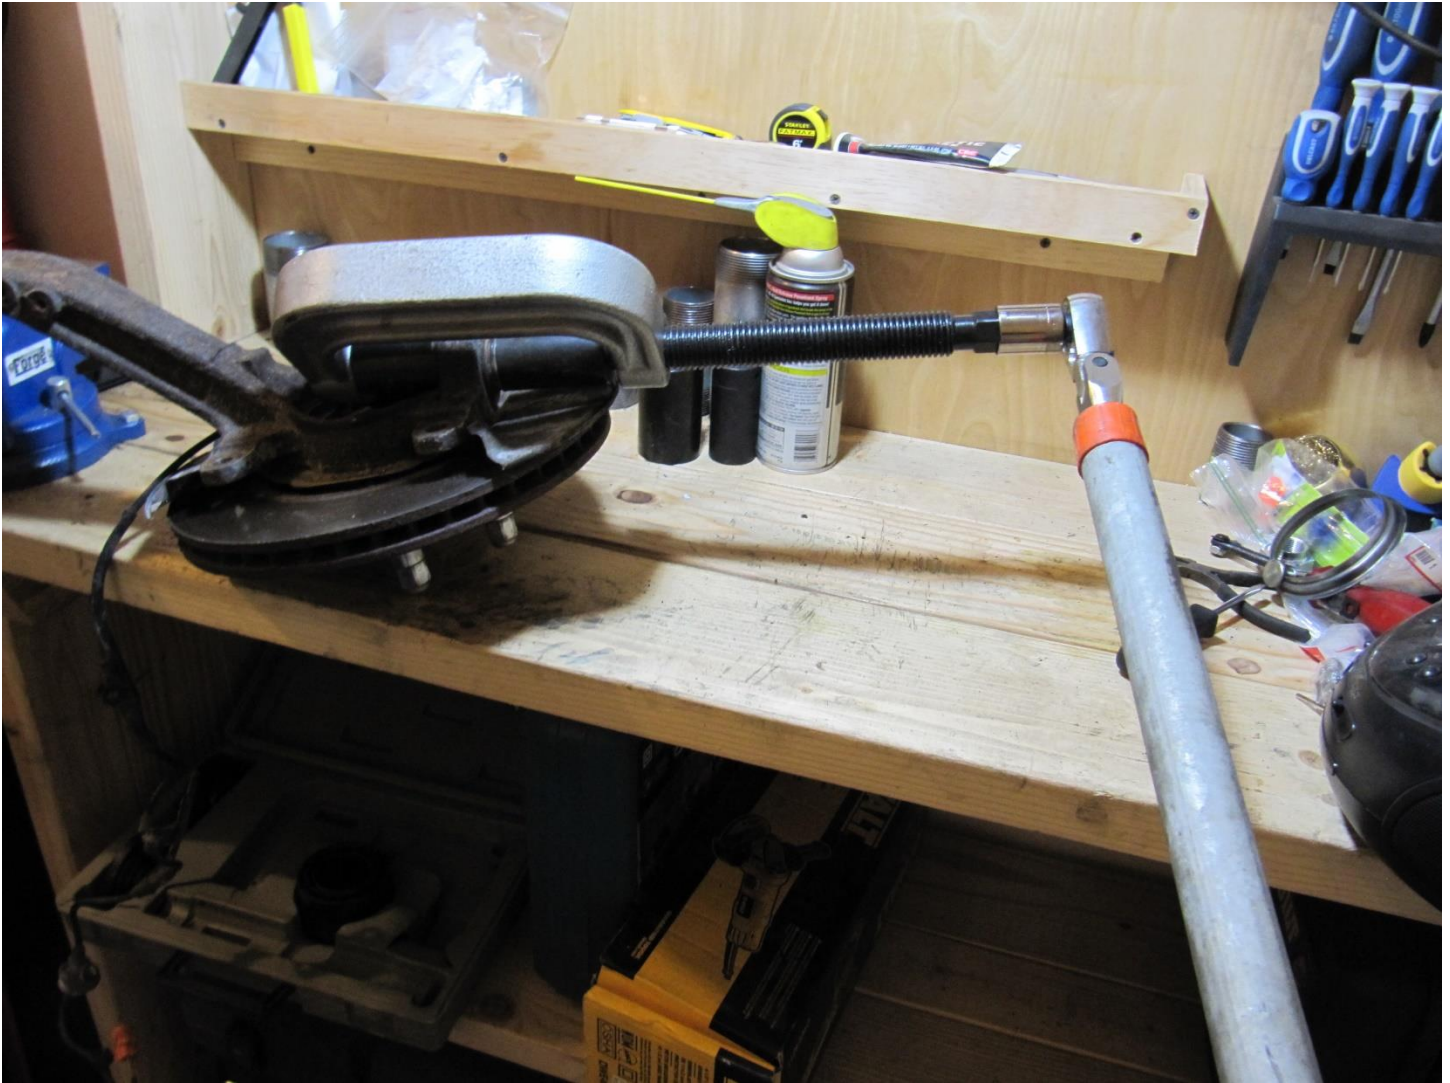
Then I used a half-inch ratchet and cheater bar to drive out the ball joint while holding the end of the knuckle in a bench vise. It wasn't too tough, but heating definitely made a big difference.

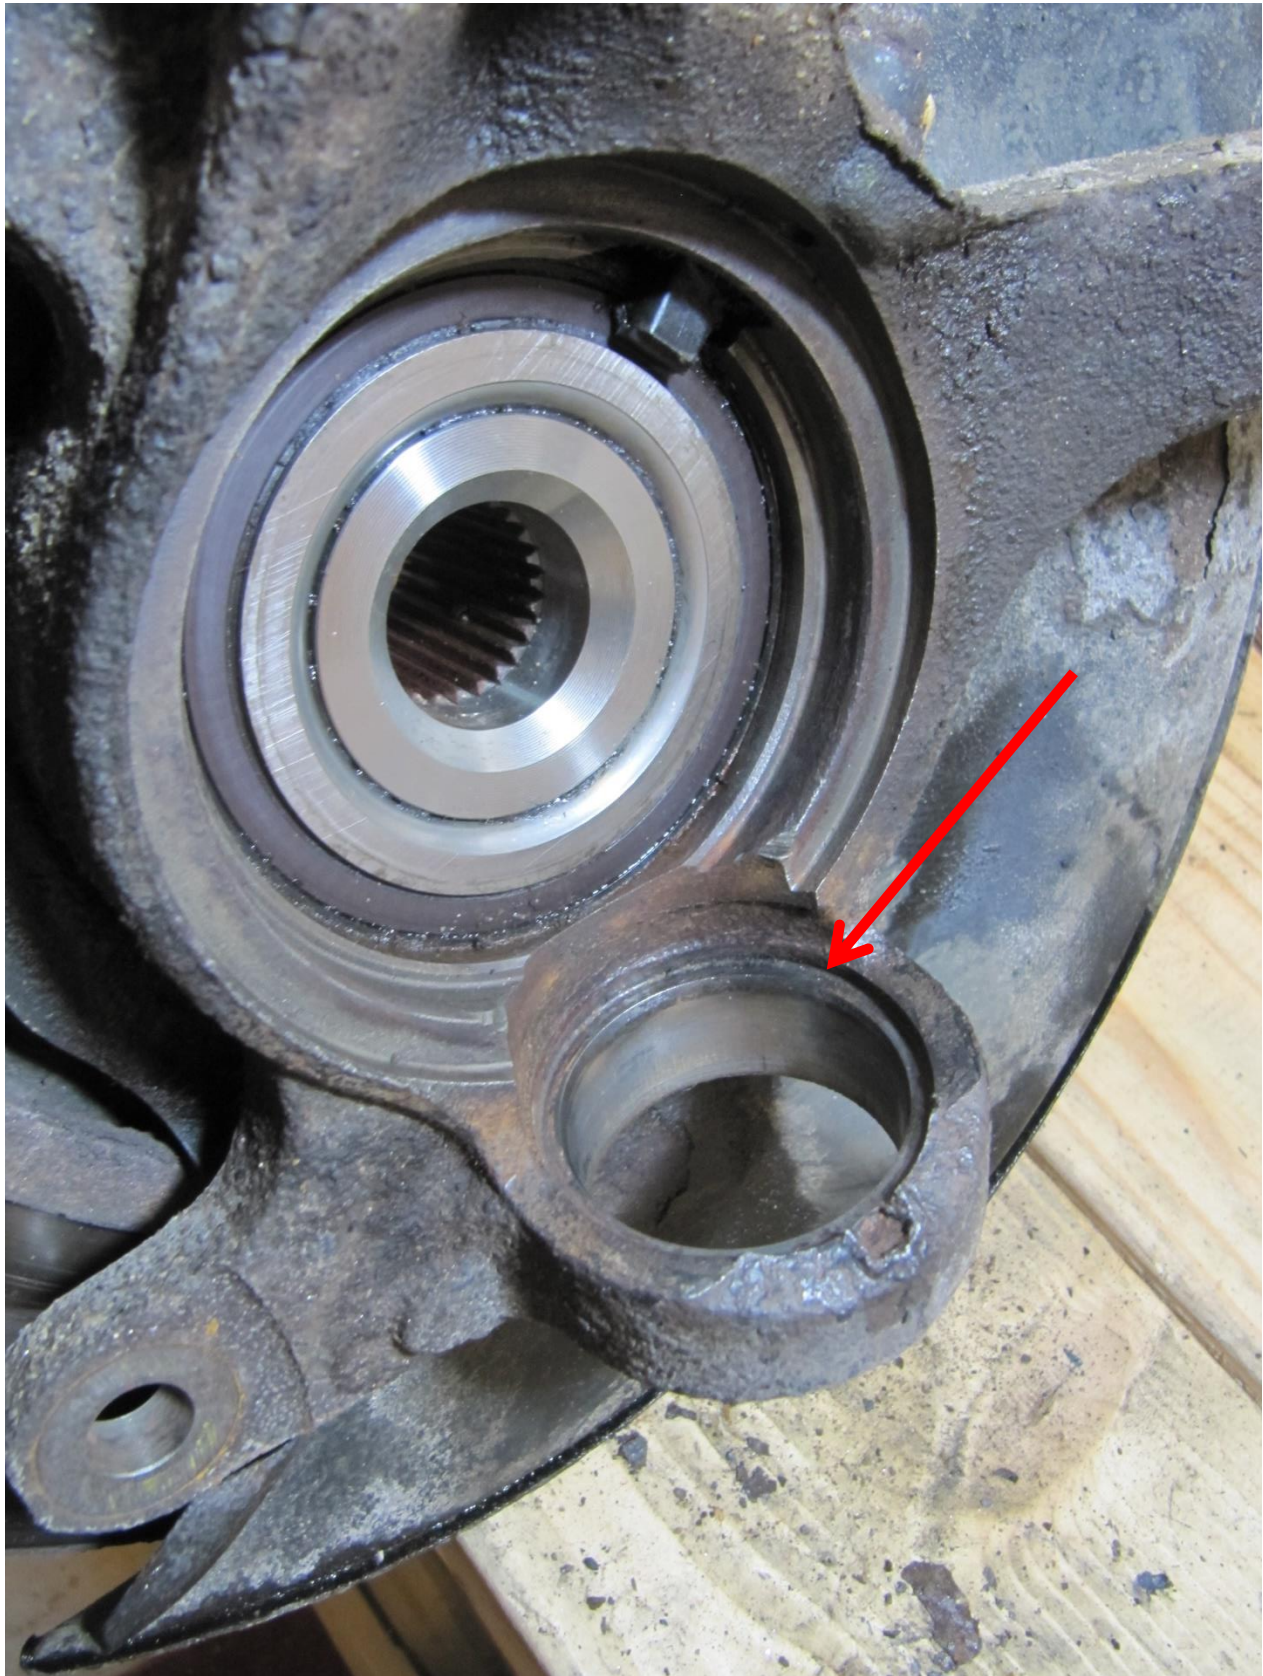
Once the ball joint was out, I cleaned up the ball joint seating surface (arrow) with the wire wheel:

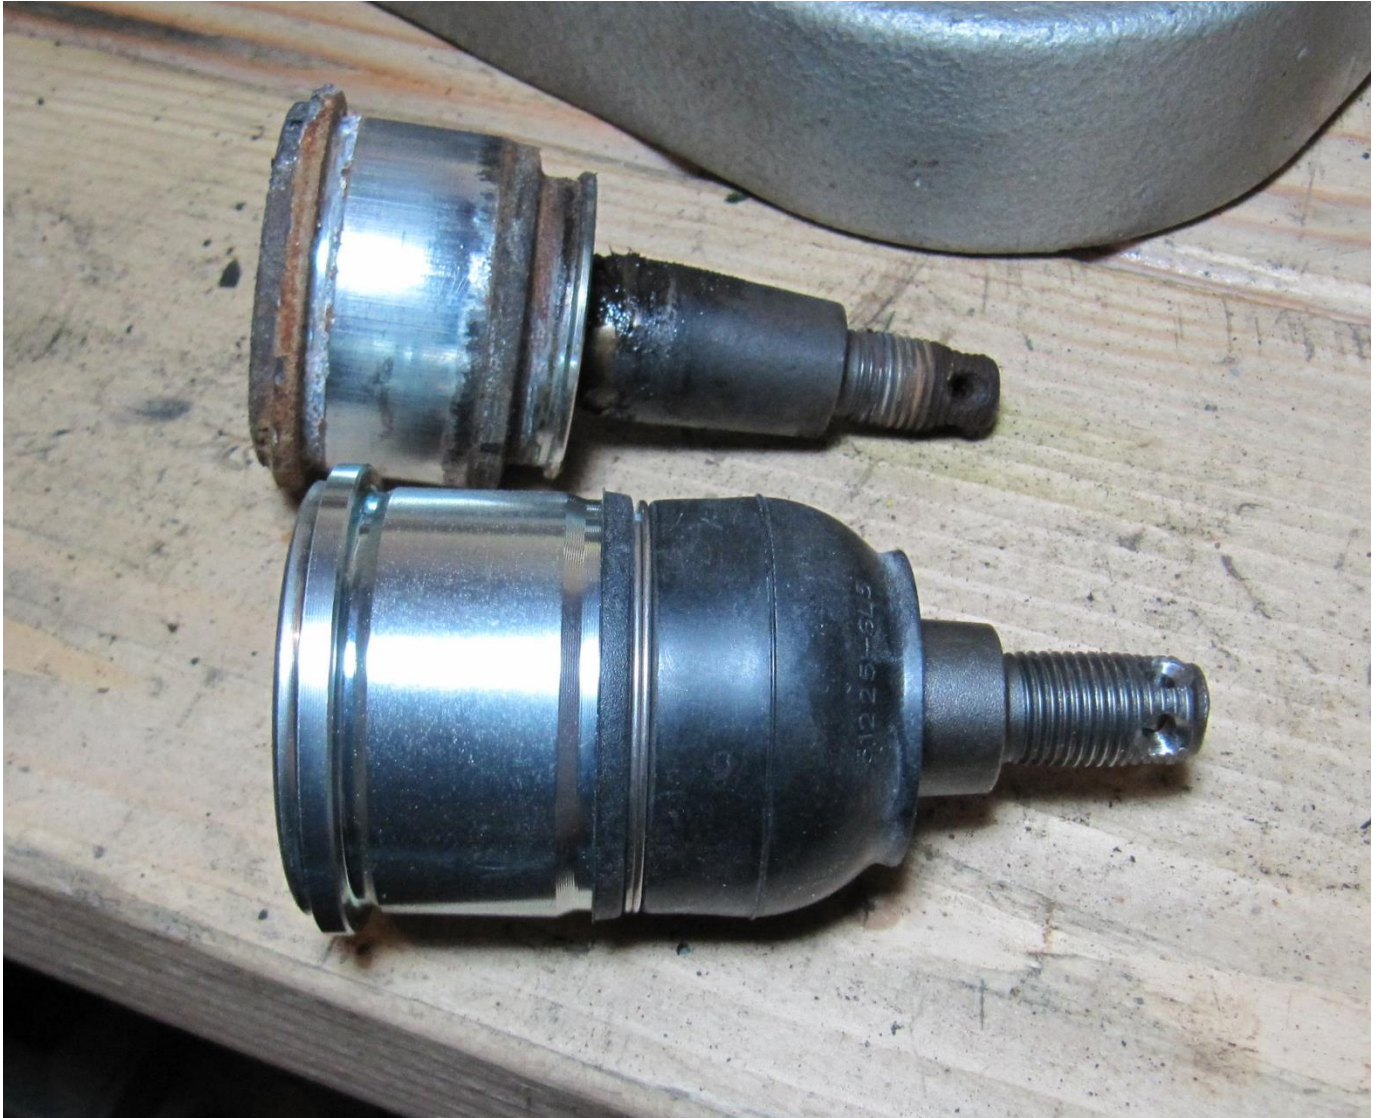
Here are the new and old ball joints:

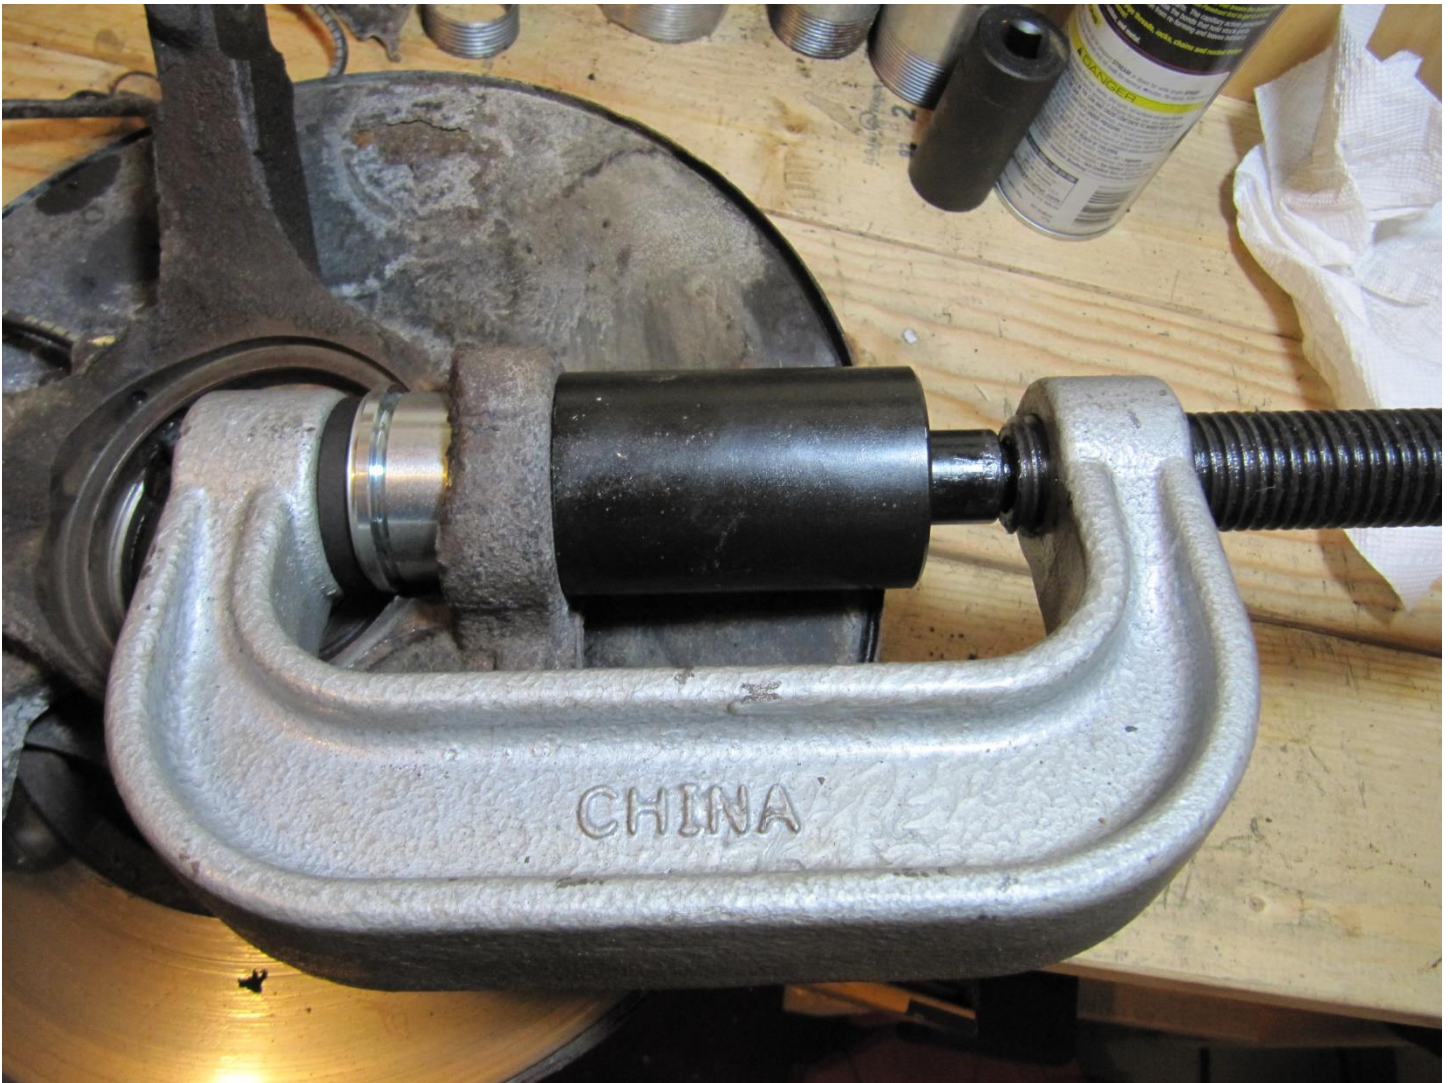
And here is the arrangement used to press in the new ball joint with the C-Frame Press. The new ball joint went in very smoothly and easily.

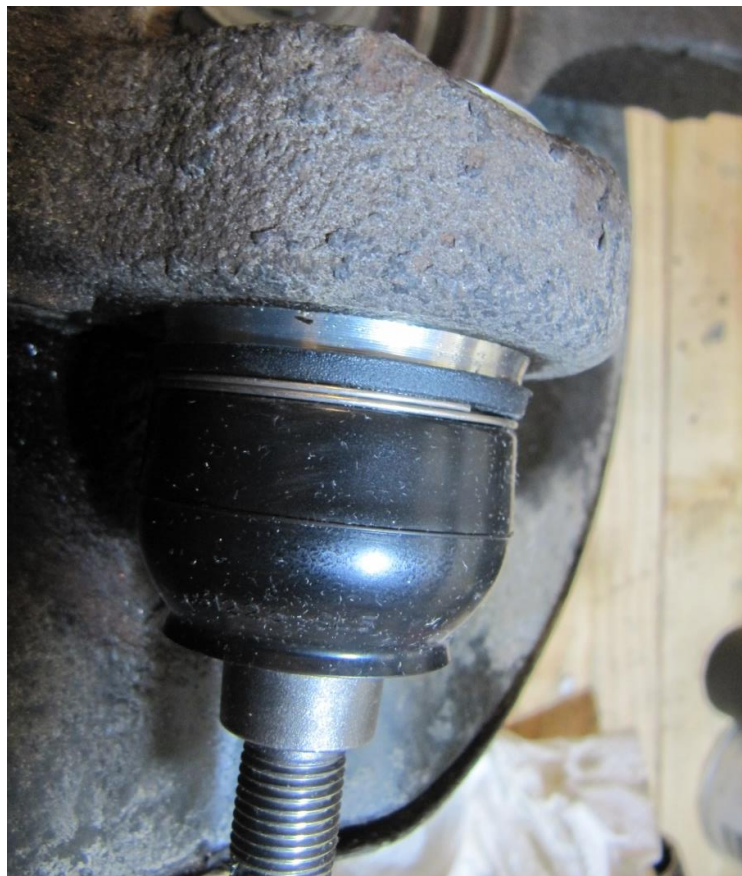
And notice that there is NO place for a snap ring on the bottom (No snap ring was present on the original factory ball joint, and no snap ring is needed for the replacement OEM ball joint. I believe some aftermarket ball joints do require a snap ring though):

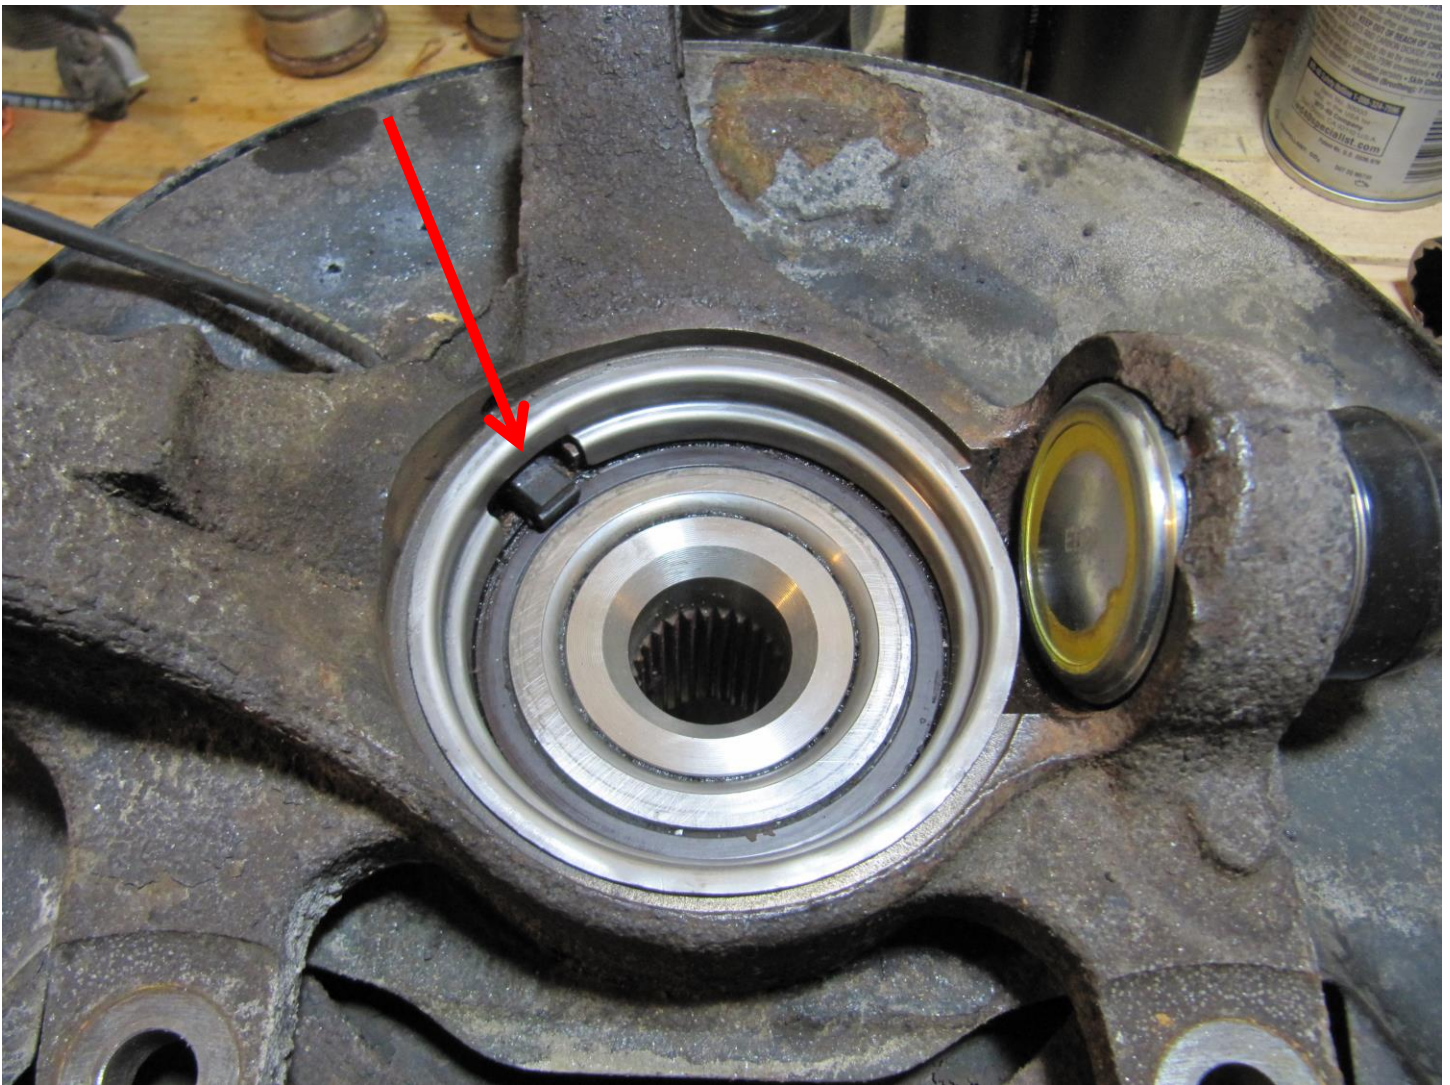
Reinstall the dust ring, lining up the gap in the ring with the ABS sensor (arrow):

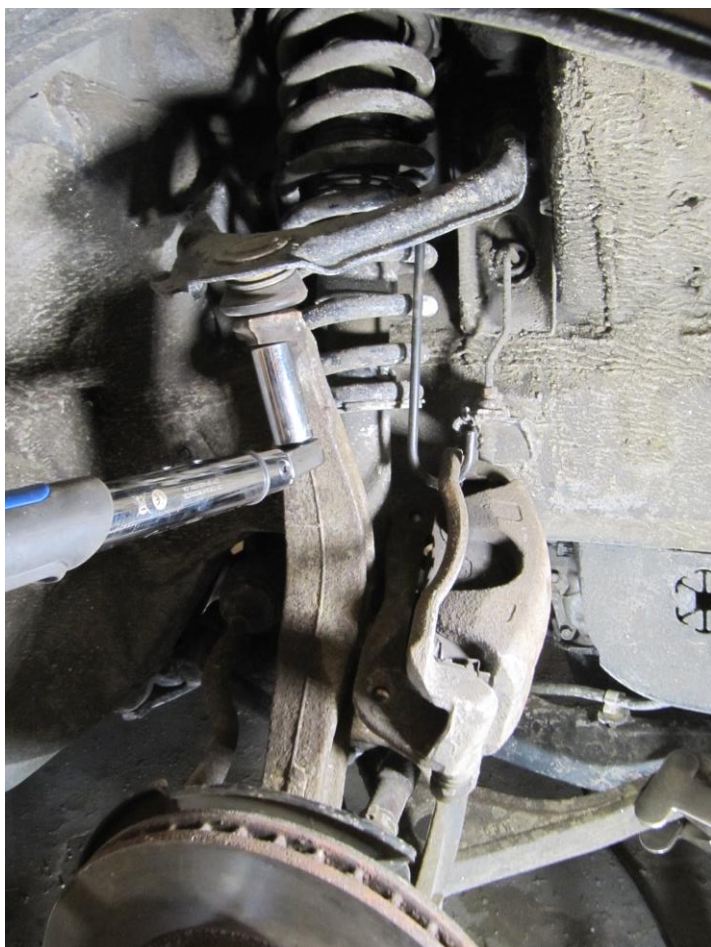
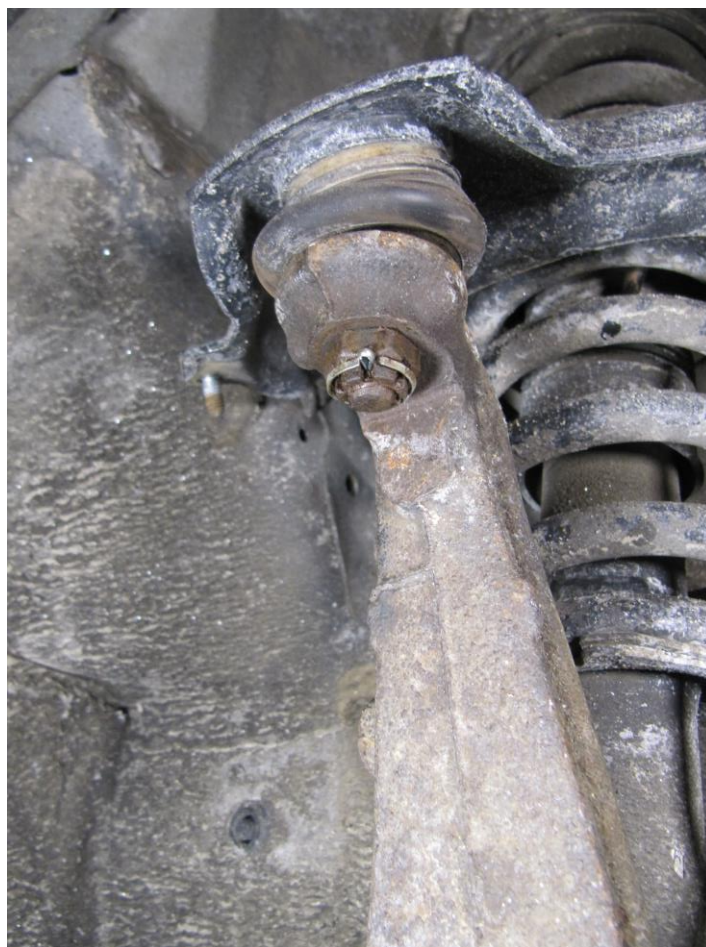
Then, it is just a matter of reassembly. Insert the knuckle and torque the upper ball joint nut to 39Nm. Then install a new cotter pin:

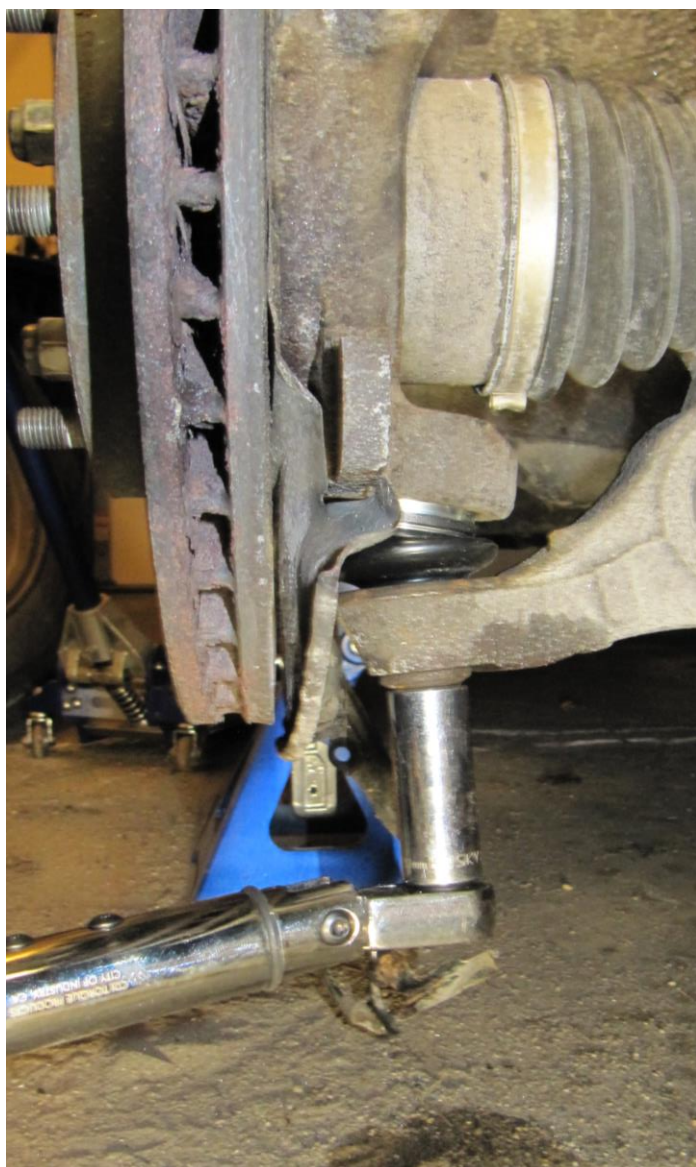
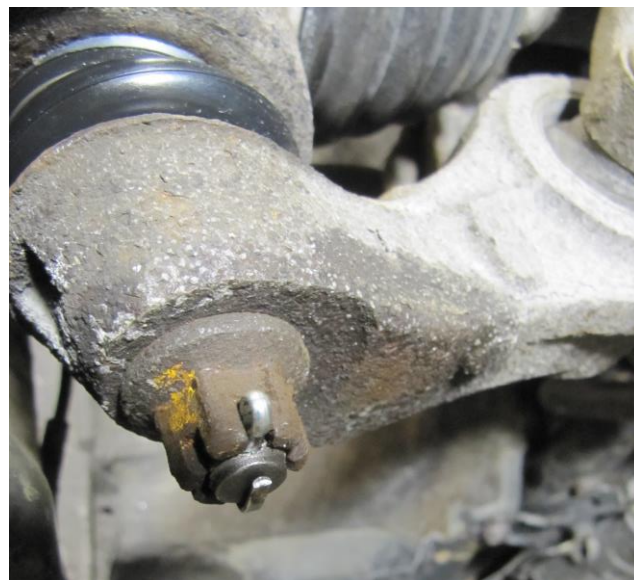
Install the lower ball joint nut and torque to 78Nm. Install a new cotter pin:

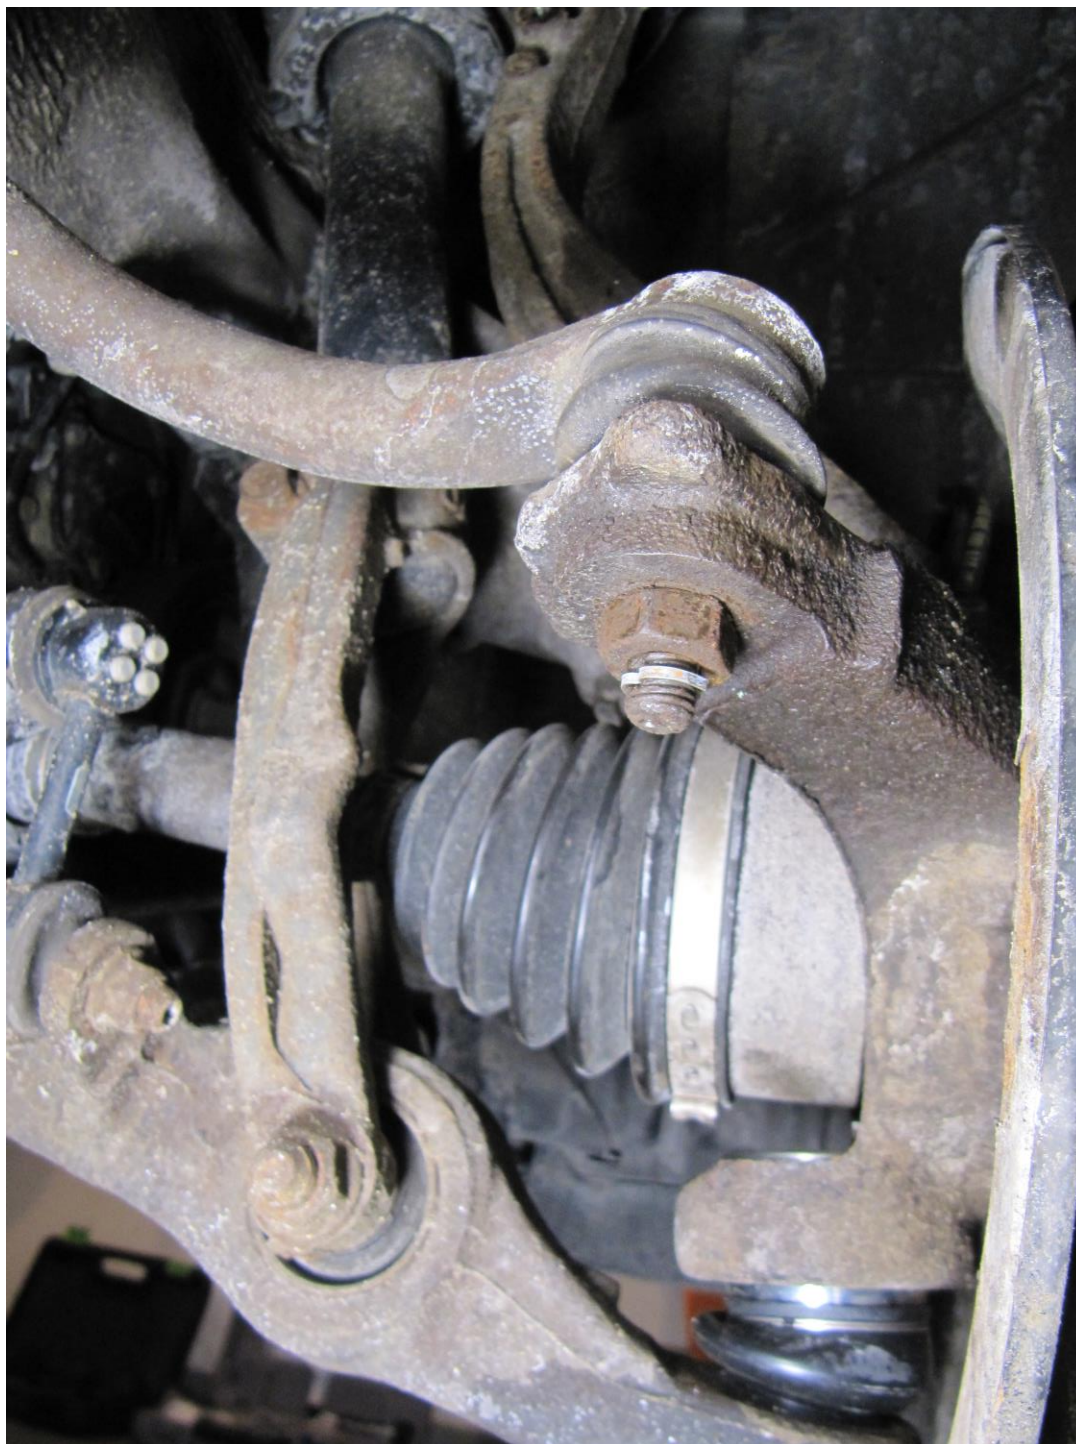
Reinstall the tie rod end nut and torque to 43Nm. Install a new cotter pin:

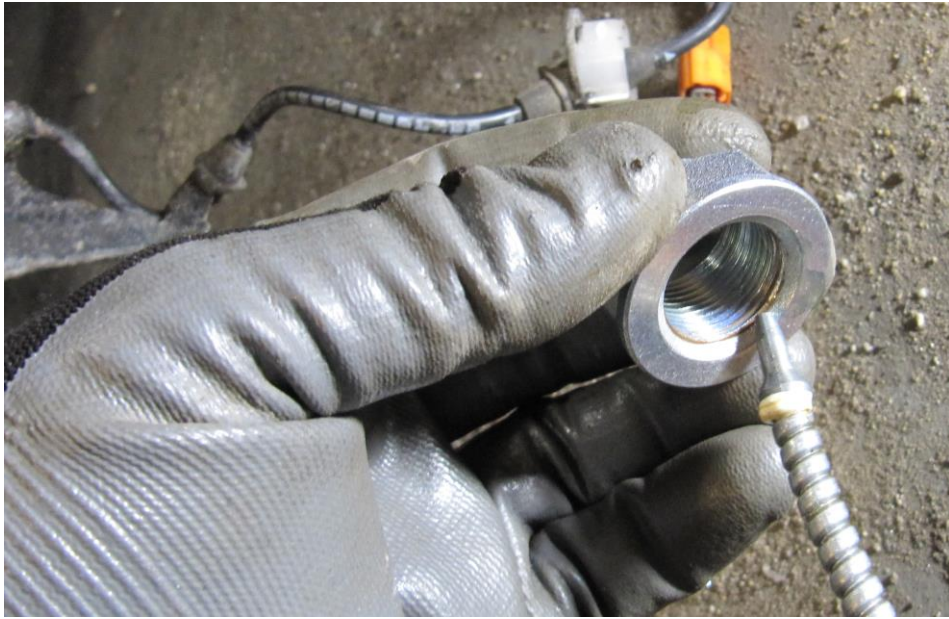
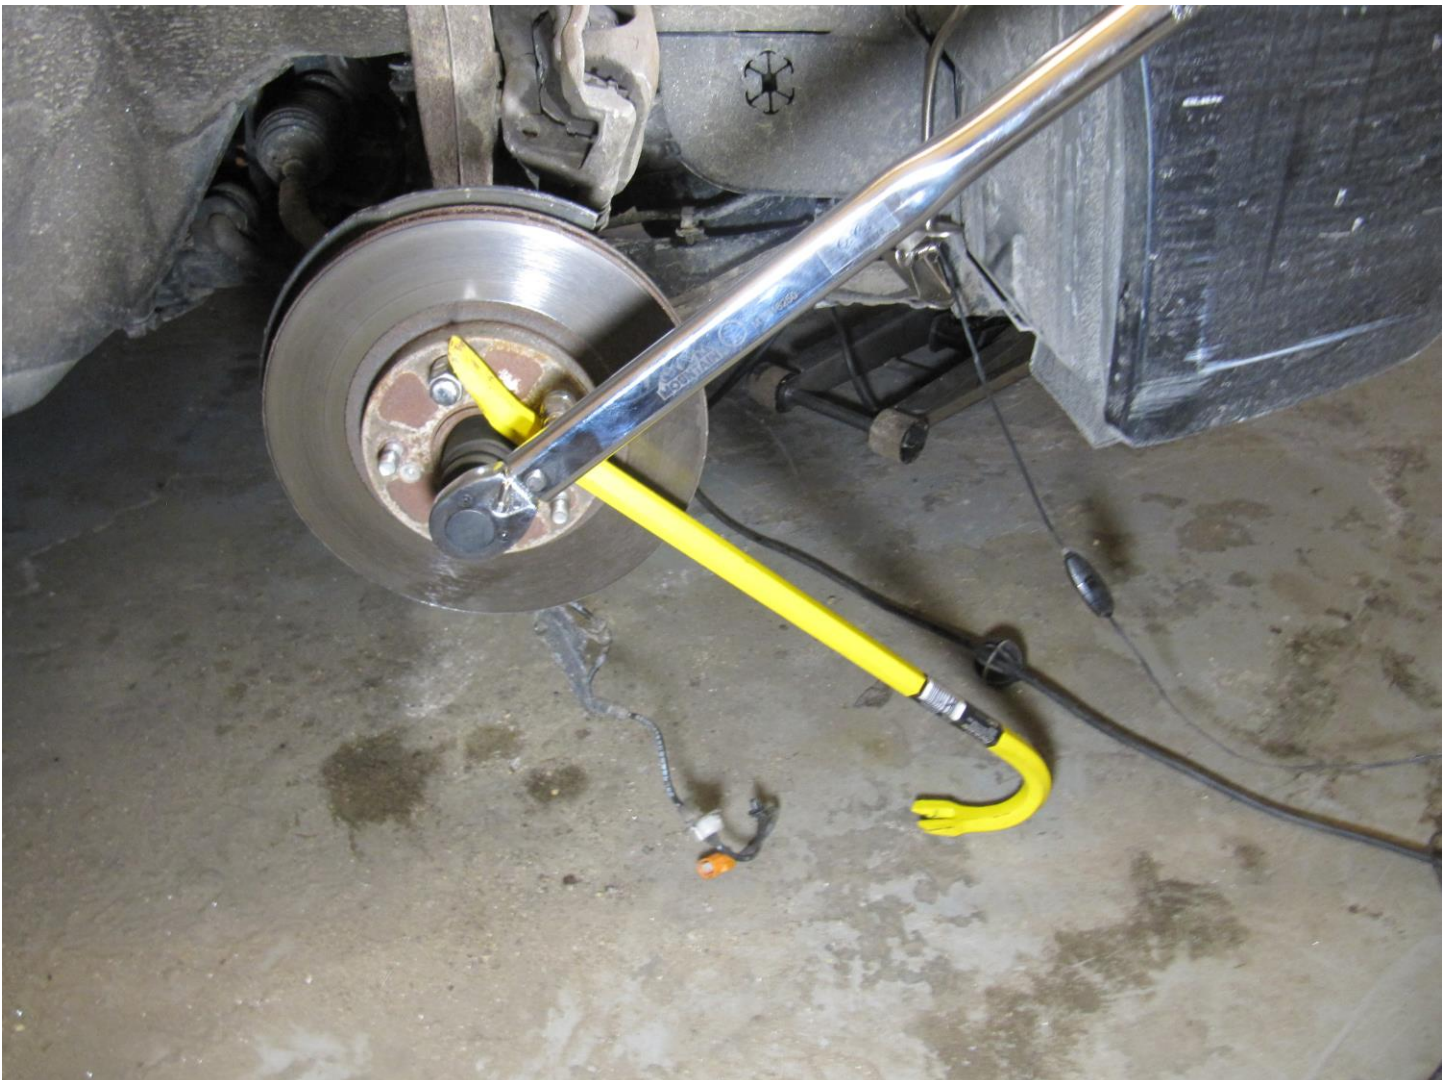
Per the Honda Service Manual, use a new axle nut when reassembling and put a drop of motor oil on the threads. Install the new axle nut and torque to 134 ft-lb.

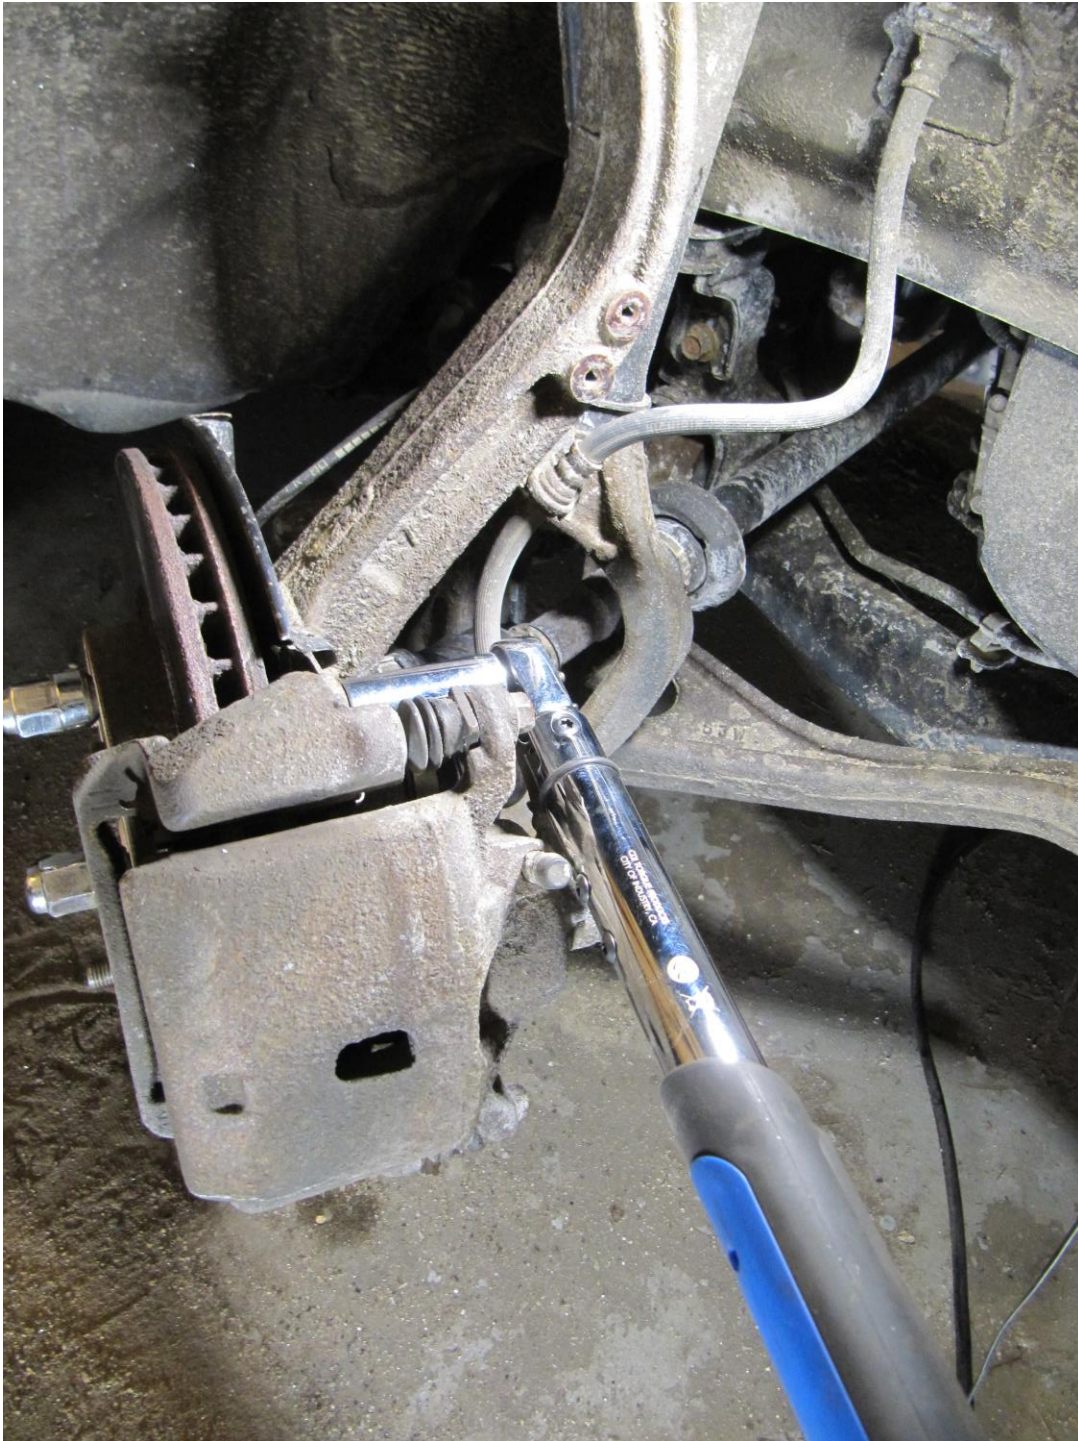
Reinstall the caliper and tighten the bolts to 108Nm:

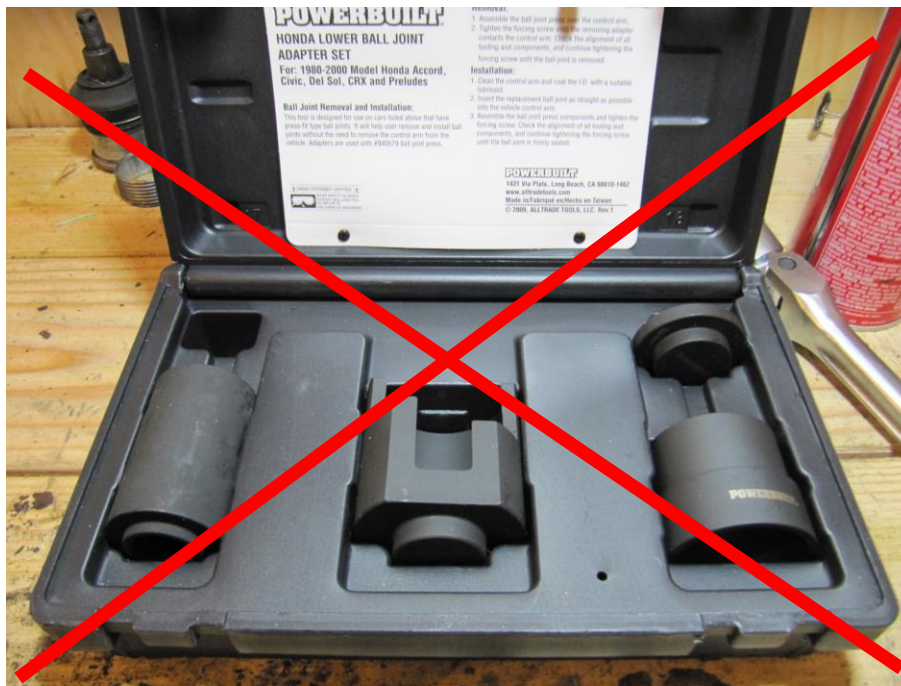
Note that the commonly available PowerBuilt Kit 76, Model 641321 adapters pictured below (which I initially borrowed from an auto parts store) do NOT work with this vehicle (nor, are they advertised to since the documentation states that this kit is for 1980-2000 Accords):

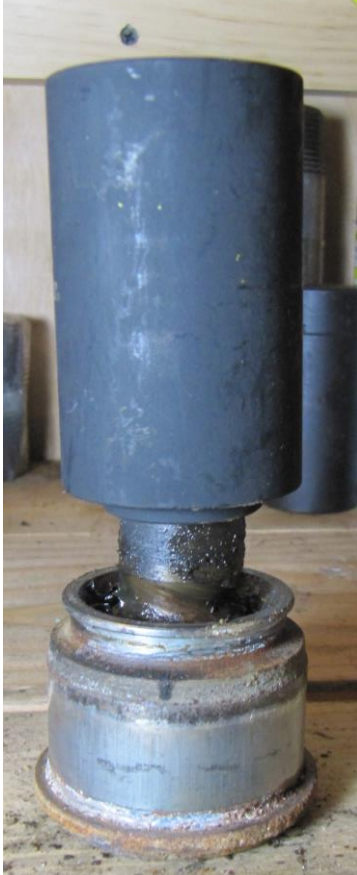
The “pushing” adapter does not fit over the shank of the ball joint:

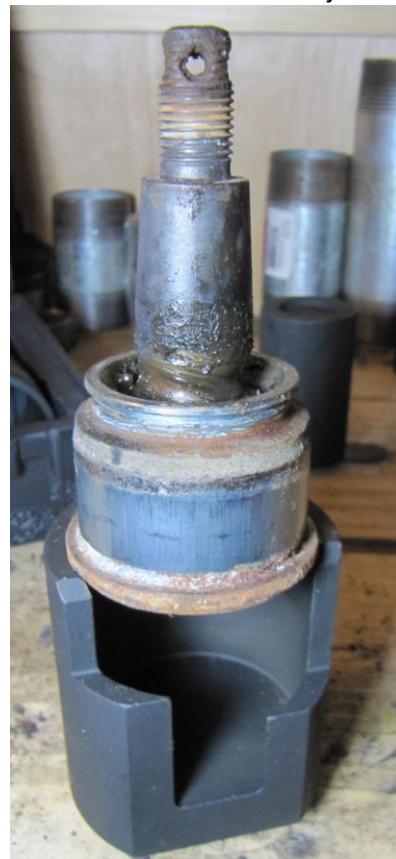
And the receiver cup isn't large enough to fit the base of the ball joint:
