Replacing Lower Control Arm Bushings on a 2007 Honda Accord 4CYL

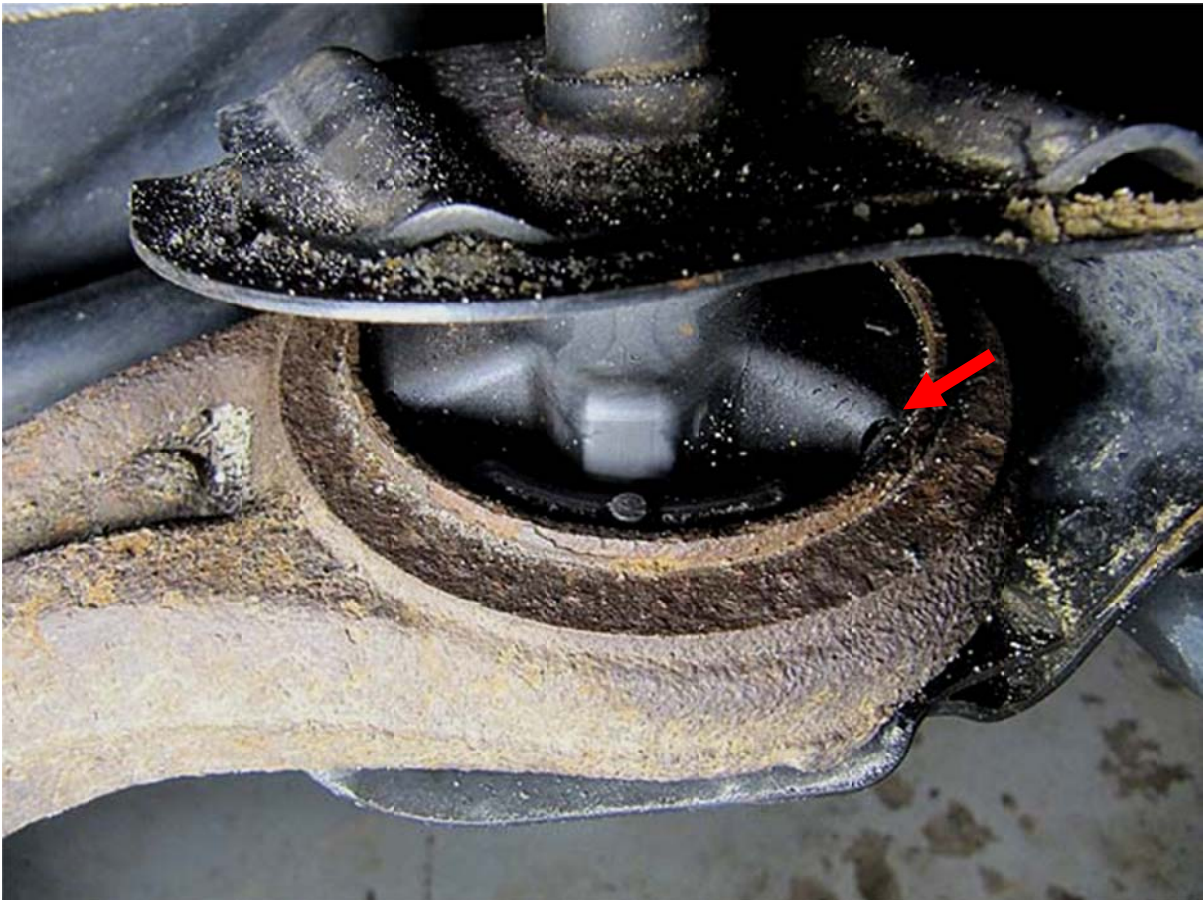
This write-up describes how I replaced the three lower control arm bushings. Usually the large Compliance Bushing (shown below) is the first to show wear, typically cracking in the bushing rubber. In extreme cases, the rubber will crack all the way through and the control arm will be "floating" leading to clunking noises and a drifting feel when steering. In the case shown below there is only very minor cracking (red arrow) and the bushing really does not need to be replaced yet (in fact it just passed inspection at a Honda dealership). However, since there are 250k miles on it, I figured I would replace the bushings while I had the time (and since the bushings are relatively inexpensive). I am sure there are different views on the subject, but I have heard some say that the bearing should be replaced when it is cracked half way through.

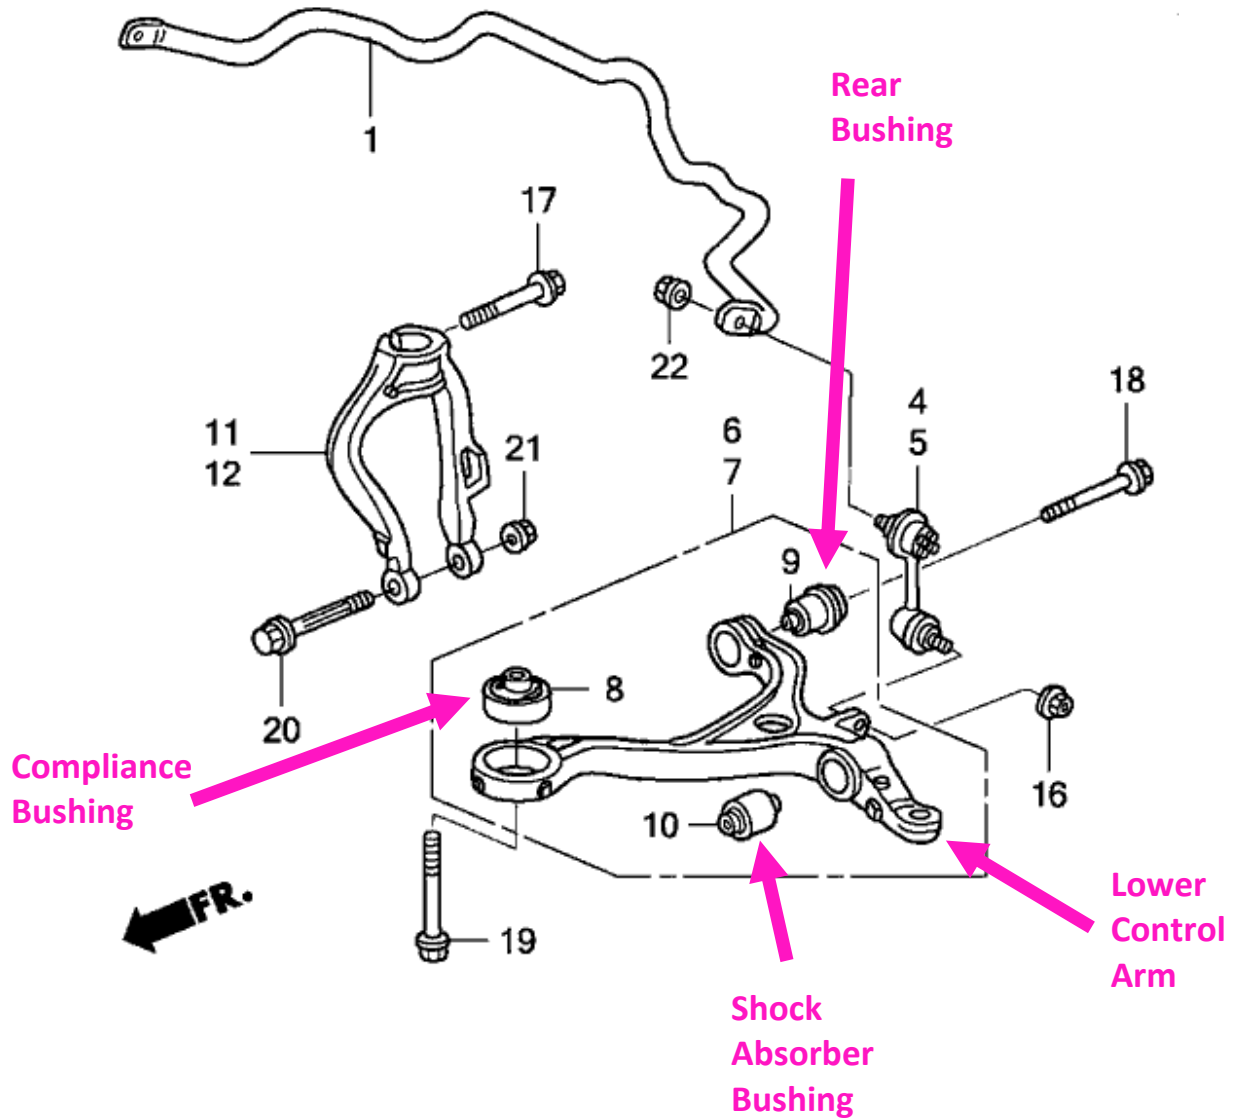
There are three Lower Control Arm Bushings: Compliance Bushing, Shock Absorber Bushing and Rear Bushing. Per the Honda service manual, the following bolts and nuts should be replaced with new parts when re-installing the lower arm (per the service manual): 20, 21, 19, 18, 16.

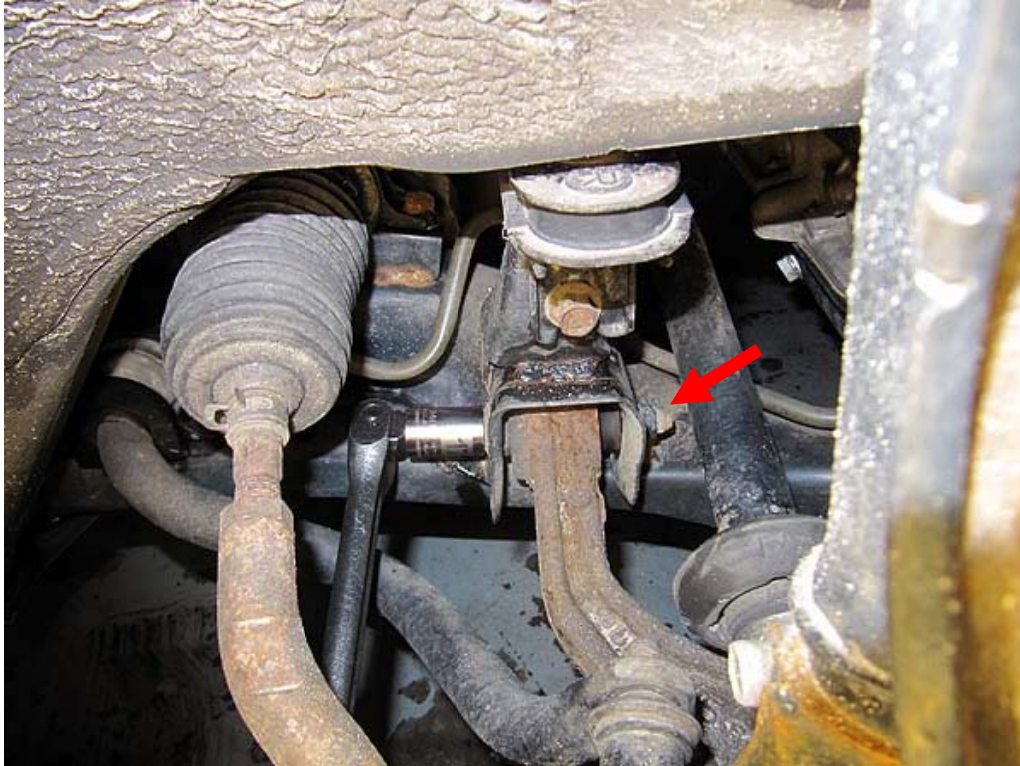
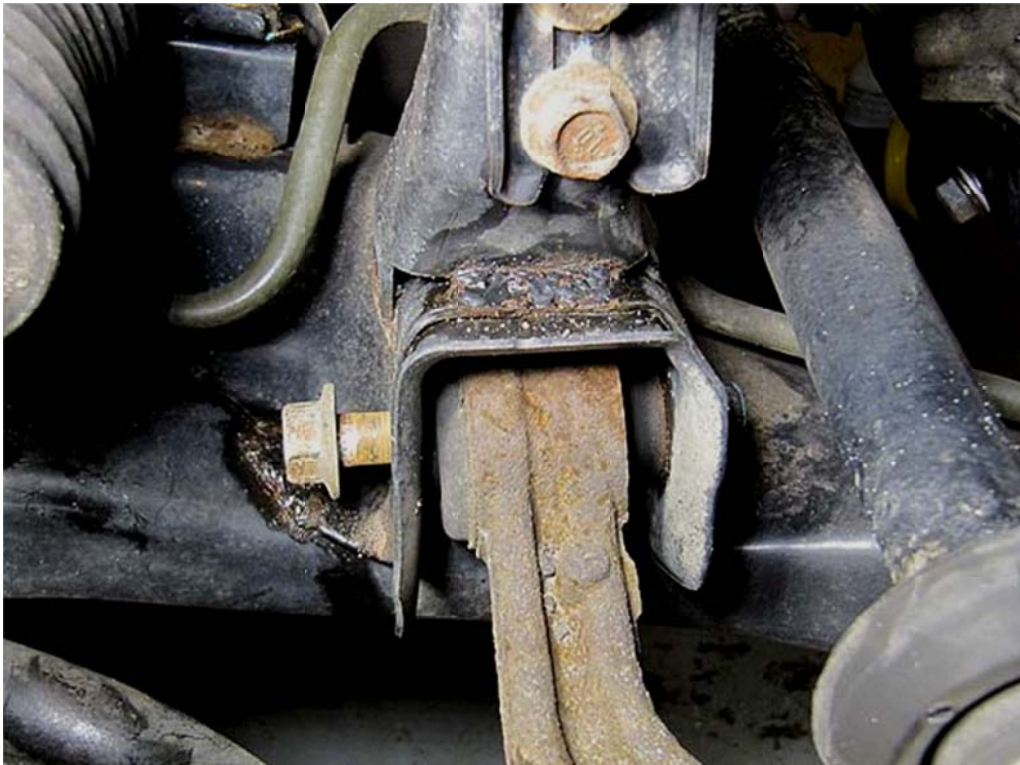
#1 – Loosen the Rear Bushing bolt but leave it in place to hold the Lower Control Arm in position when the ball joint is removed. This bolt was not too bad to get out, but was much worse on the other side where I had to use a torch (MAPP) to heat the nut (red arrow).

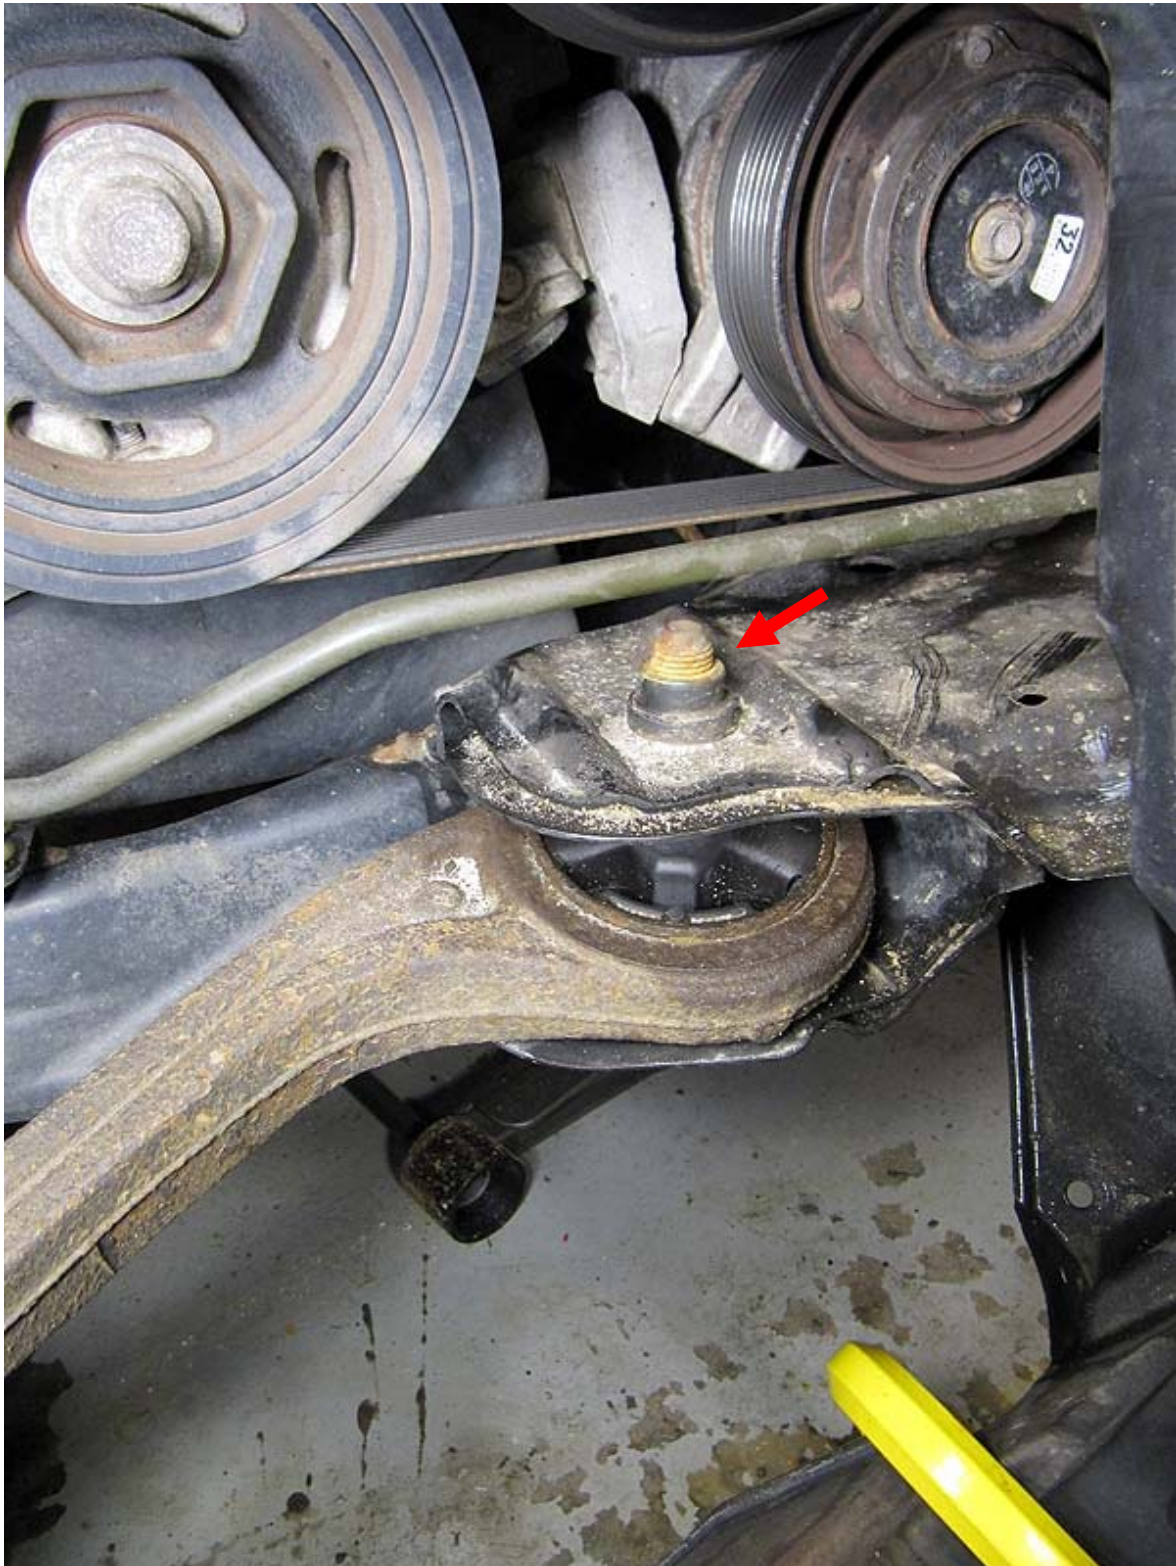
#2 – Loosen the Compliance Bushing bolt. Sounds easy, but it wasn't, at least in my case (the bolt was in there for 250k miles and through New England winters). The bolt didn't budge with an impact wrench (780 ft-lb rating) or breaker bar with 3' cheater.

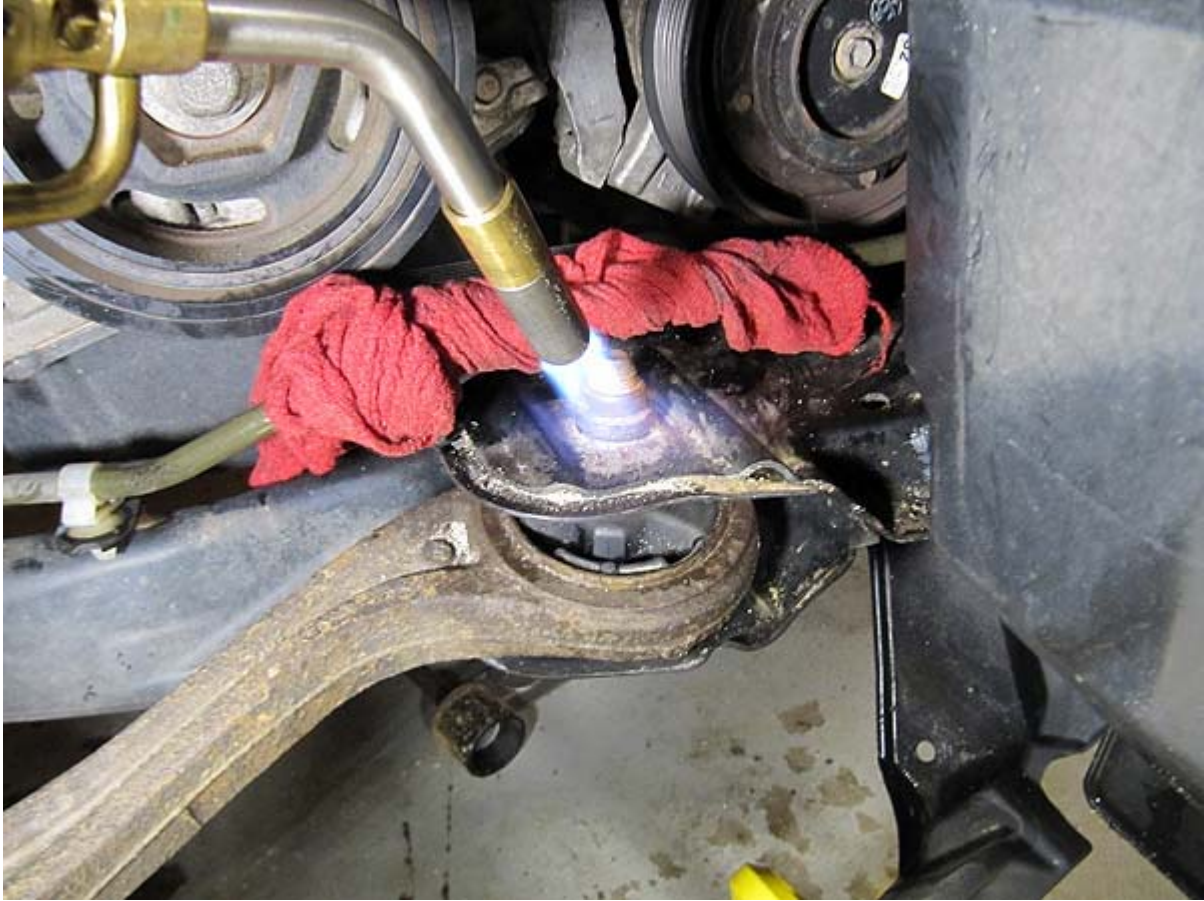
#3 – I heated the top and bottom of the bolt using a MAPP torch. There is a metal power steering line that runs very close to the bolt. To protect it, I wrapped it in a water-soaked rag.

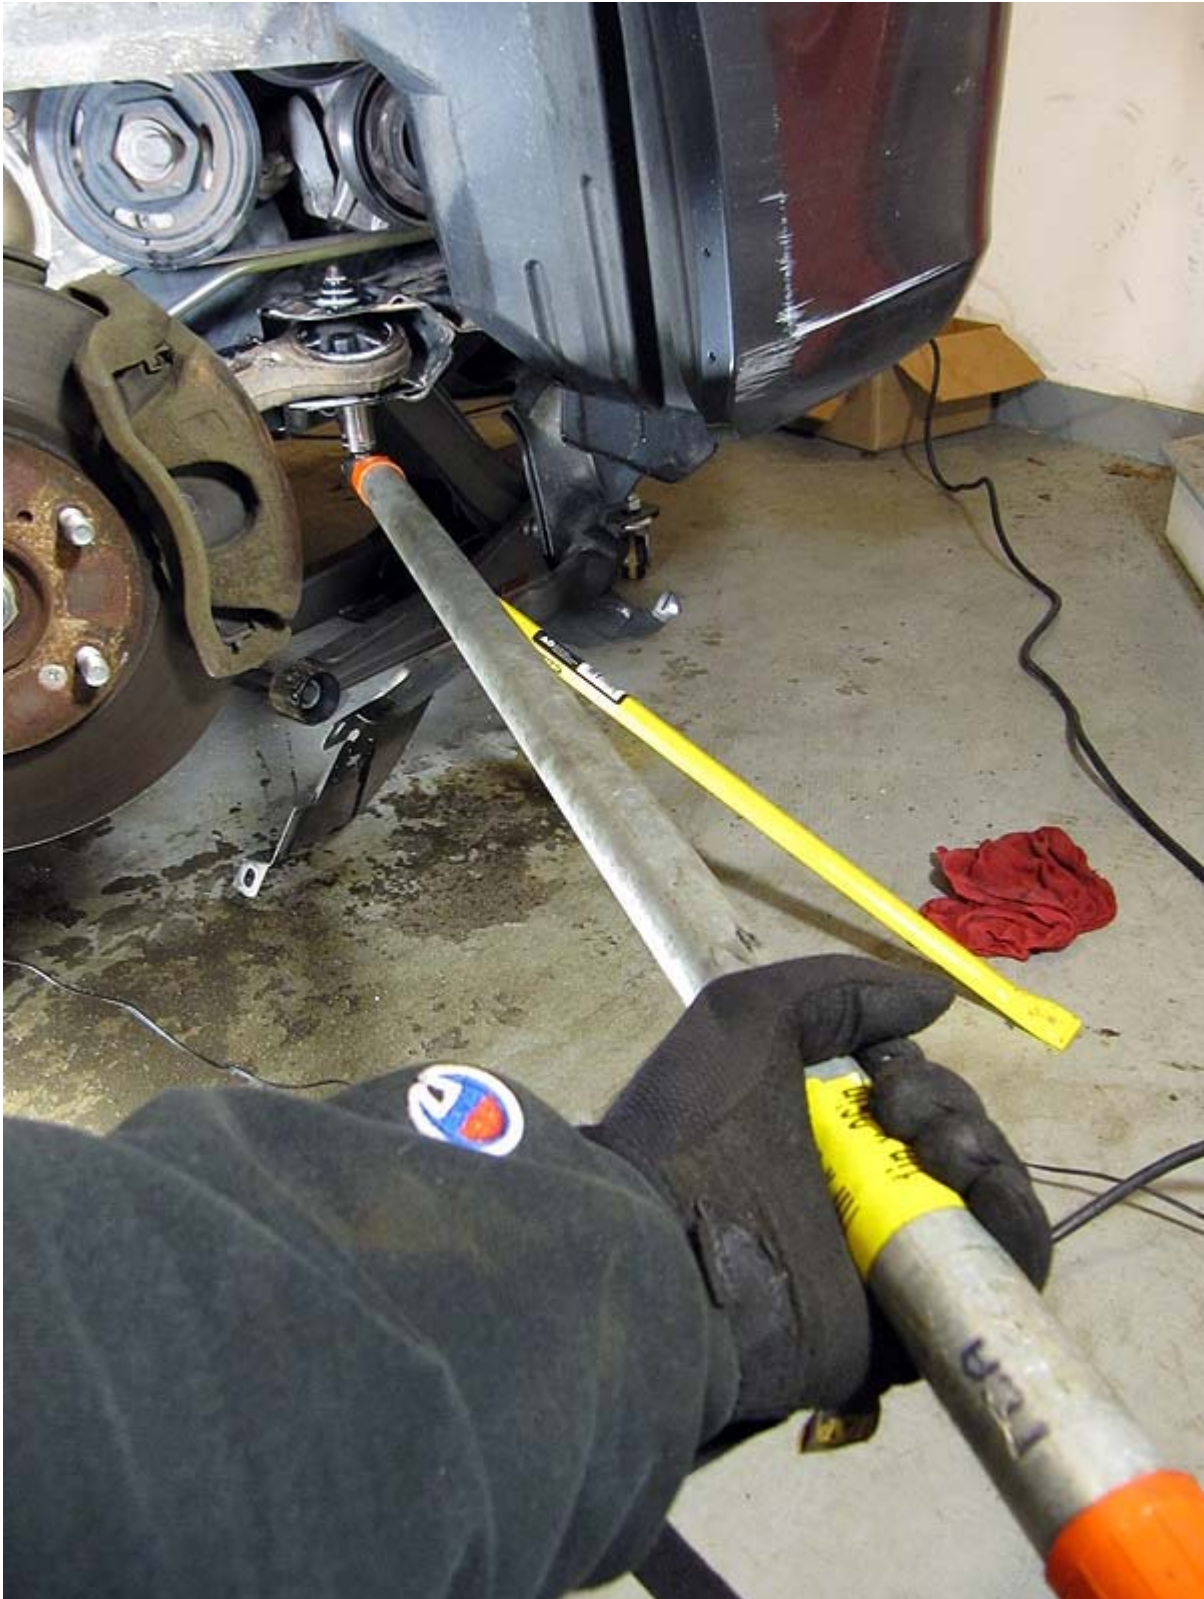
#4 – Then using a breaker bar and 3' cheater I was able to break the bolt free. However, I was not out of the woods yet!

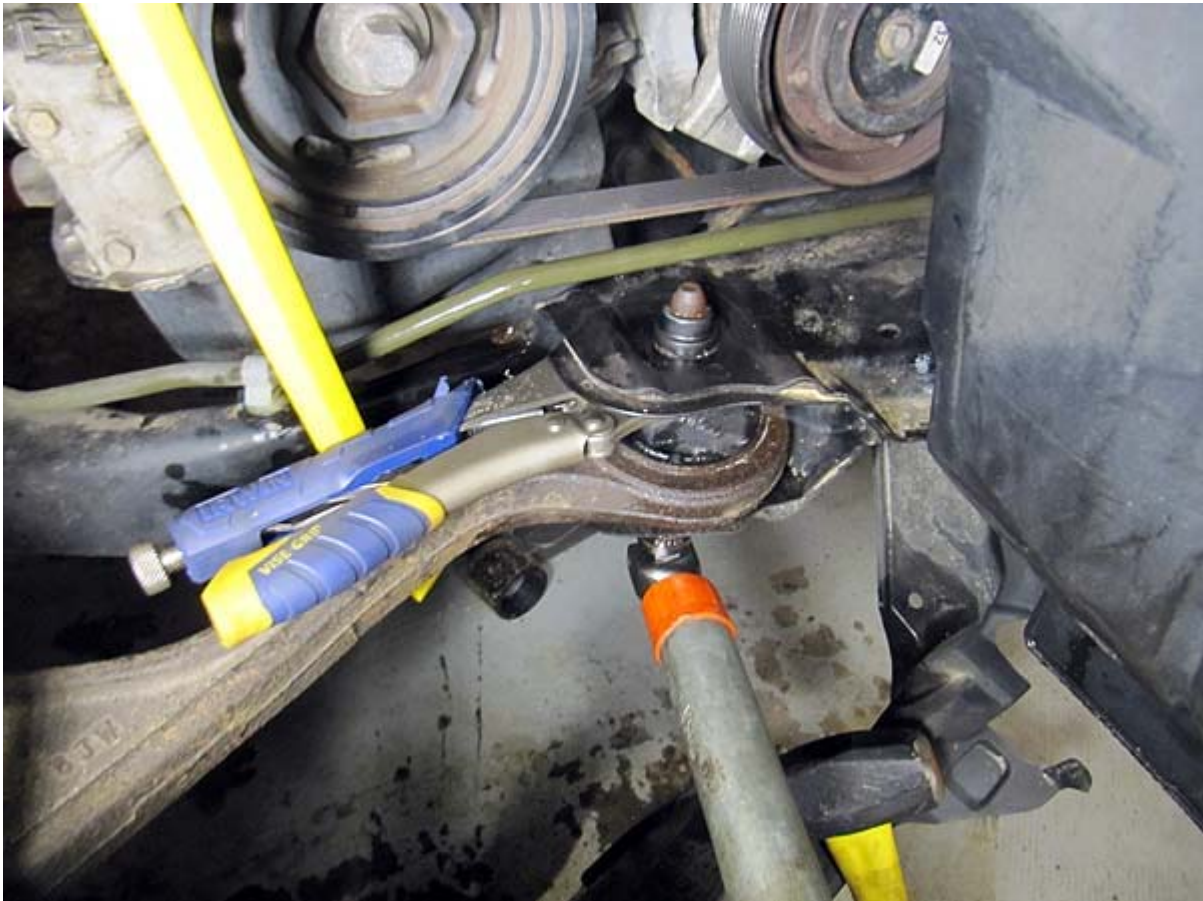
#5 – Even after the bolt was broken free of the nut, the metal bushing sleeve remained frozen to the bolt. So as I twisted the bolt, the center of the bushing twisted with it. I pushed hard enough that I thought the bushing was twisted so far that it could break. I didn't really want to tear the bushing apart so I put a pair of Vise Grips on the inner sleeve of the bushing and used a crow-bar (yellow) against the frame to keep the Vise Grips from twisting. With a LOT of force on the end of the cheater, the bolt eventually broke free (somewhat amazingly the Vise Grips held despite all that torque).

Another possibility is to simply twist the bolt and not worry if the inner part of the bushing tears free. As the bolt is extracted it should force the inner sleeve off the bolt and the bushing is going to be replaced anyway. I just didn't want to do that because I didn't want to destroy the bushing in case I wasn't able to get the bolt out.

Another possibility would be to try and heat the inner bushing sleeve with a torch to get it to expand. I suspect this would work well but the only problem with that approach is that it will likely set the bushing on fire and make a lot of stinky smoke.

I did also apply penetrating oil, and perhaps it helped some. However, it certainly didn't help as much as the heat. I don't think I could have gotten this bolt out without using heat.

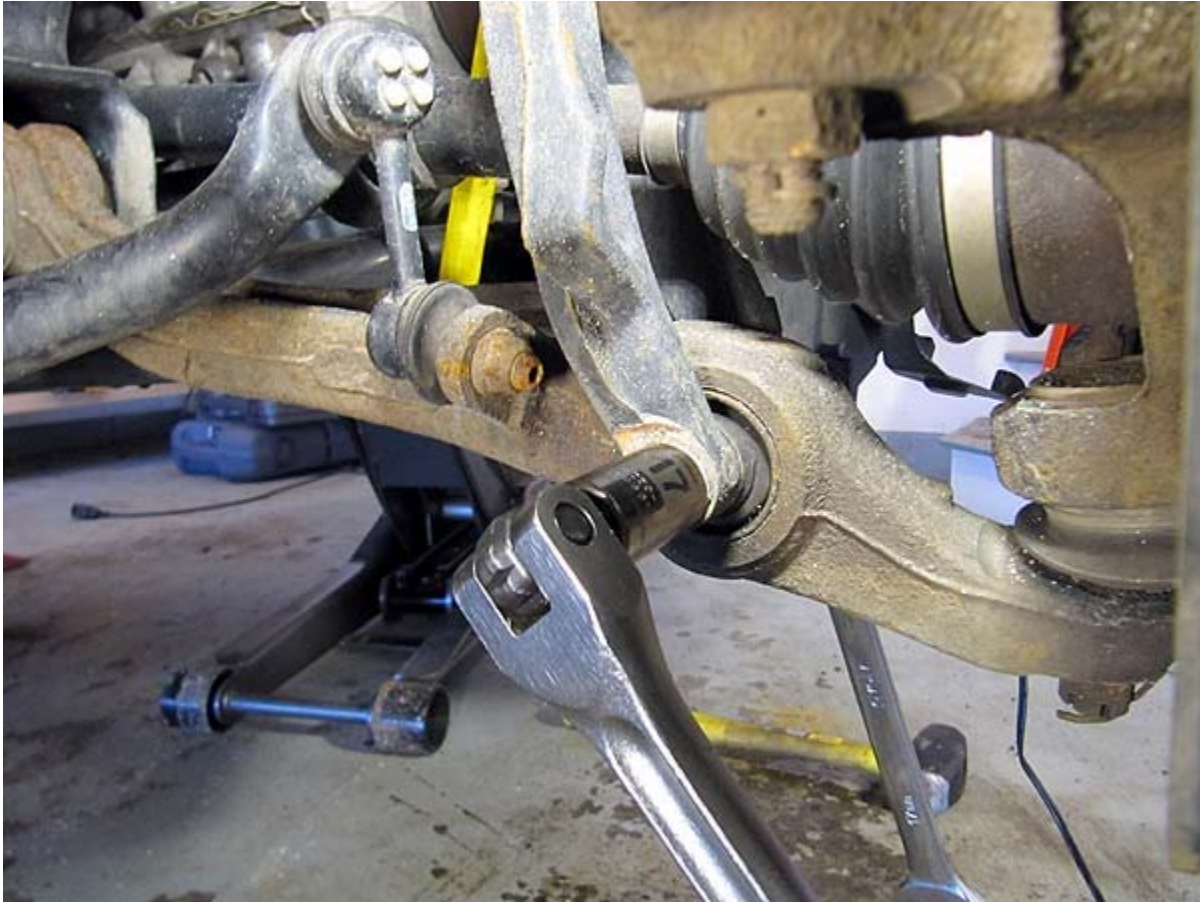
#6 – Remove the bolt holding the fork to the lower control arm.

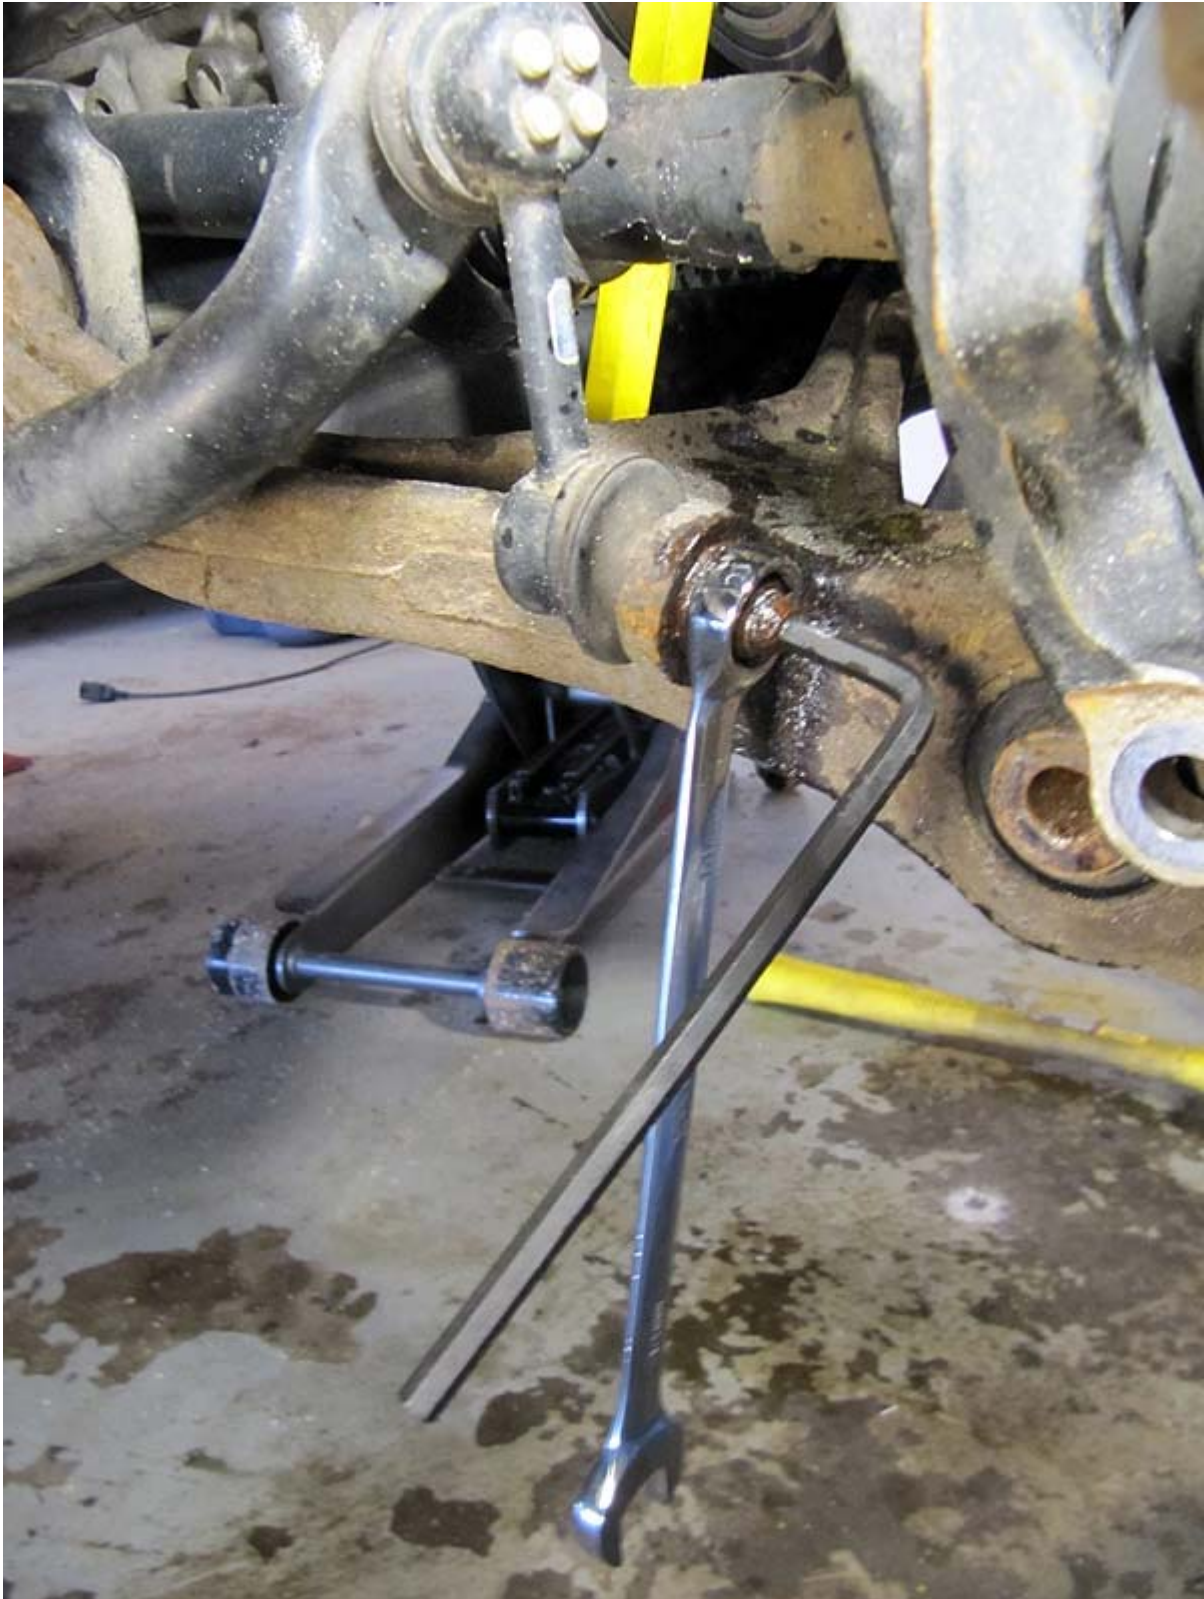
#7 – Remove the stabilizer link from the lower control arm. Use an Allen wrench in the end of the bolt to hold the stabilizer link bolt from turning while the nut is removed.

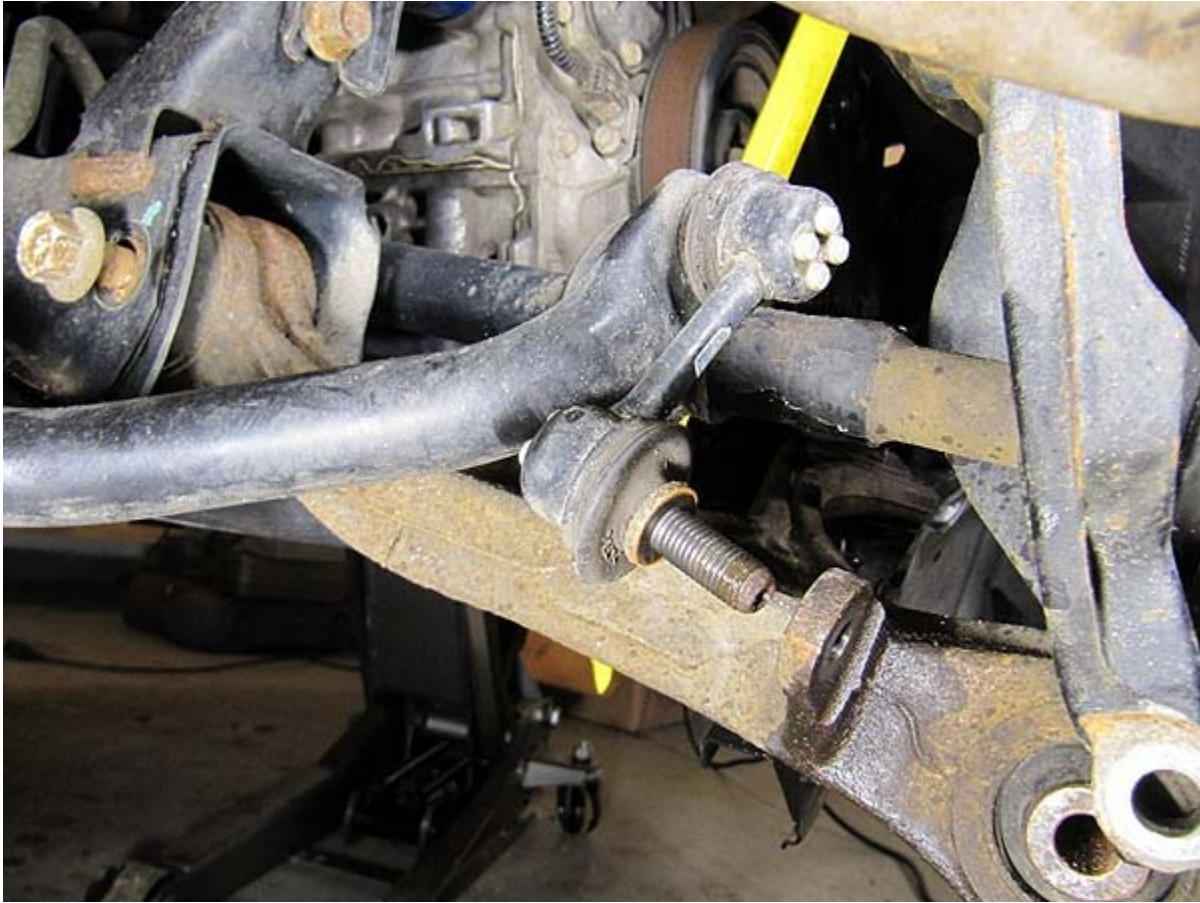
#8 – Pull the stabilizer link out of the lower control arm.

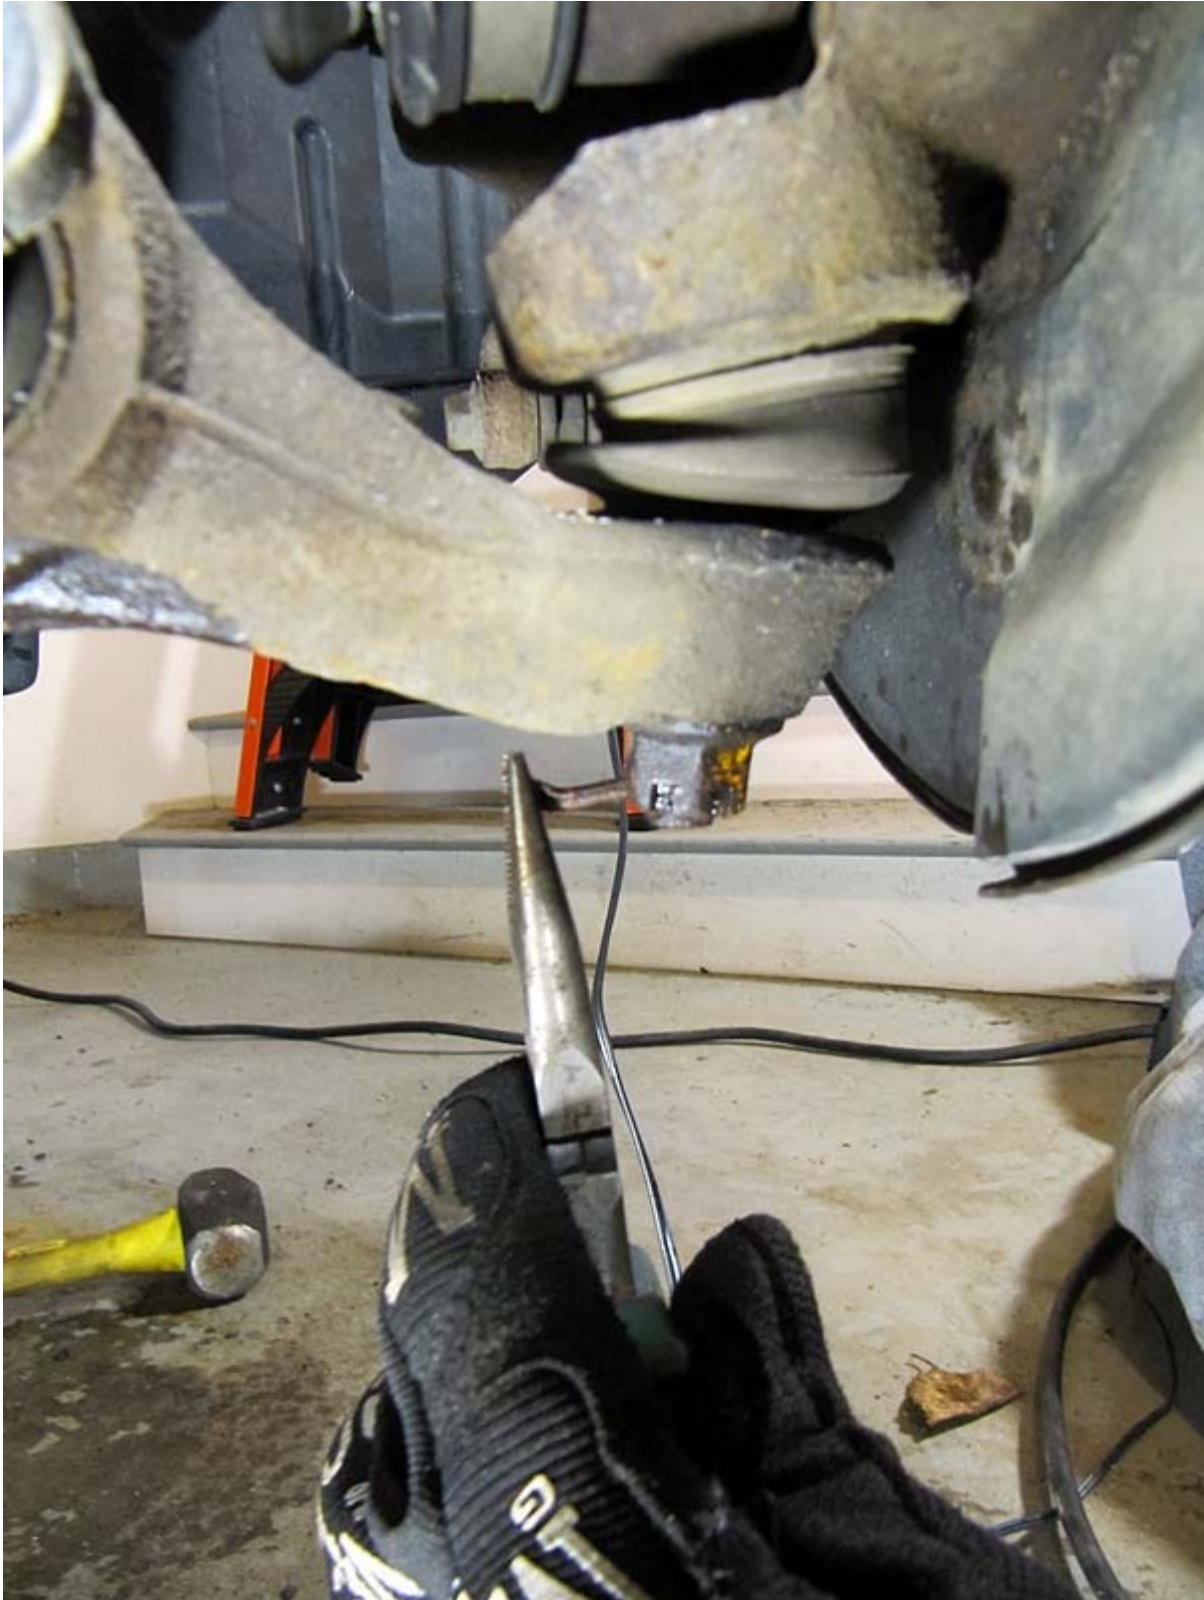
#9 – Remove the cotter pin from the lower ball joint nut.

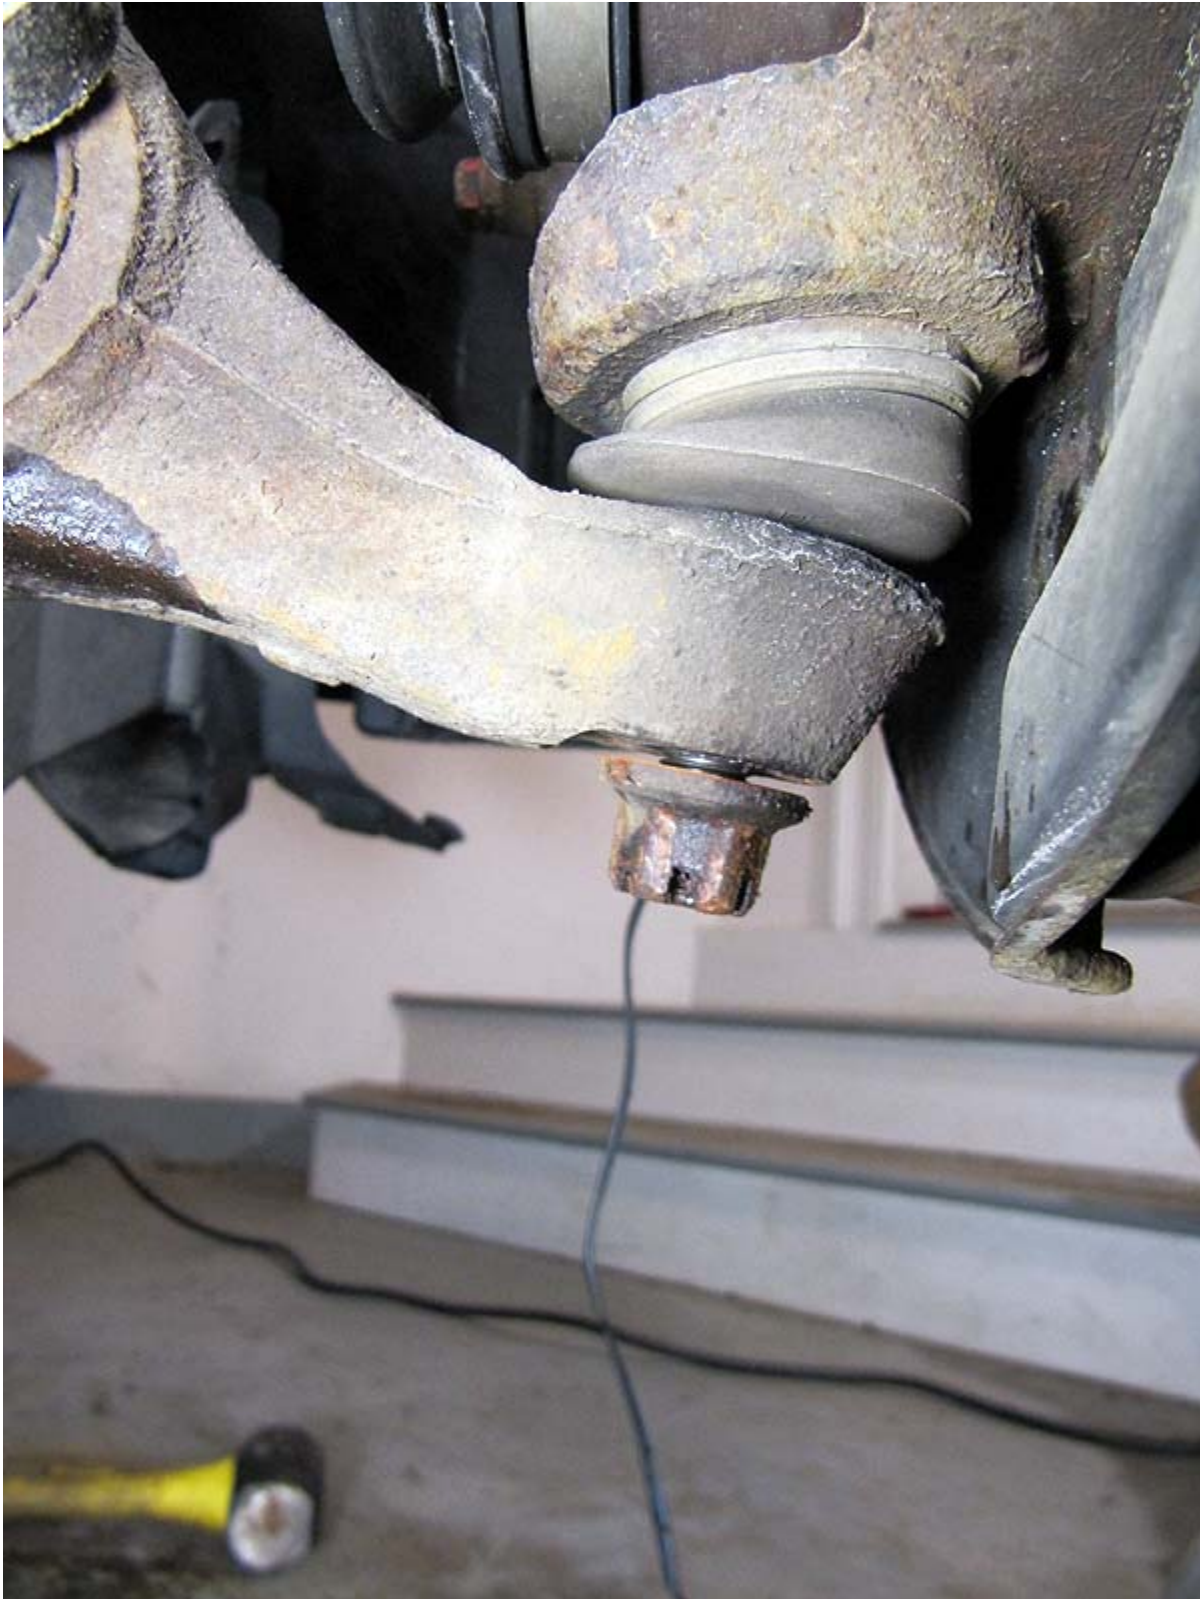
#10 – Loosen the lower ball joint nut, but don't remove it completely (to keep the knuckle and lower arm from flying around wildly when the lower ball joint is separated).

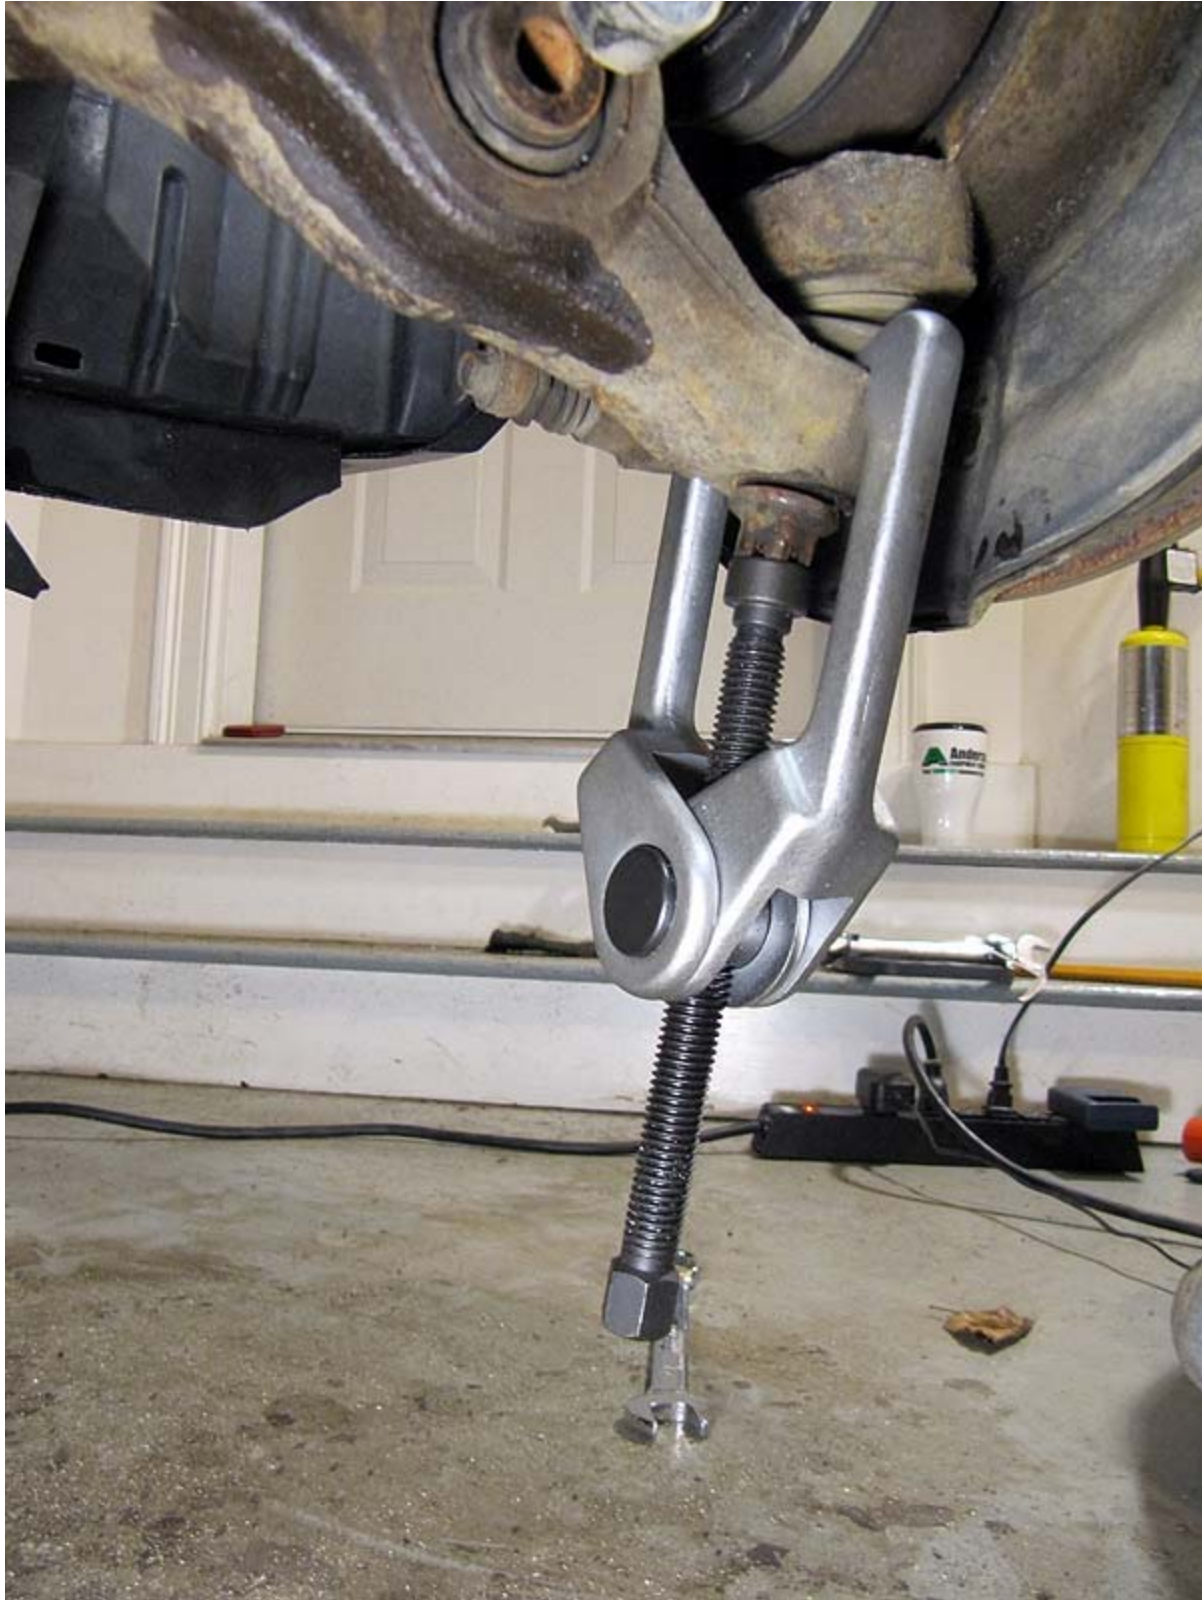
#11 – Use a two-jaw puller to separate the lower ball joint from the control arm.

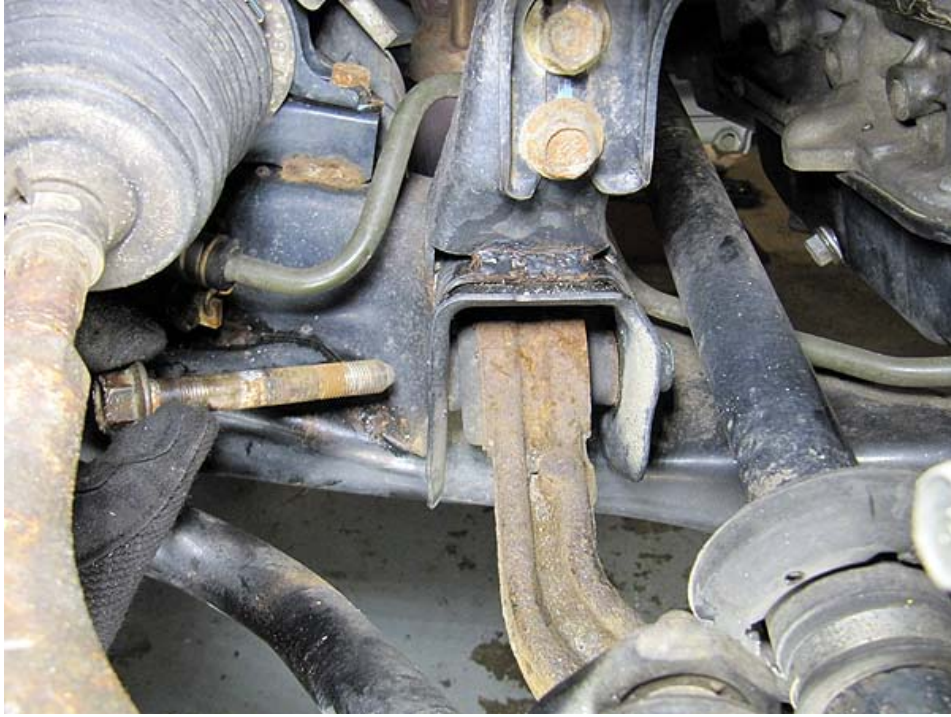
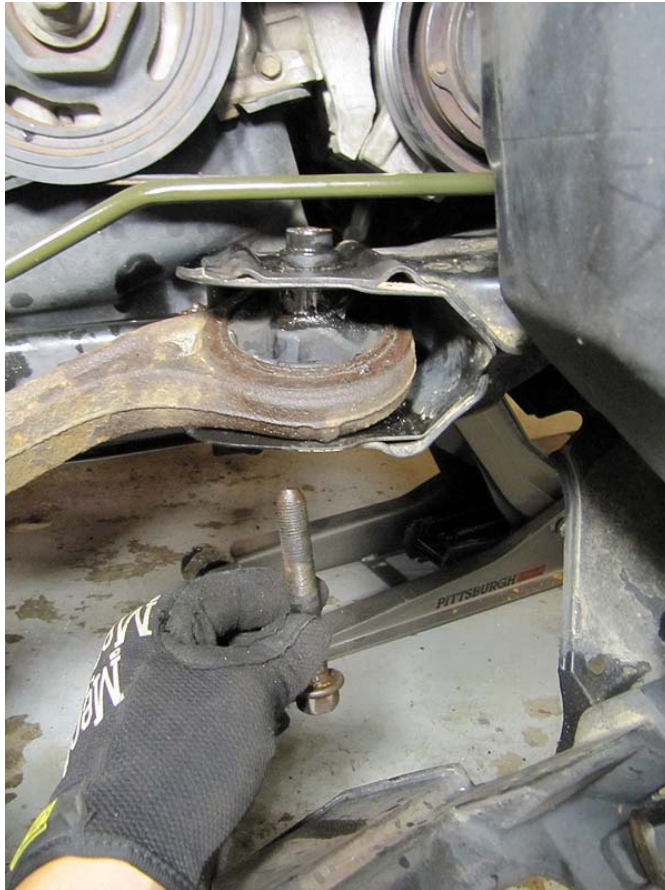
#12 – Remove the bolts from the Rear Bushing and Compliance Bushing.

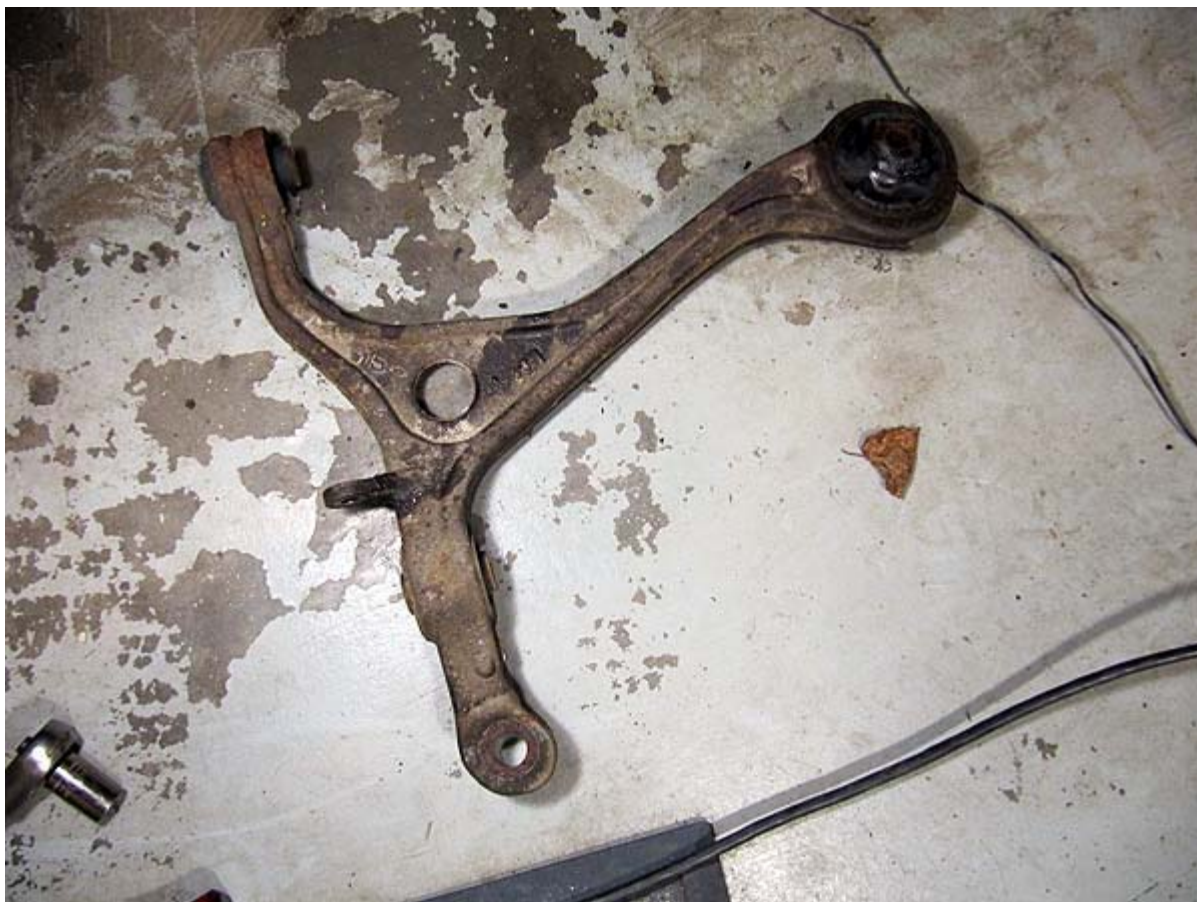
#13 – And with a little struggling, out comes the Lower Control Arm!
