Replacing Lower Control Arm Bushings on a 2007 Honda Accord 4CYL

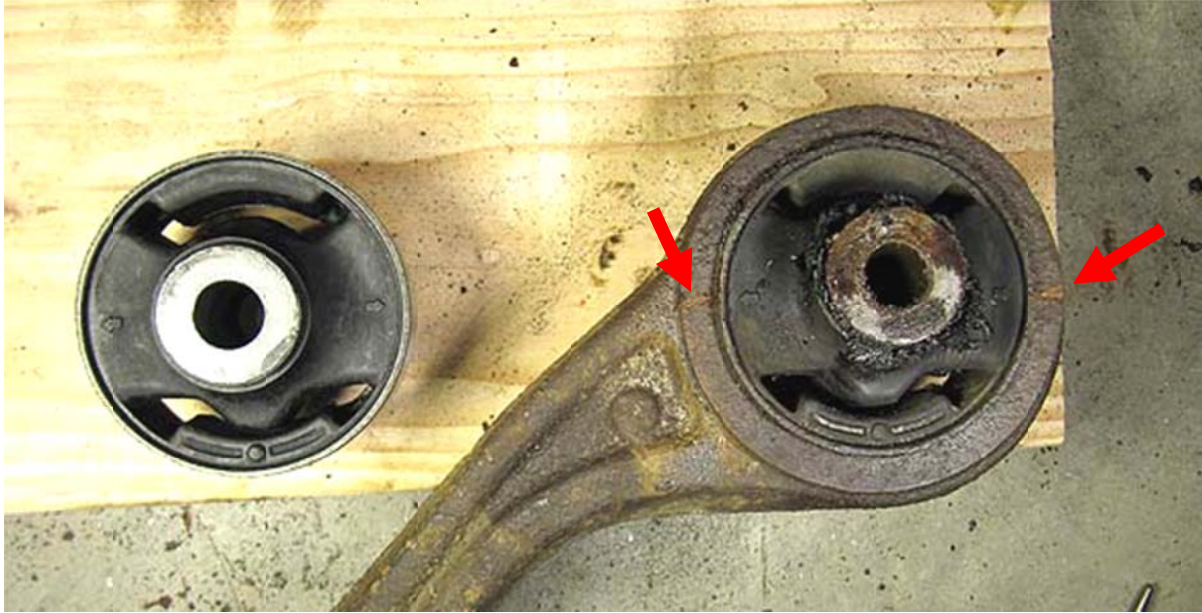
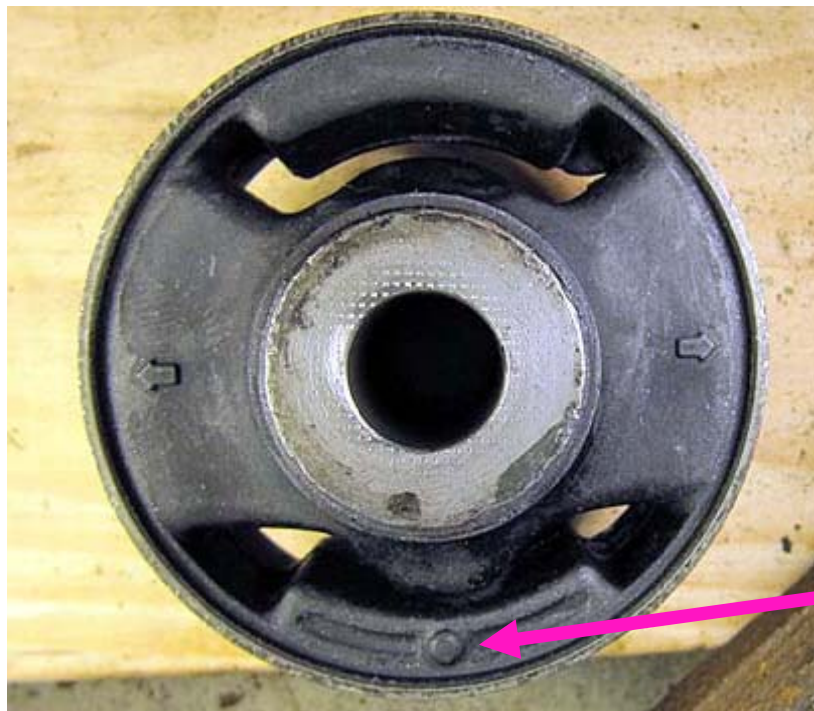
#14 – The Compliance Bushing must be installed in the correct orientation. Scratch some marks in the control arm (red arrows) lining up with the arrows on the Compliance Bushing.

DOT goes to
Outside of
Vehicle

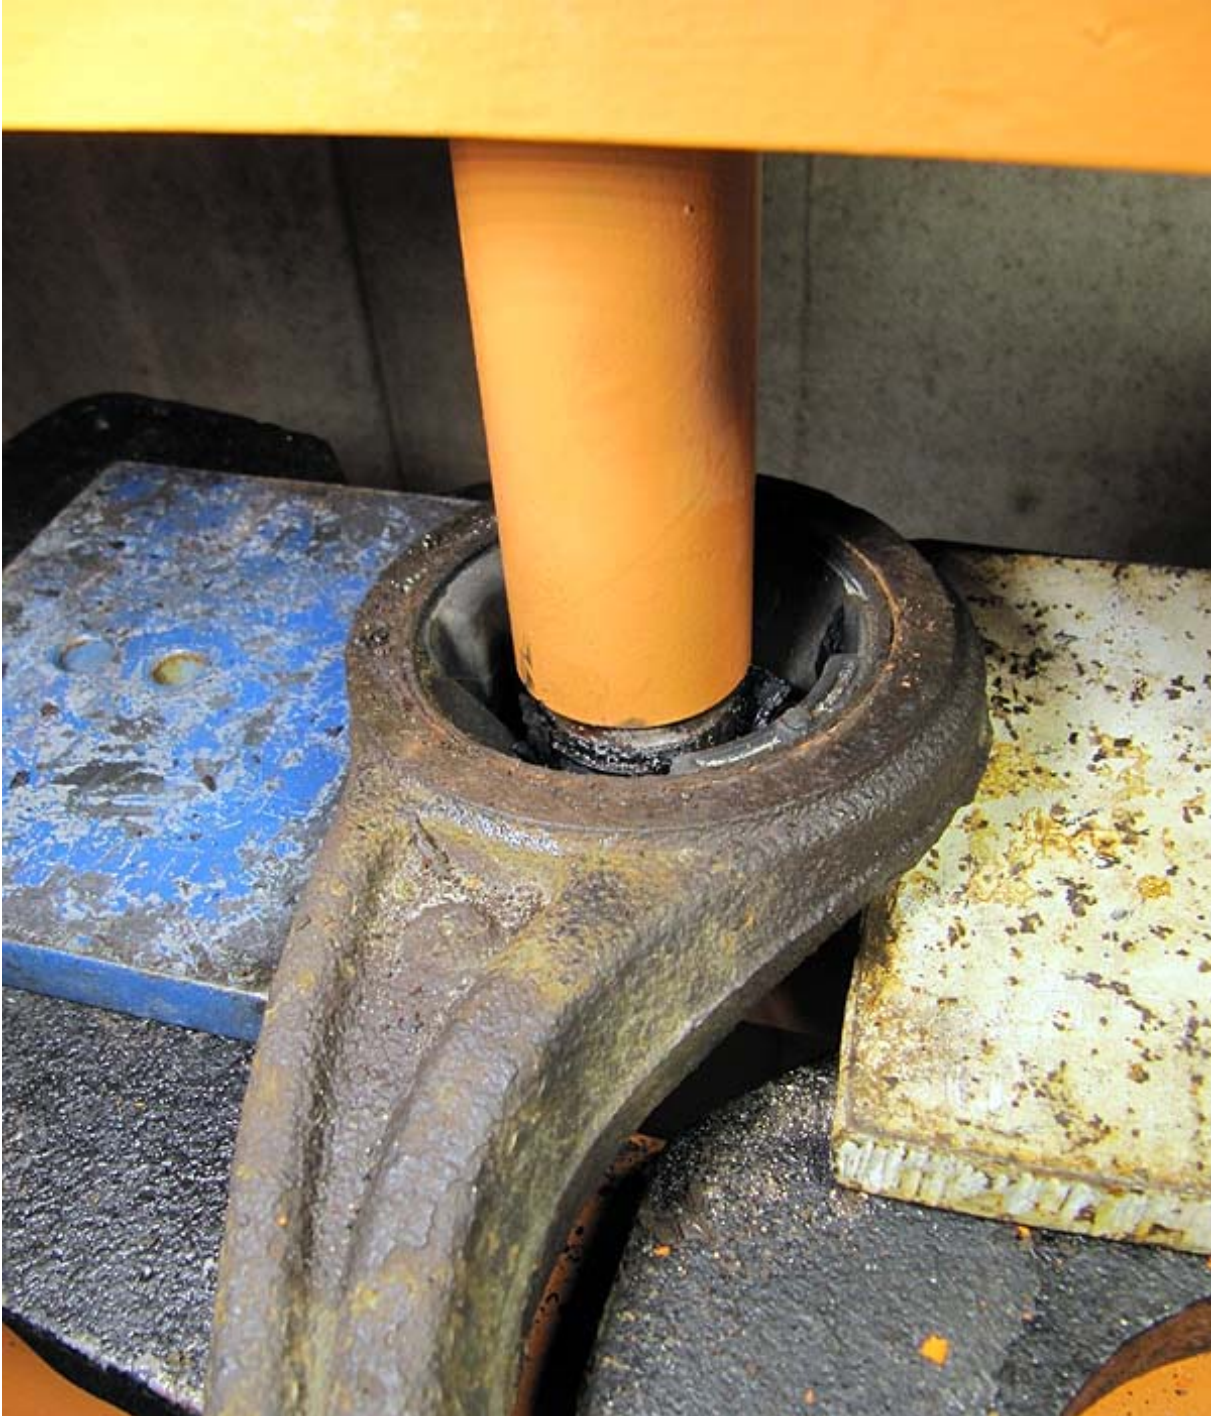
#15 – I started by driving out the center of the bushing just to get it out of the way. I pushed until the bushing snapped and the center portion of the bushing broke free.

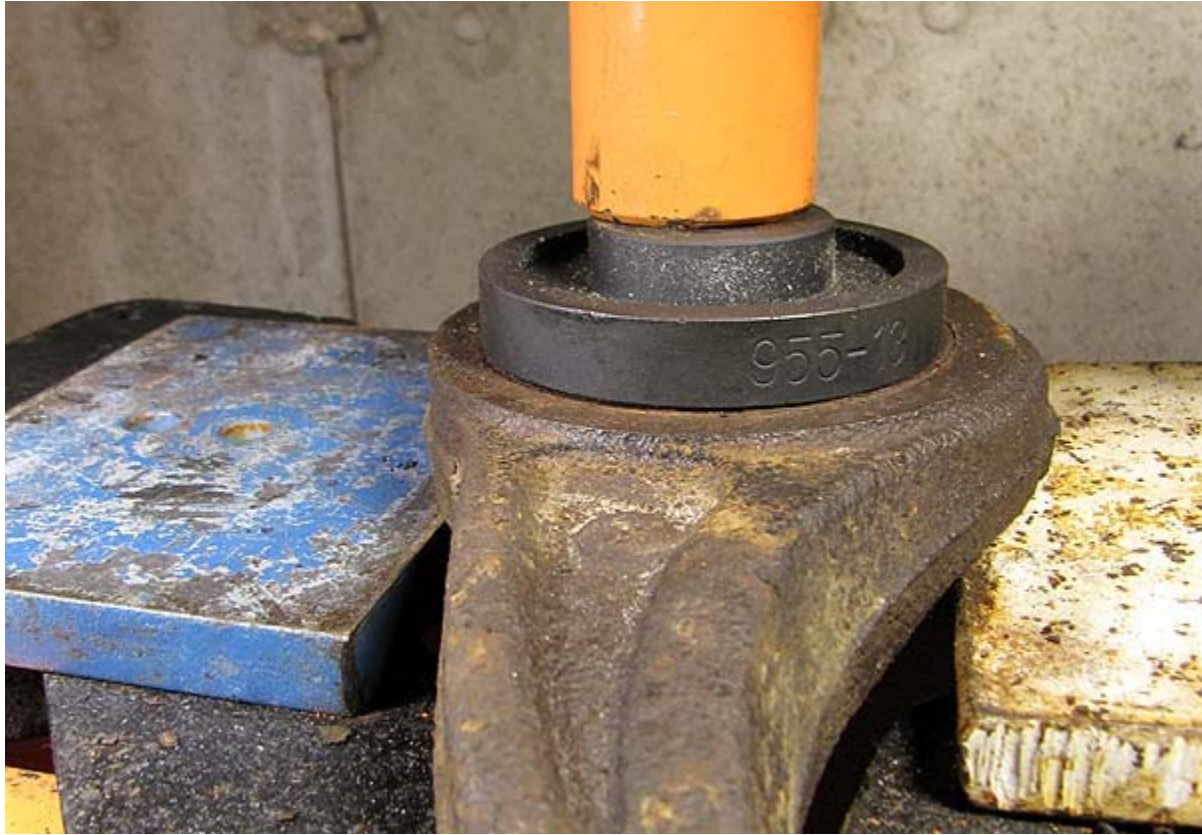
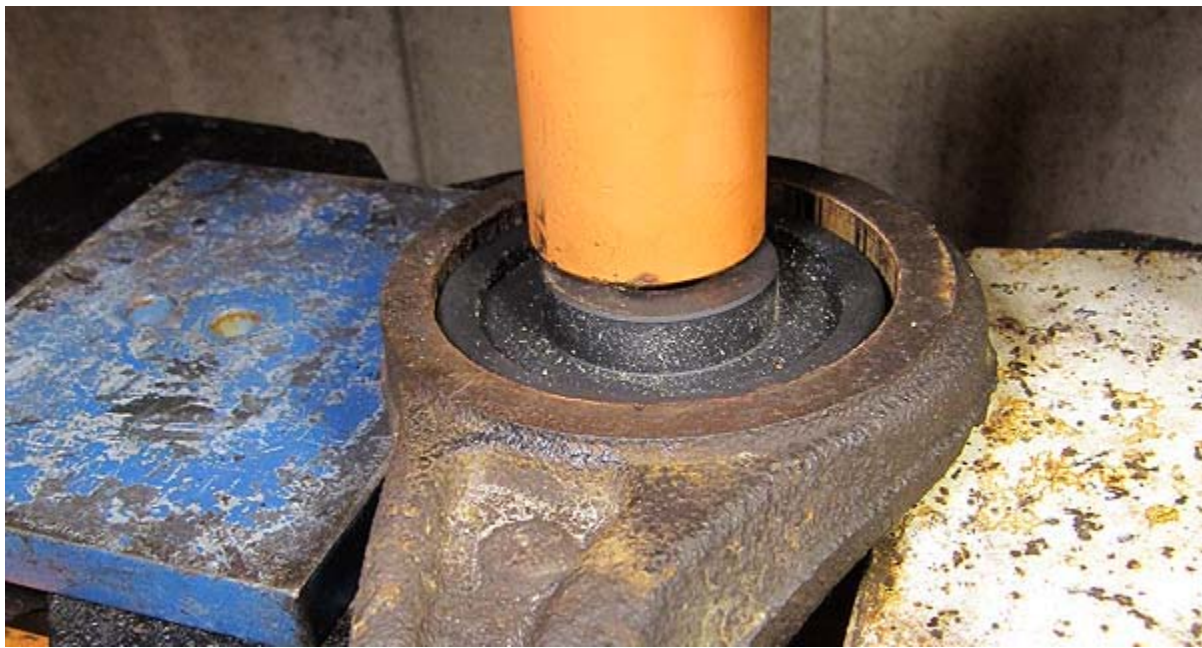
#16 – With the inner portion of the bushing removed, I was able to use a flat disk (from a wheel bearing press kit) that fit over the outer bushing sleeve to push the Compliance bushing out of the lower control arm.

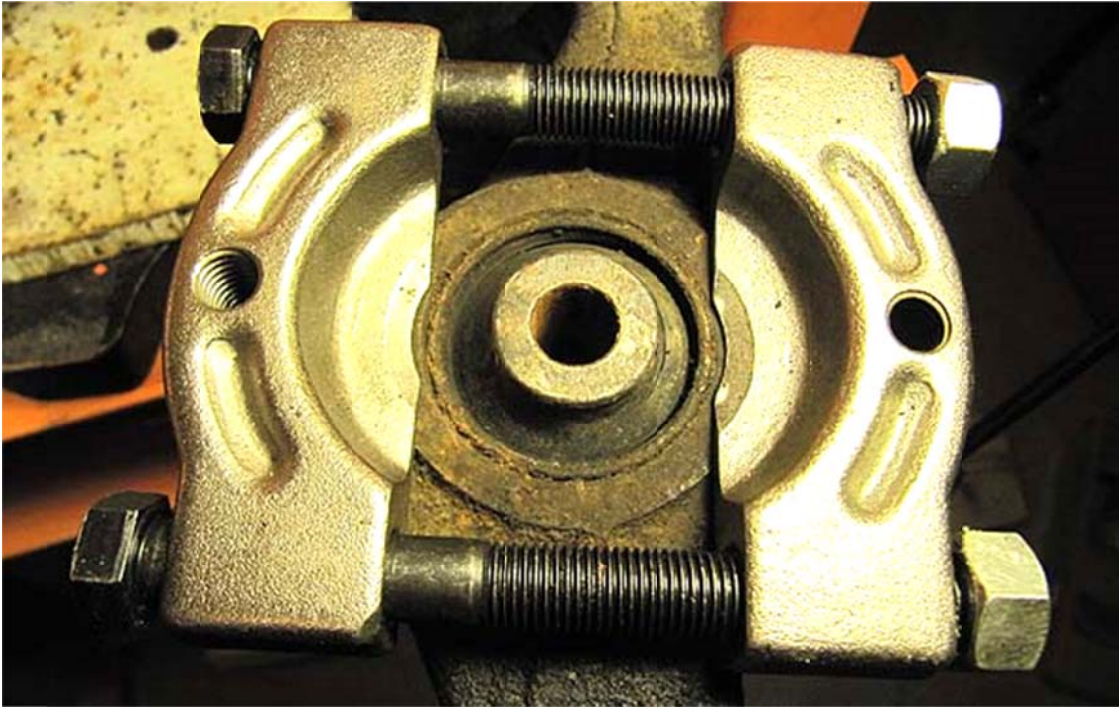
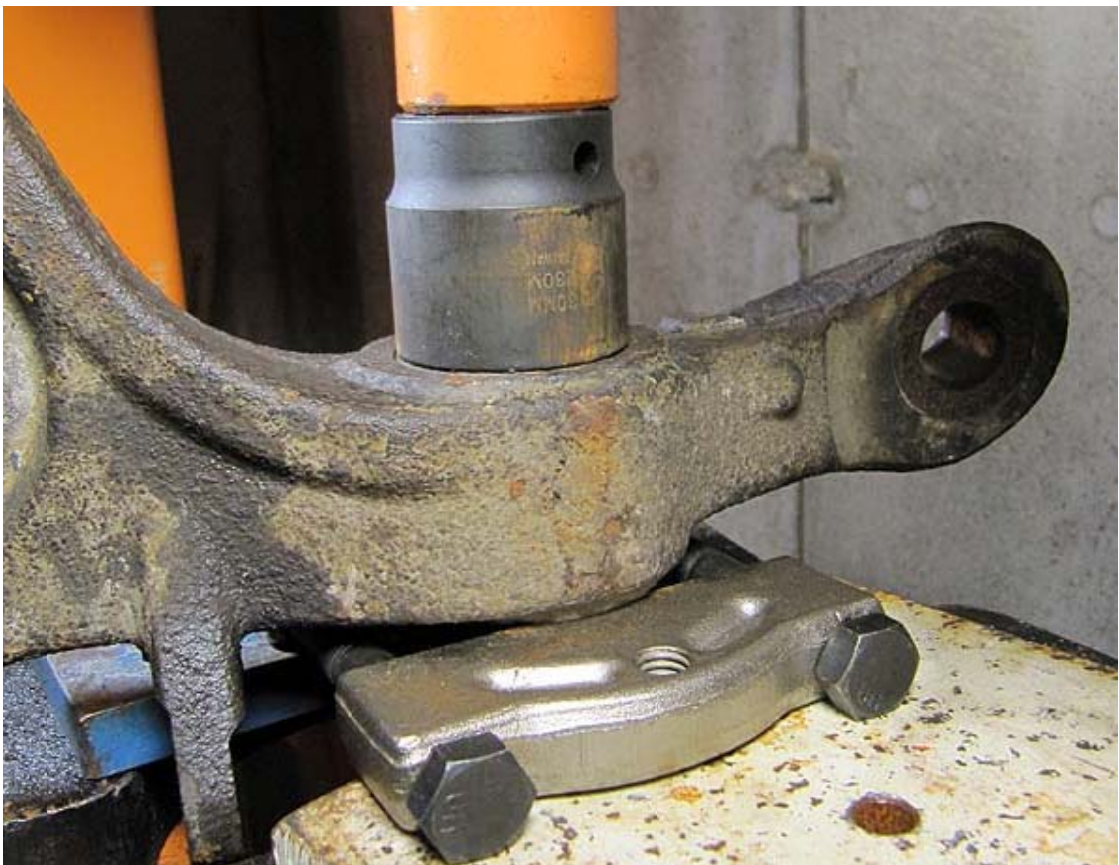
#17 – To push out the Shock Absorber bushing I used a bearing separator sized to be just larger than the bearing sleeve and a socket that fit on the outer sleeve of the bearing.

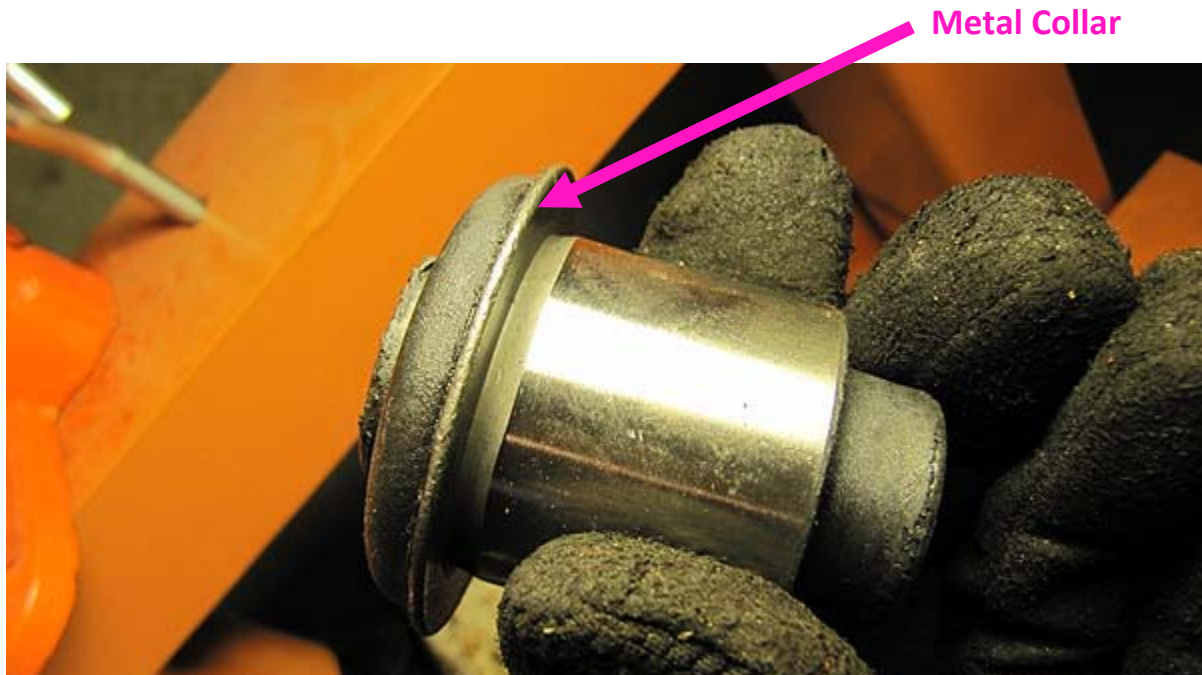
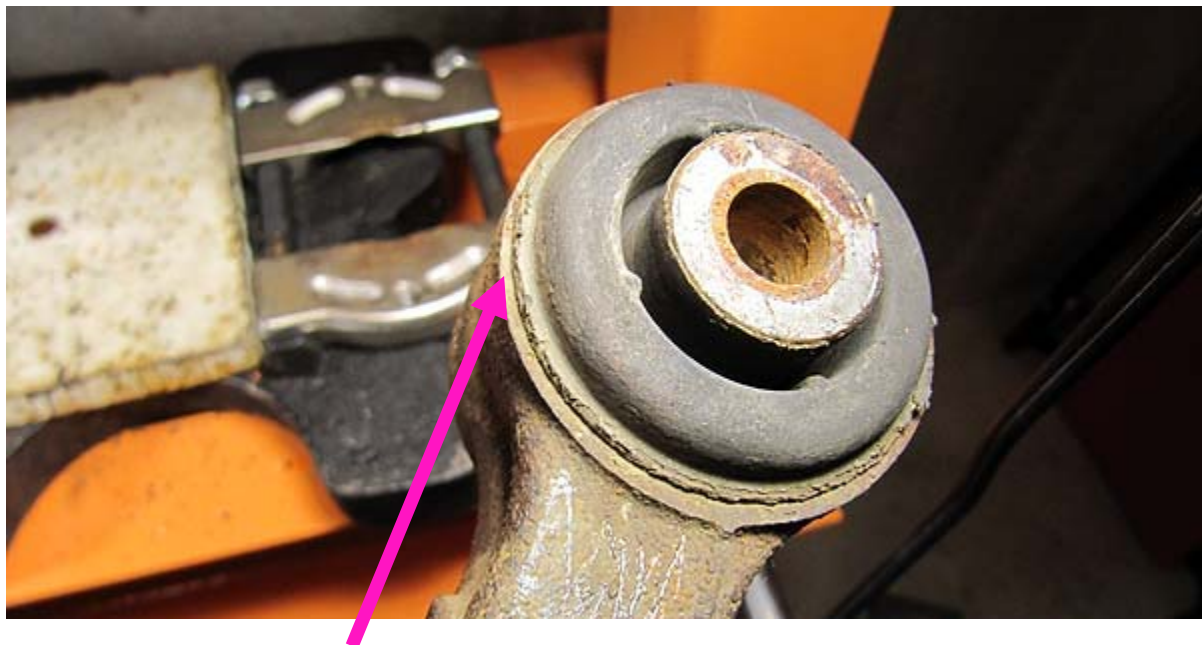
#18 – The rear bushing is perhaps the trickiest because it has a collar on the sleeve that leaves very little room to hold the lower control arm while pushing the bearing through.

Metal Collar

The metal collar leaves very little of the control arm exposed to support when pushing out the bushing

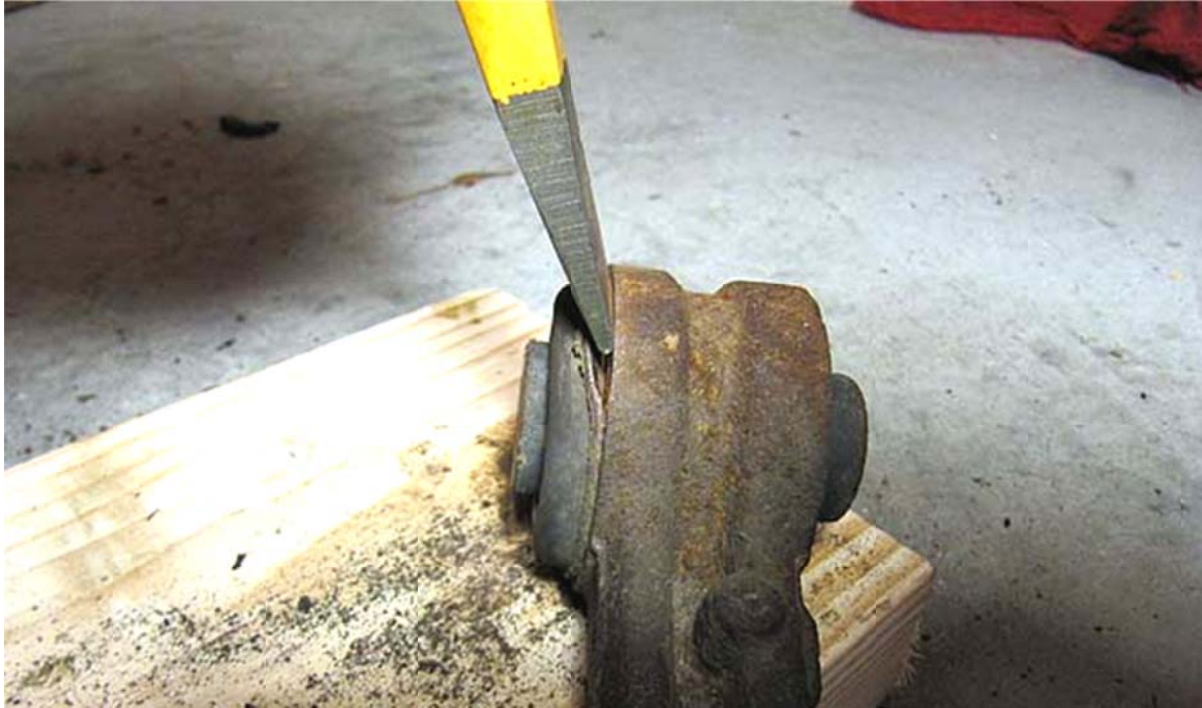
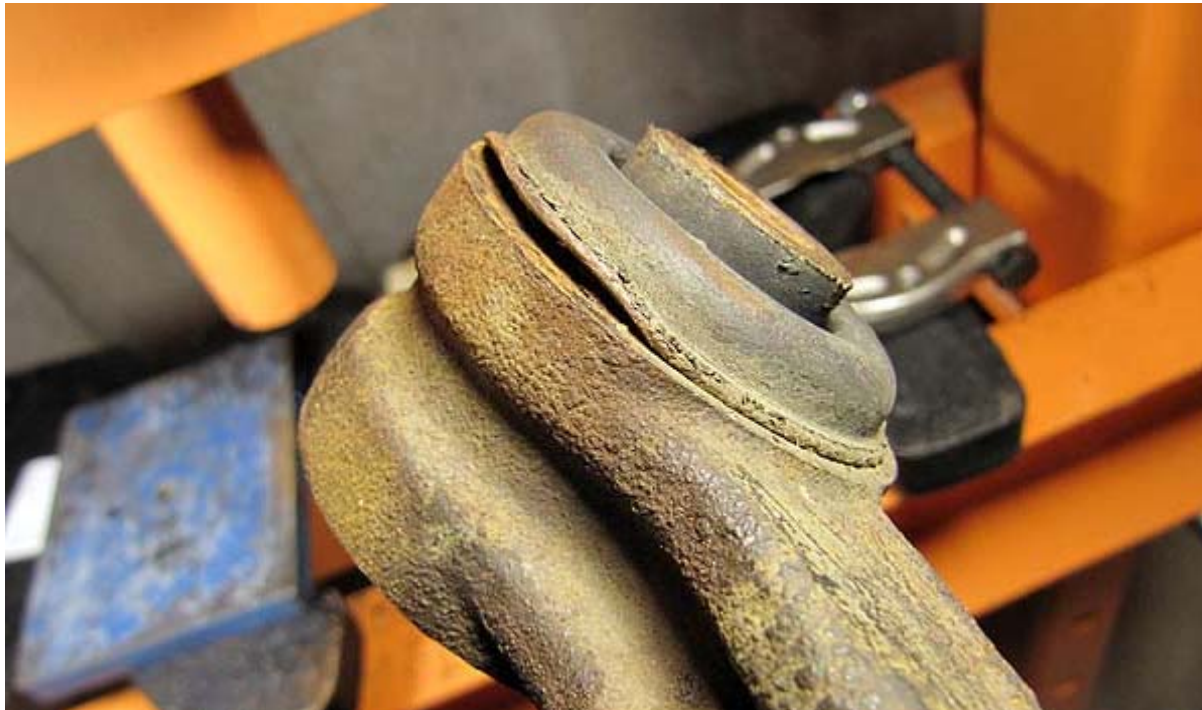
#19 – I used a cold chisel and hammer to bend up the metal collar of the bushing on two opposite sides.

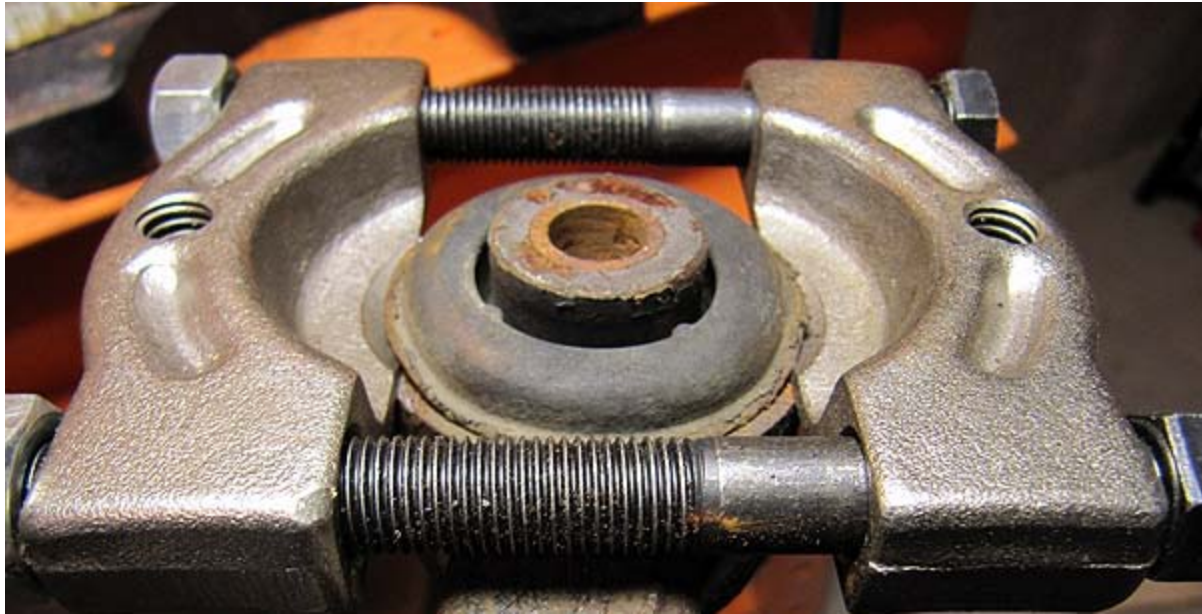
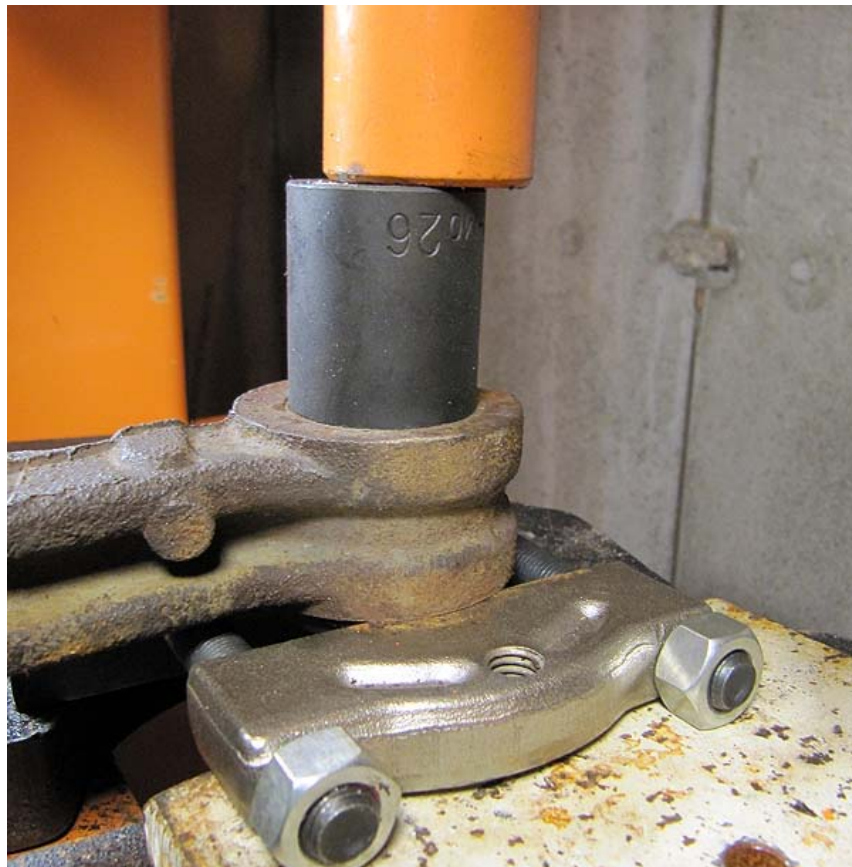
#20 – Then I was able to insert a bearing separator under the collar and push out the bushing using a socket that fit on the outer sleeve of the bushing.

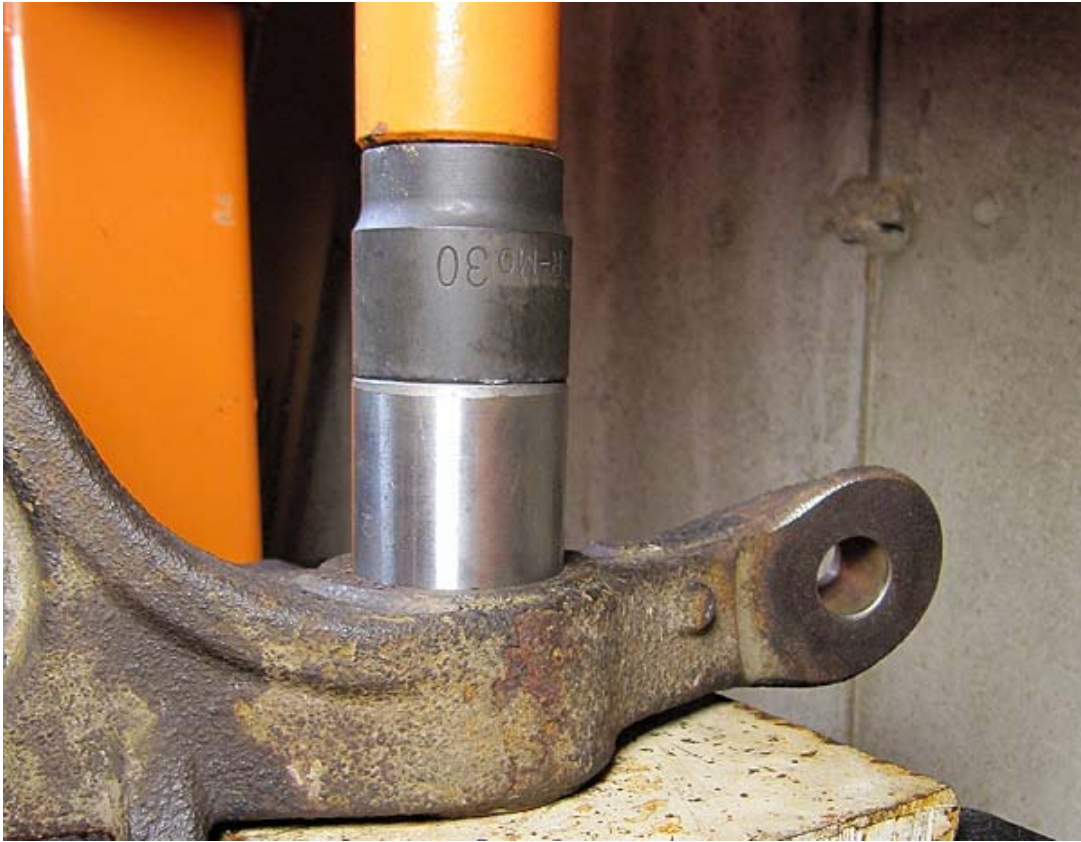
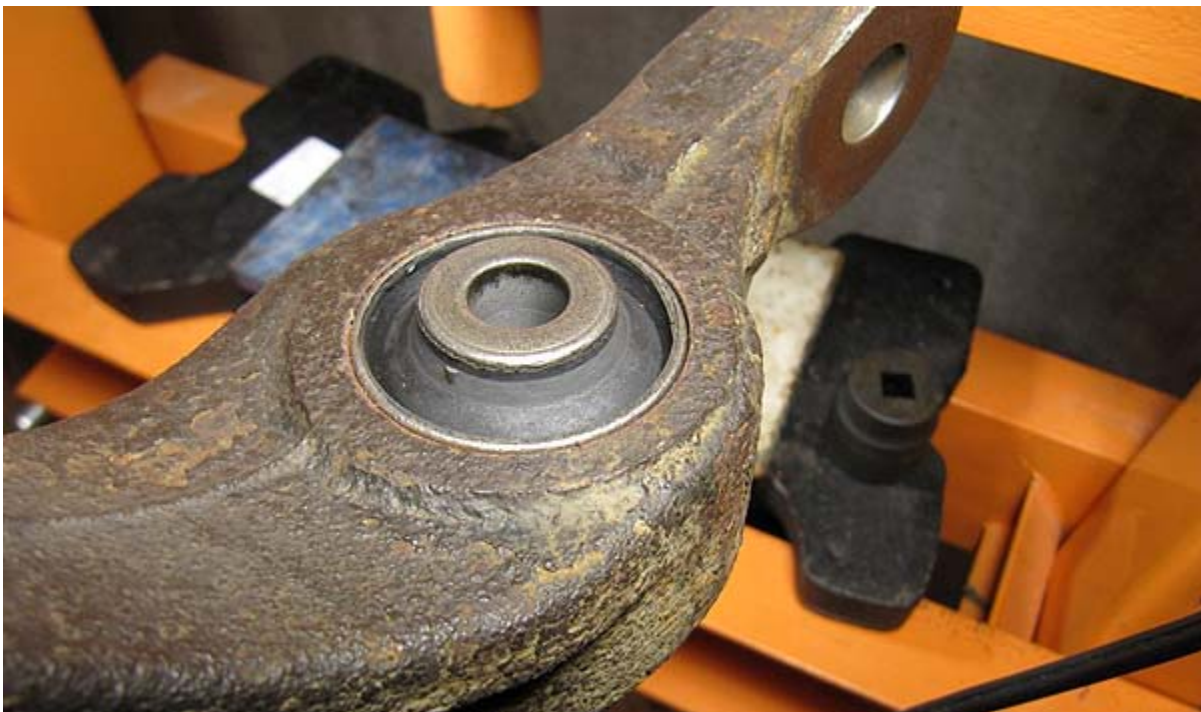
#21 – The new Shock Absorber bushing can be pressed in using a socket that fits on the outer sleeve.

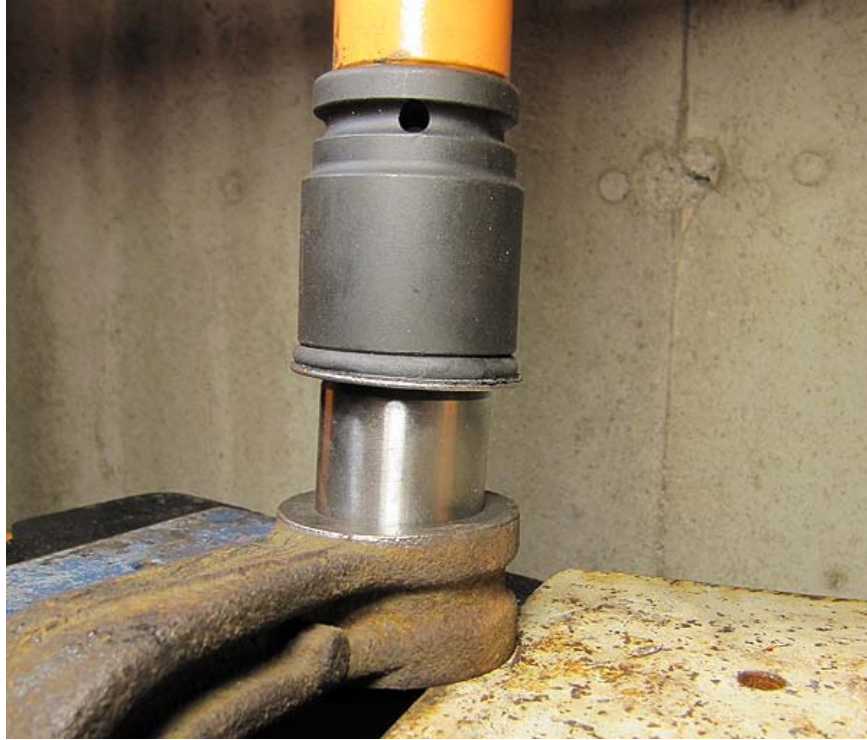
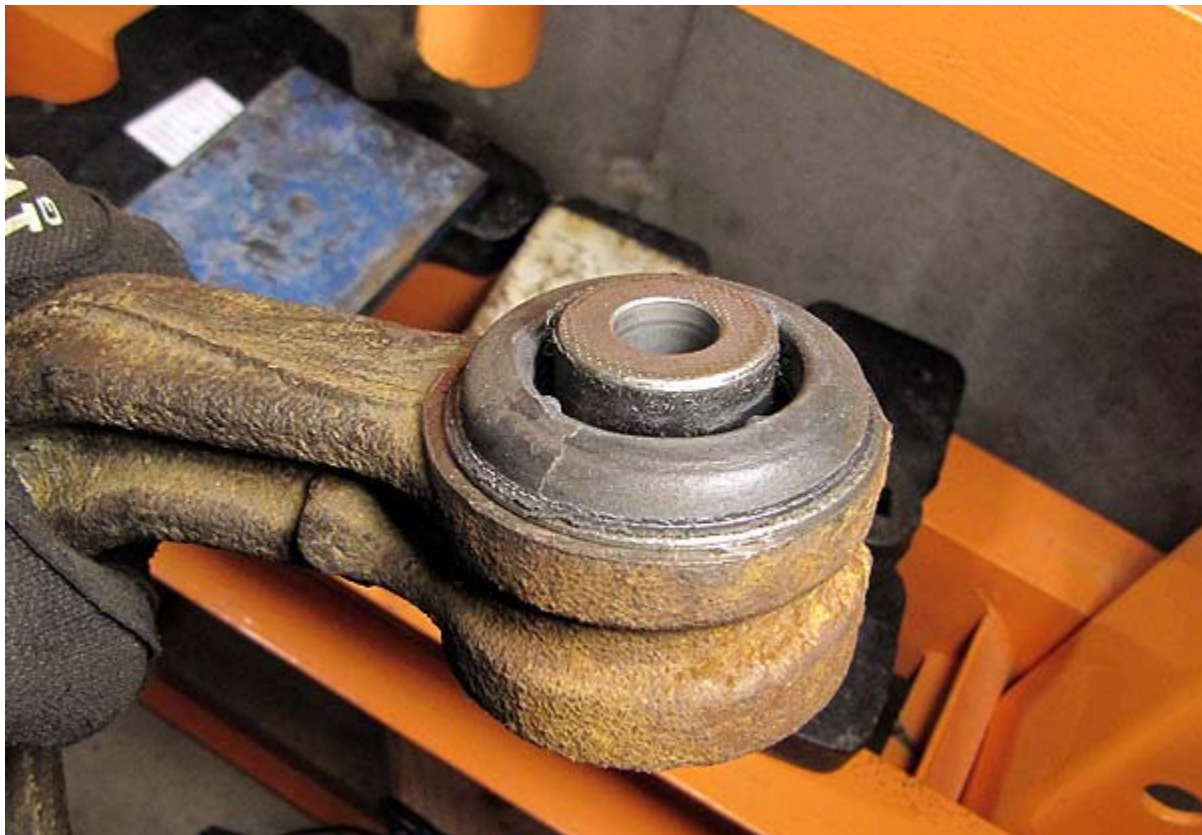
#22 – The new Rear Bushing can be pressed in using a socket that fits on the outer sleeve. (Yeh, I know it is crooked – but it straightened out!)

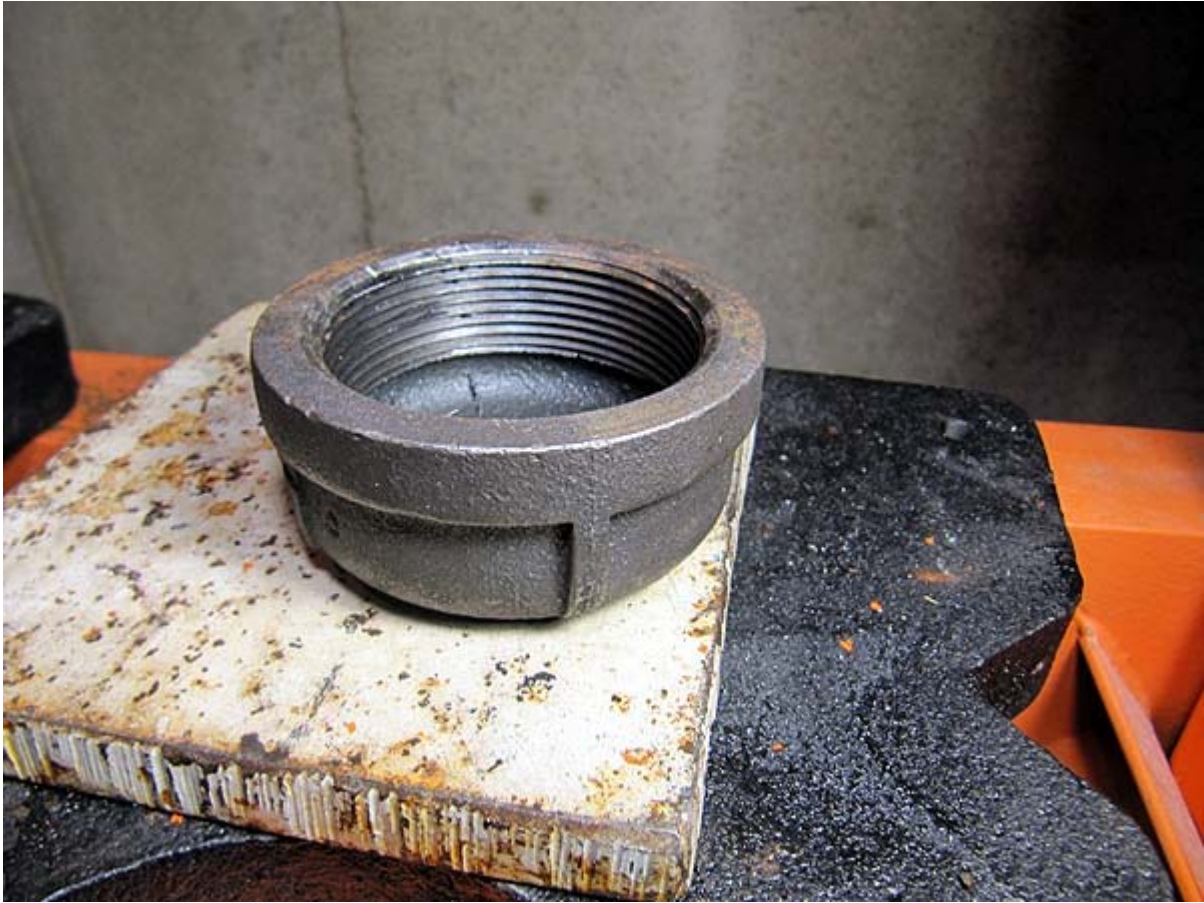
#23 – To push in the new Compliance Bushing you will need something that lines up with the outer metal sleeve of the bushing but gives clearance for the inner bushing sleeve. I used a 2" steel pipe end cap as shown below.

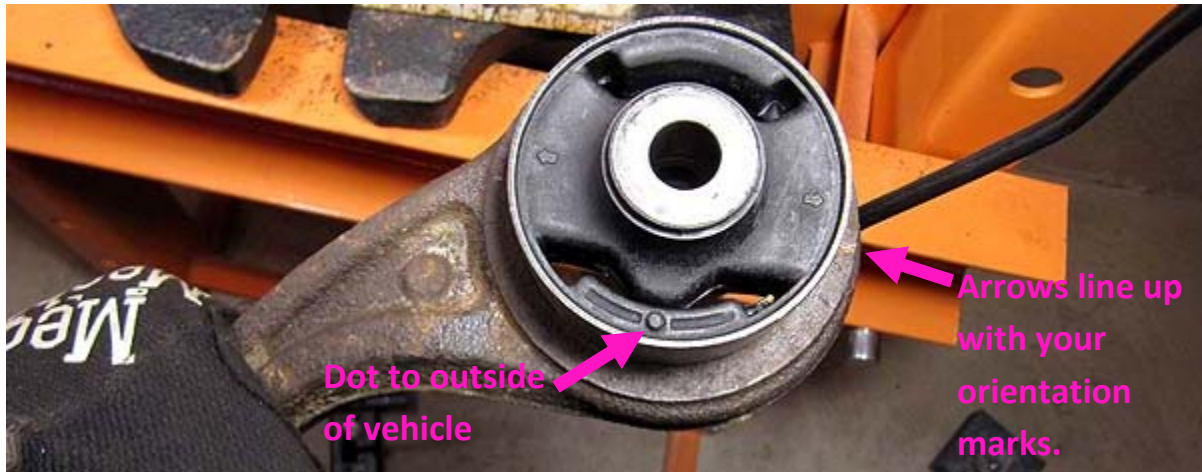
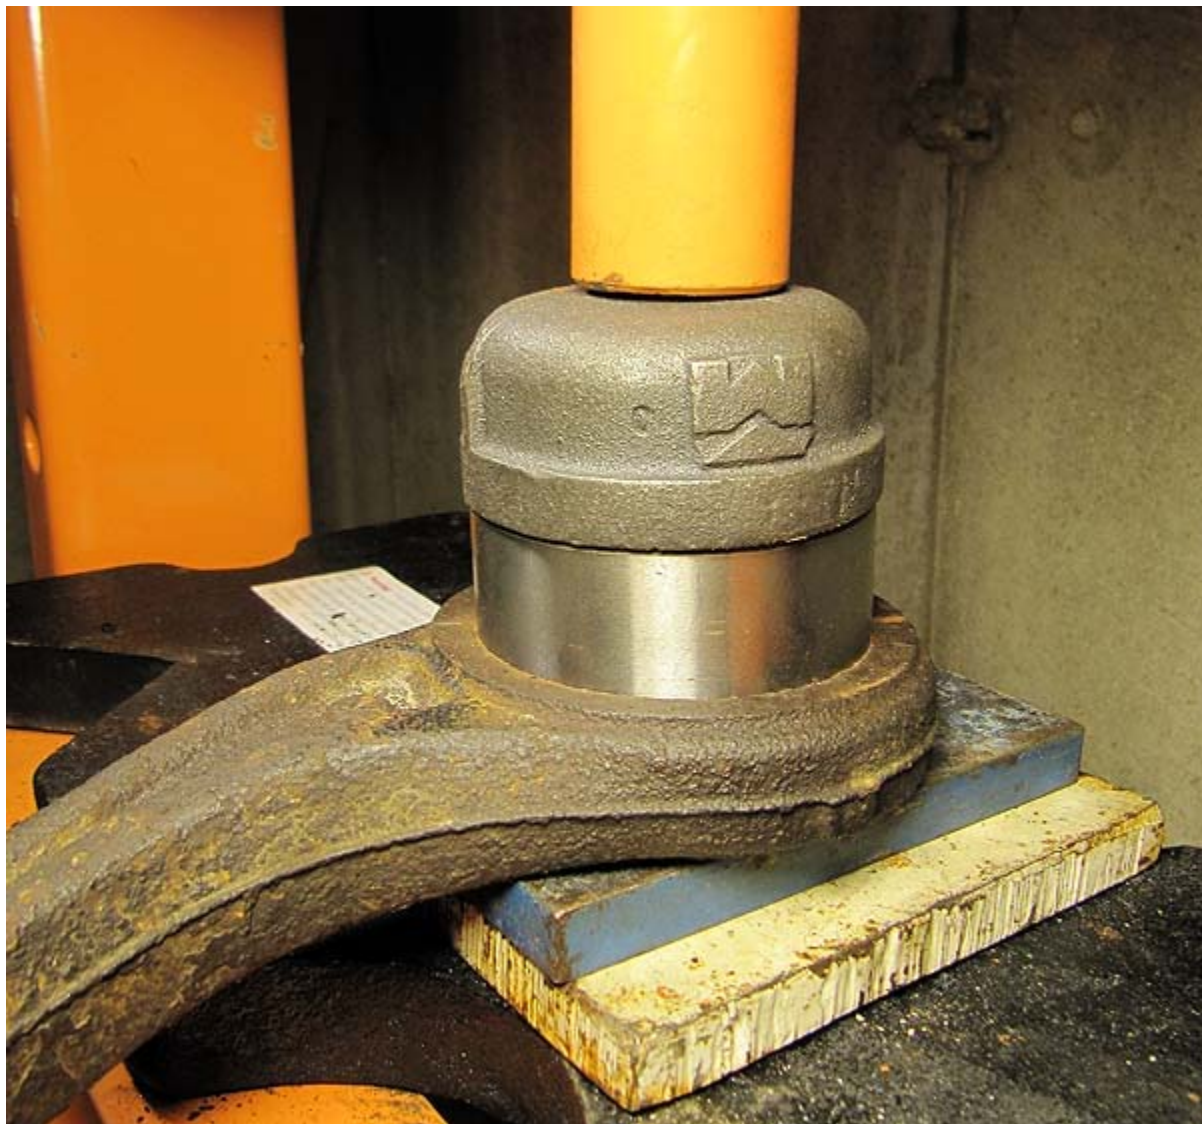
#24 – Make sure that the orientation of the Compliance Bushing is correct and push it in.

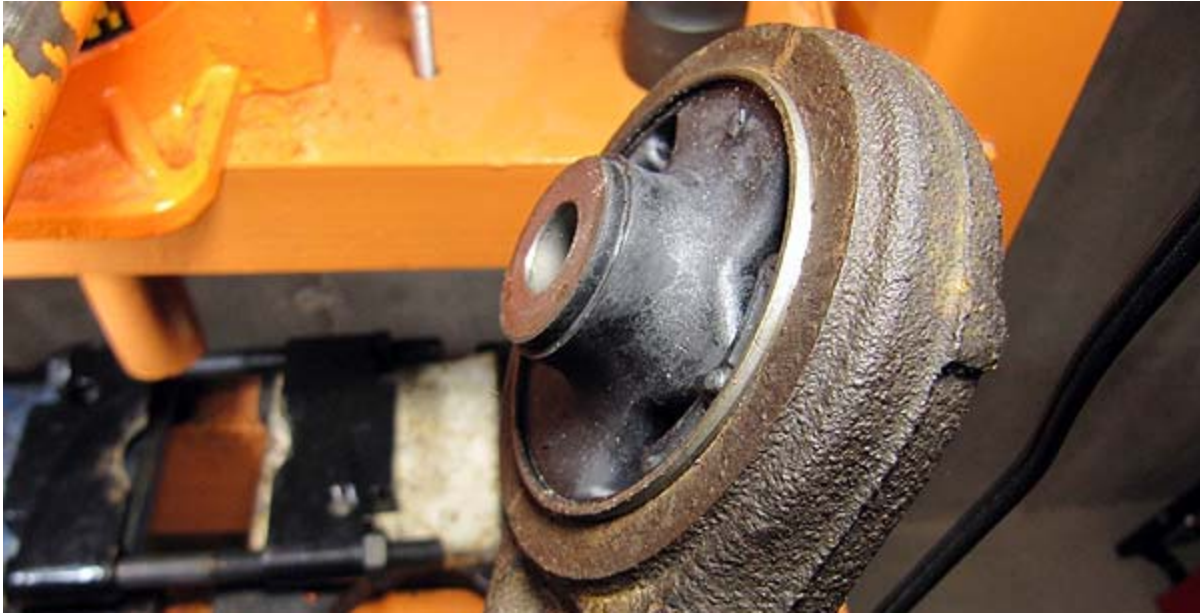
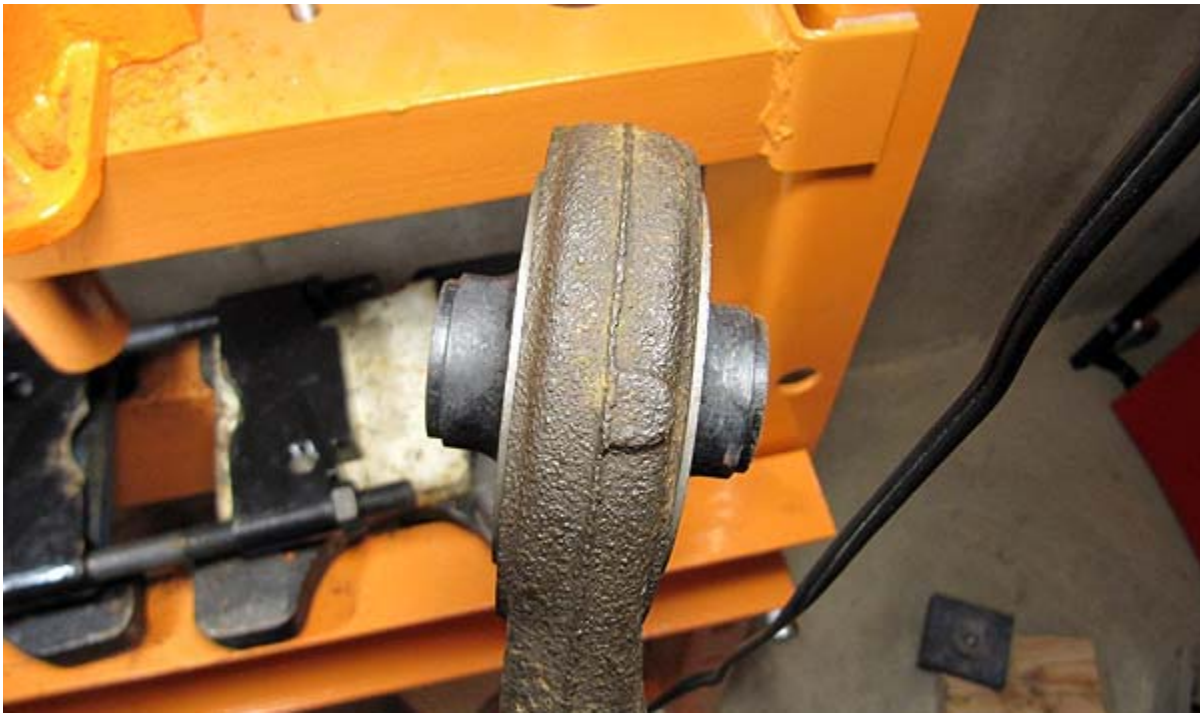
#25 – Push the bushing in until there is an equal amount of the bushing sleeve exposed on either side.

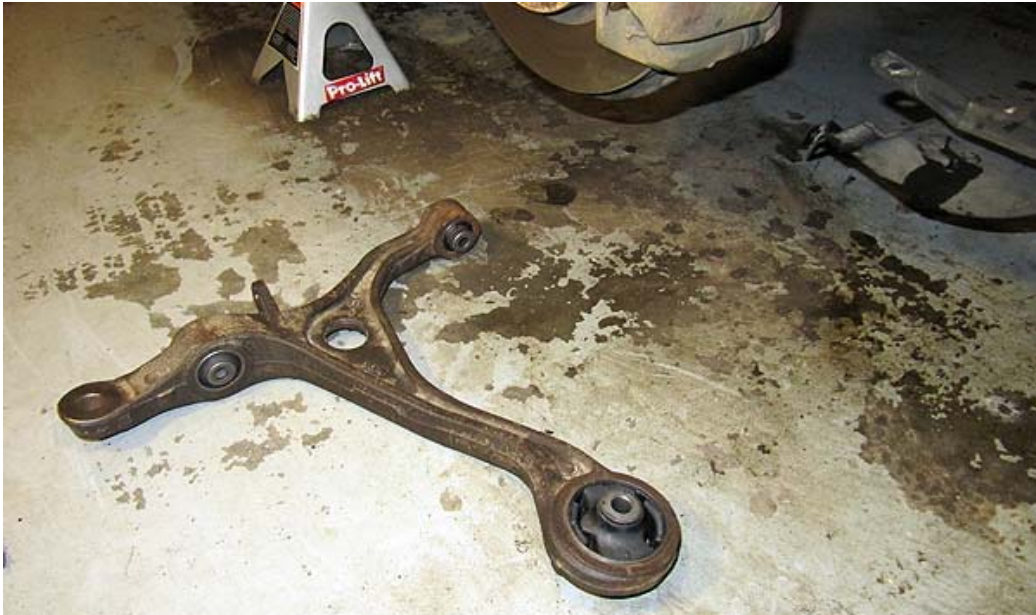
#26 – Now the Lower Control Arm with new bushings is ready to be reinstalled!

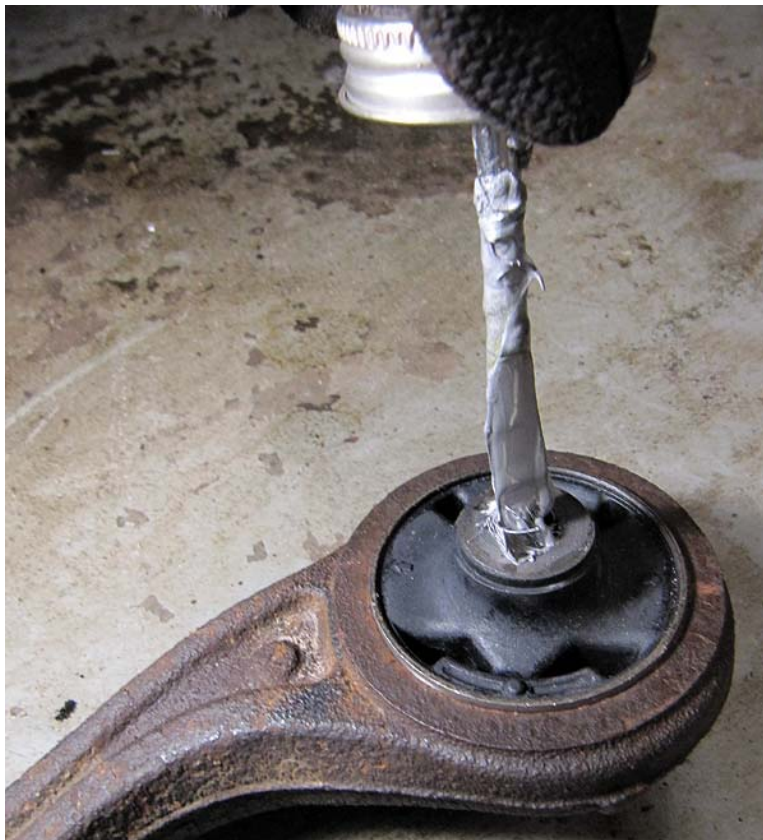
I coated the inside sleeves of the bushings with anti-seize.

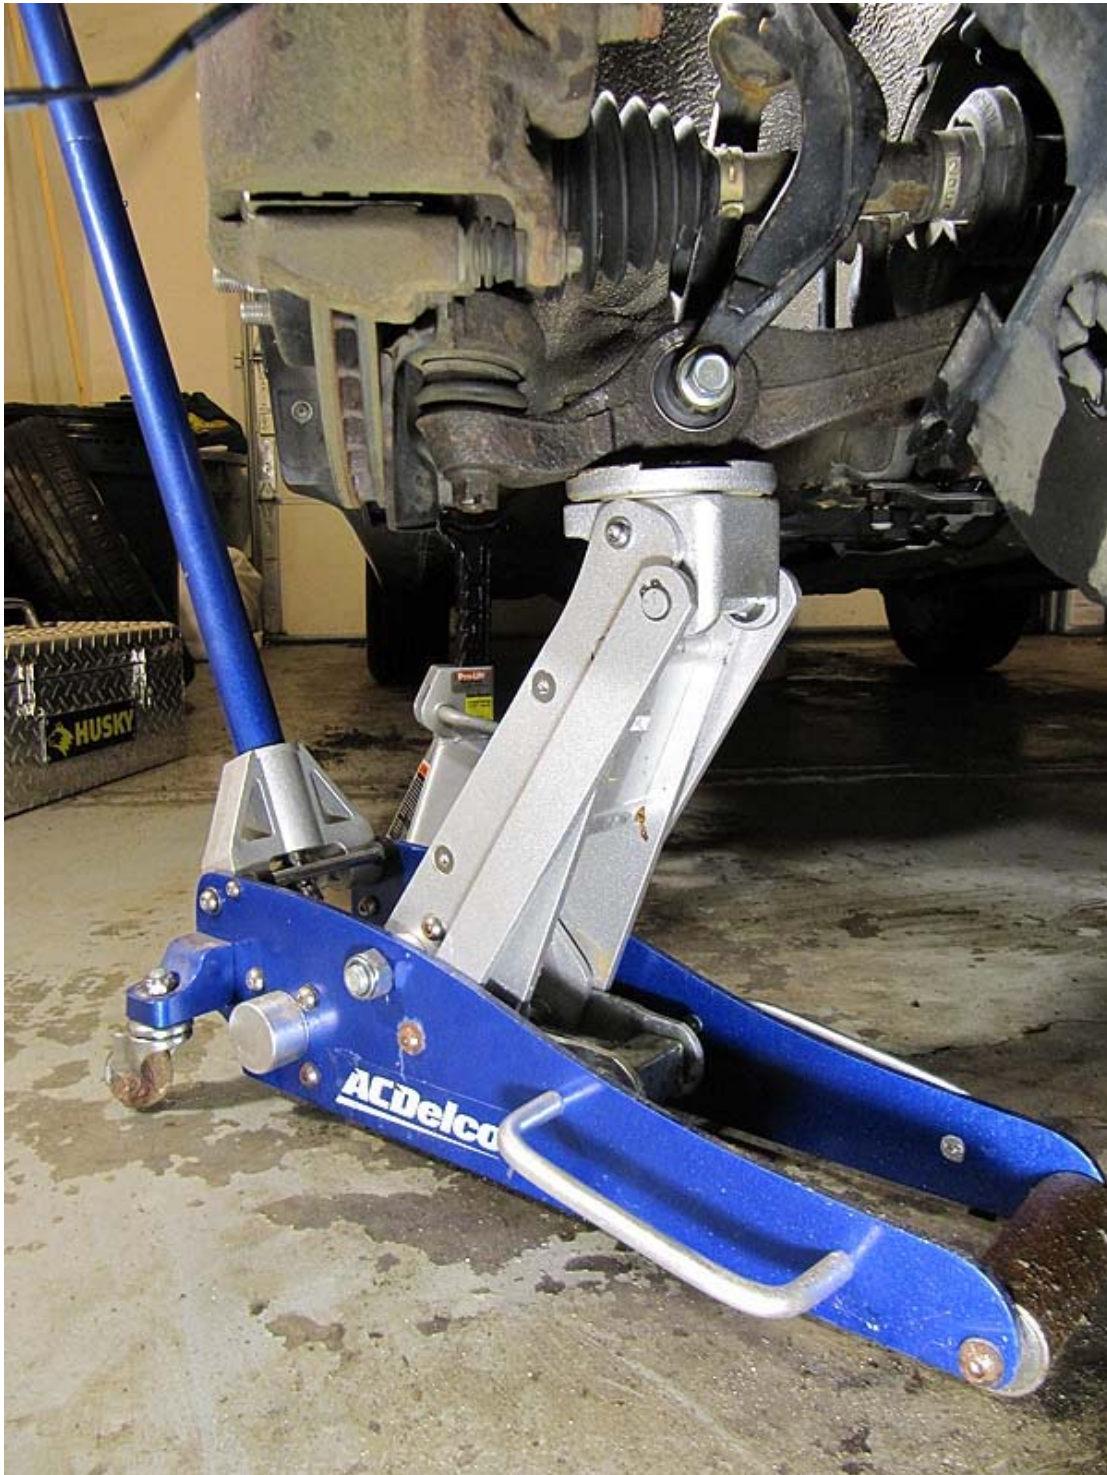
#27 – Reinstall the Lower Control Arm and loosely install all fasteners (Compliance Bushing bolt, Rear Bushing bolt, Shock Absorber bolt, Stabilizer Link nut and Lower Ball Joint Nut). Then, before torquing down the fasteners, raise the lower control arm so that it supports the vehicle's weight.
