Replacing Lower Control Arm Bushings on a 2007 Honda Accord 4CYL

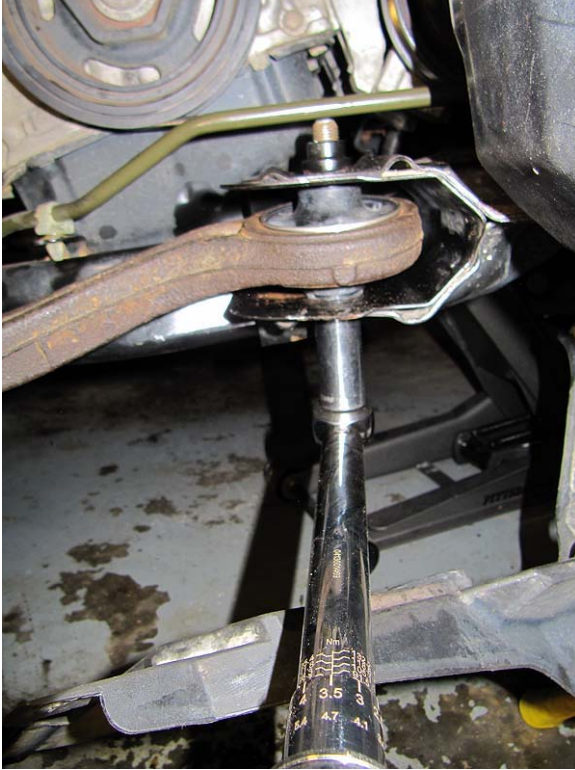
Torque the Compliance Bushing bolt to 61 ft-lbs.

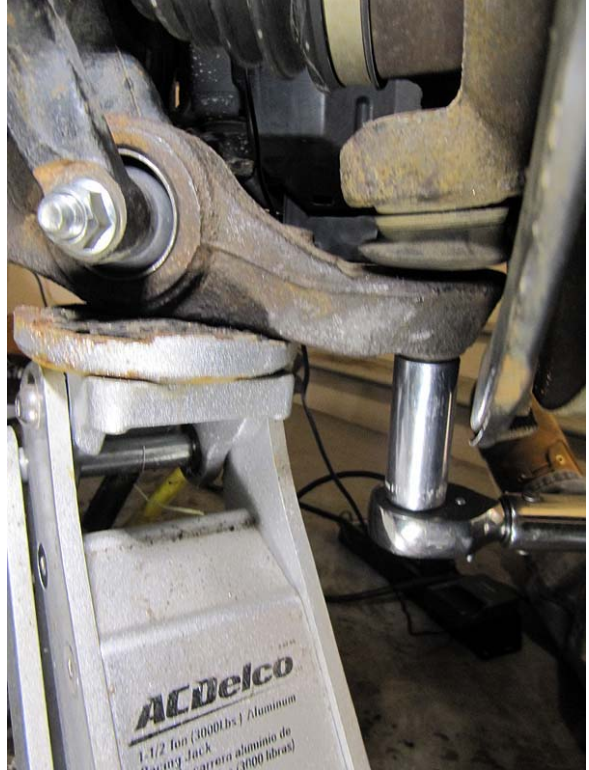
Torque the Lower Ball Joint nut to 58 ft-lbs.

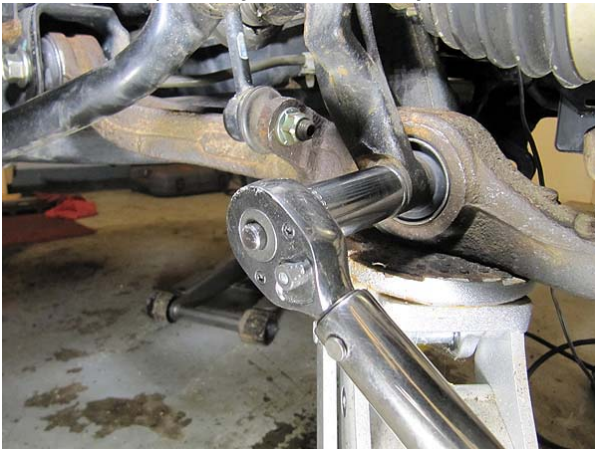
Torque the fork bolt to 47 ft-lbs.

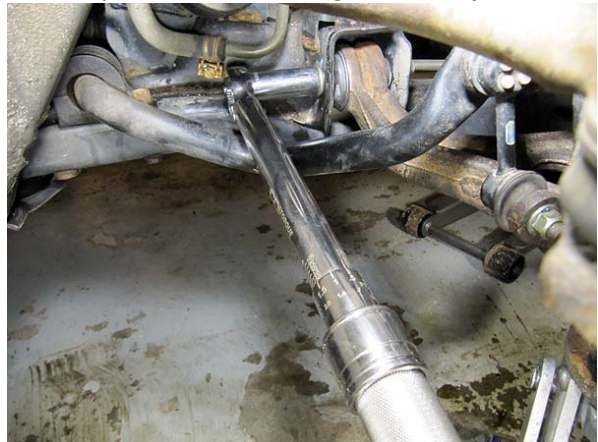
Torque the Rear Bushing bolt to 47 ft-lbs.

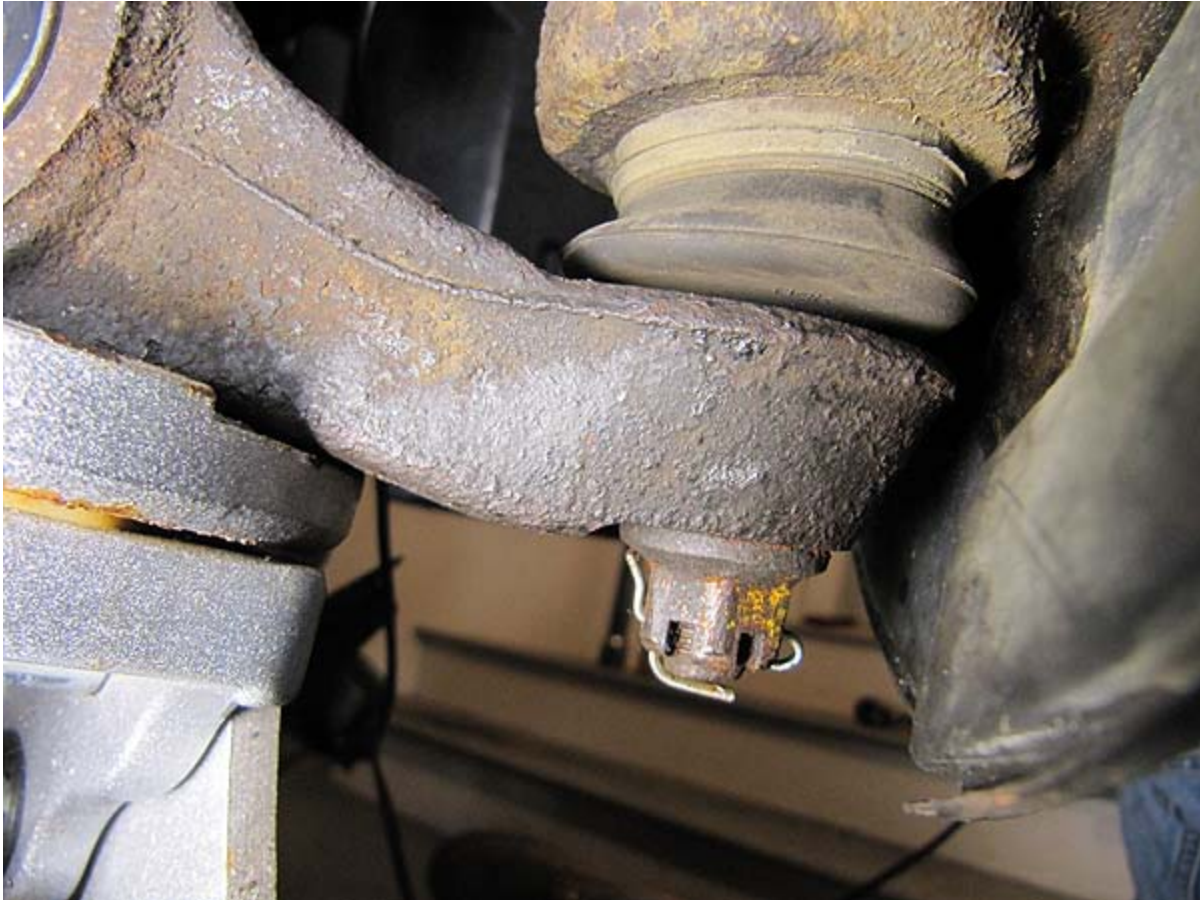
#29 – Install a new cotter pin on the Lower Ball Joint nut.
